Michigan State University
Beaumont Tower - Asbestos Inspection Photo Log

Beaumont Tower (#12)

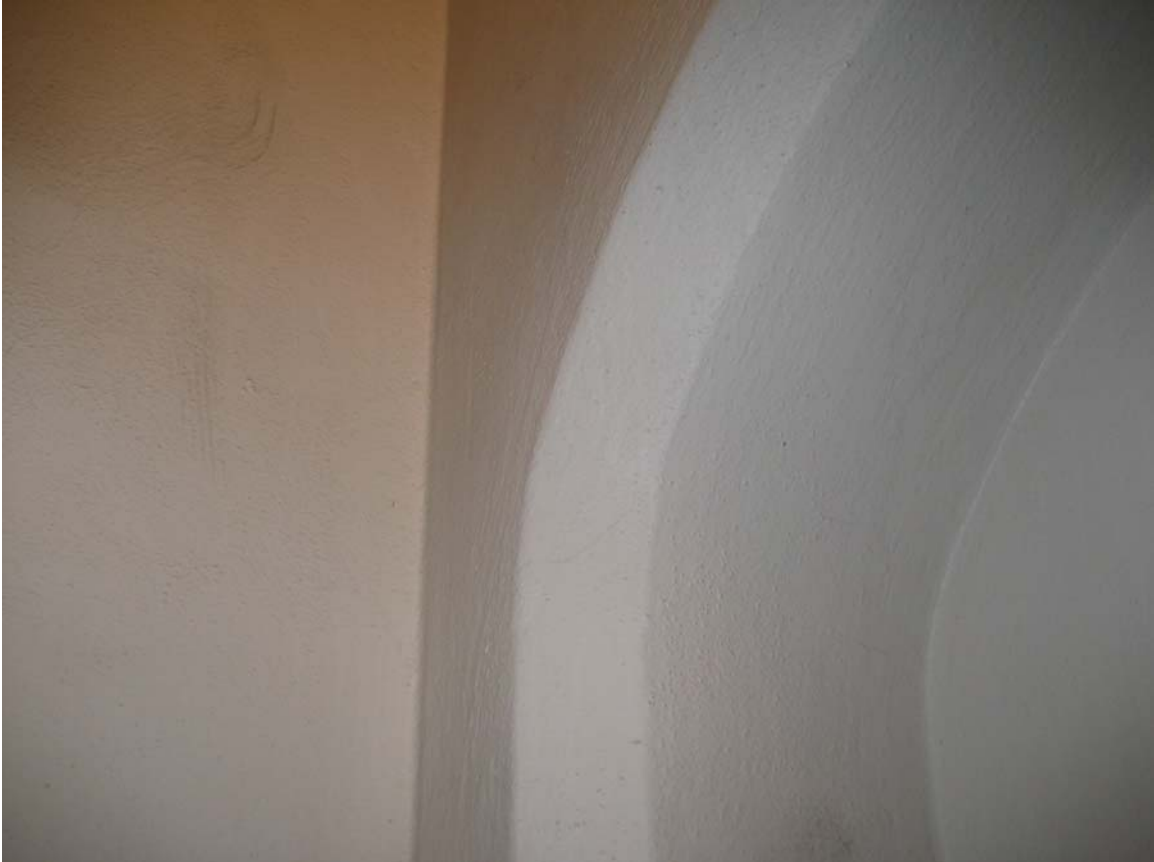
HA #1 – Non asbestos containing plaster with light texture

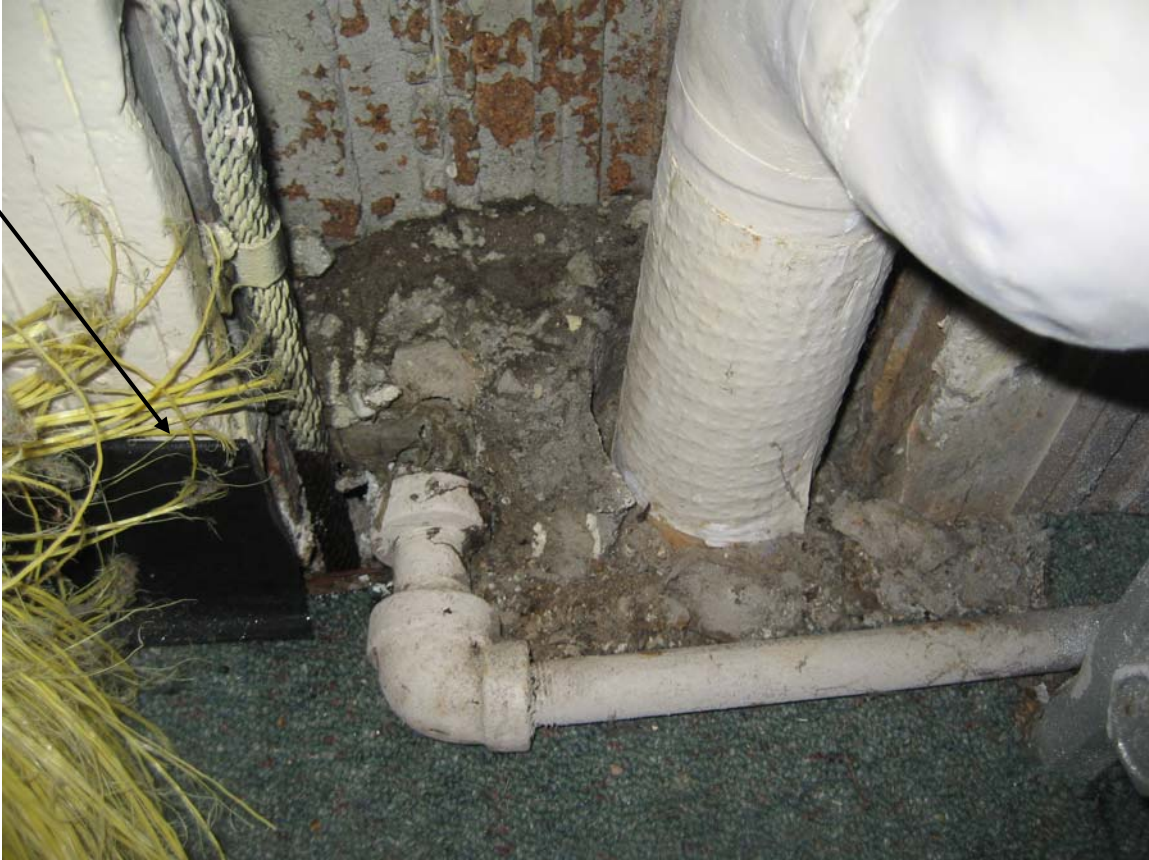
HA #2 – Non asbestos containing 4” black cove molding and associated mastic

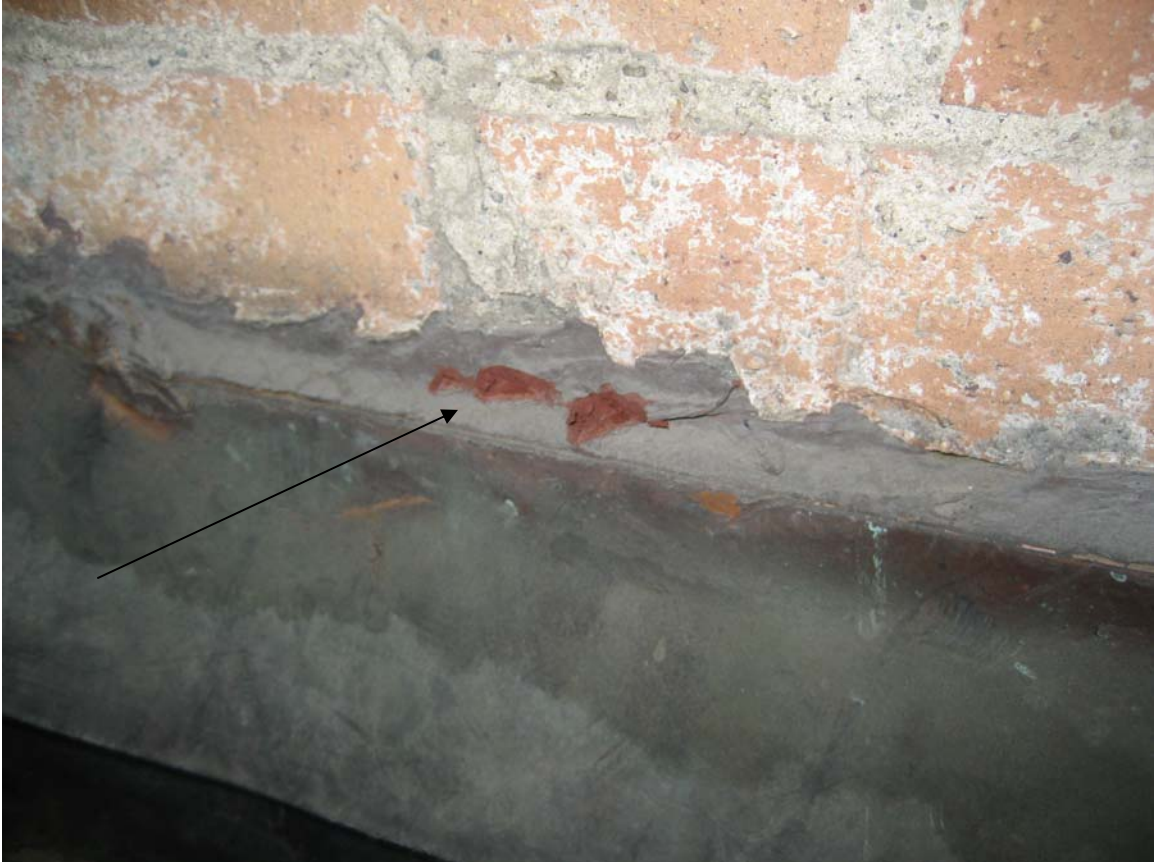
HA #3 – Asbestos containing black and brown building caulk

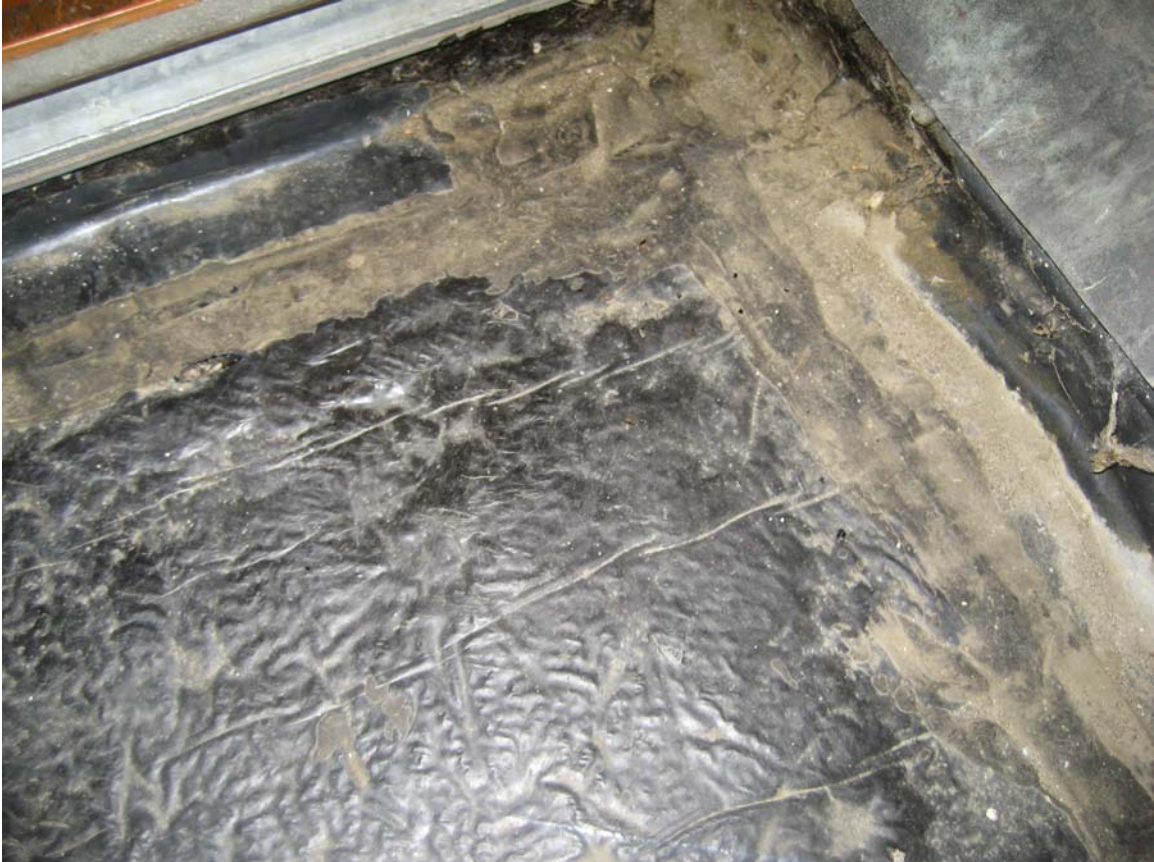
HA #4 – Non asbestos containing black vinyl waterproof material

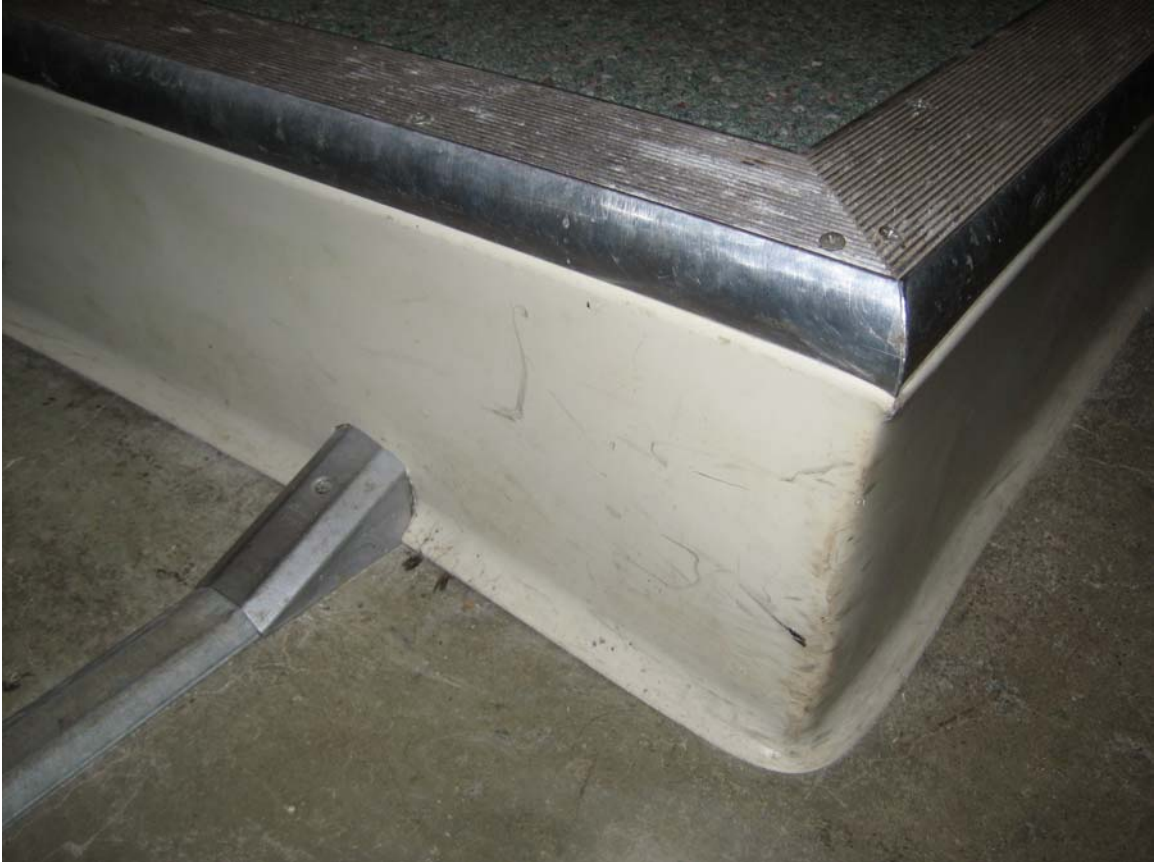
HA #5 – Assumed asbestos containing 6” khaki cove molding and associated mastic

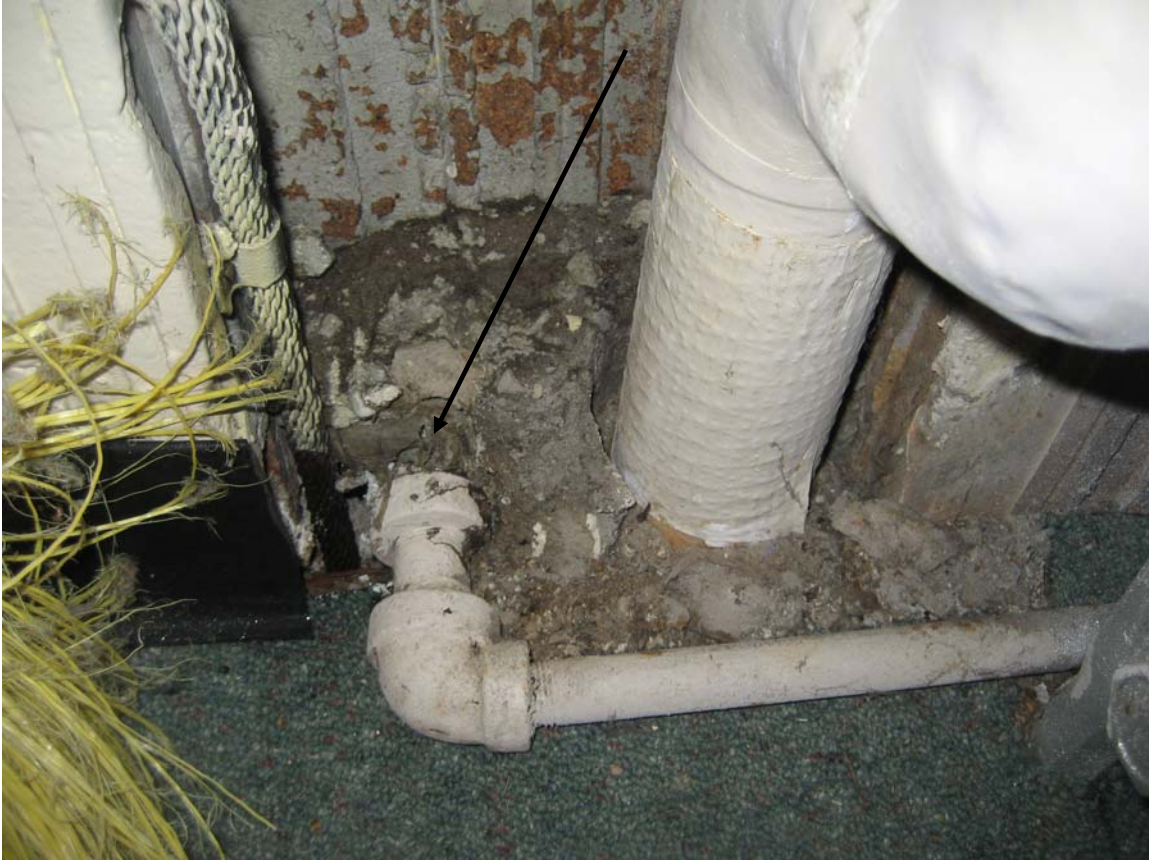
HA #6 – Asbestos containing pipe insulation between floors

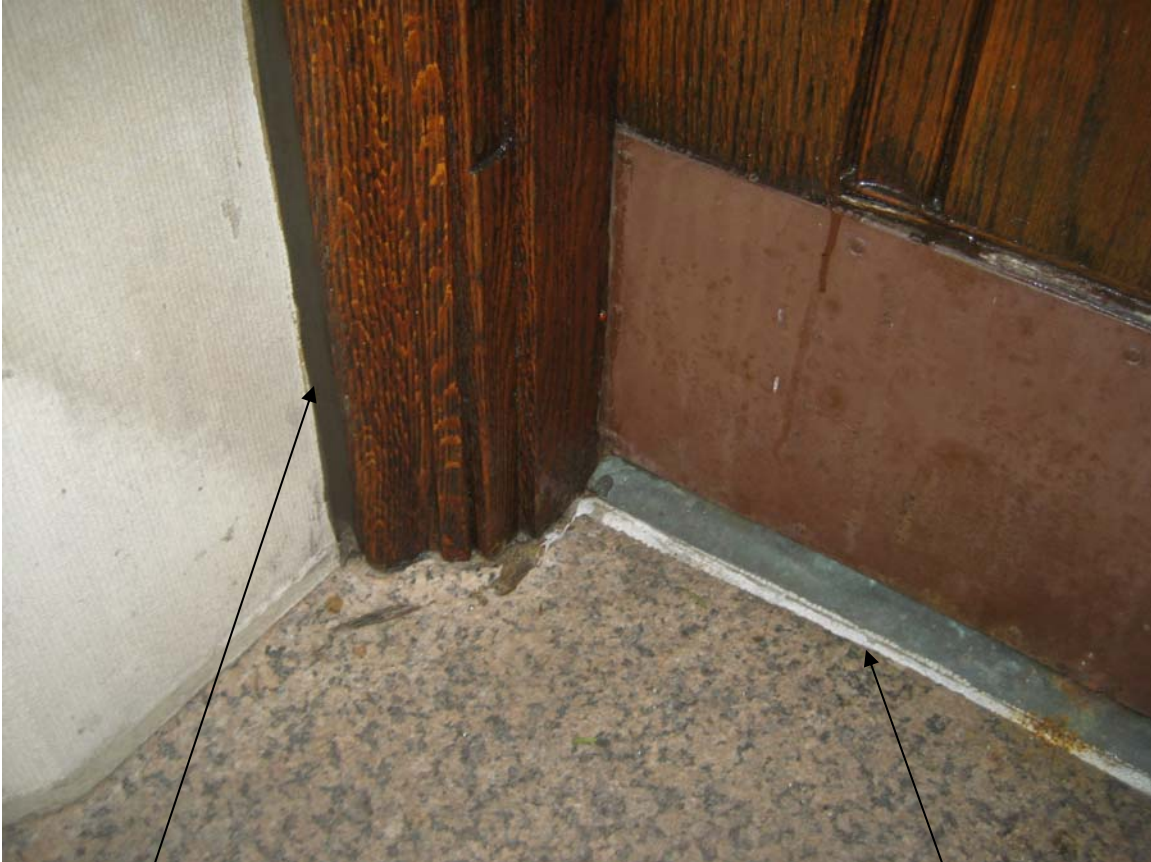
HA #7 – Non asbestos containing brown exterior door caulk

HA #8 – Asbestos containing white door stop caulk
