Michigan State University Old Botany Building #17

Old Botany Photo Log

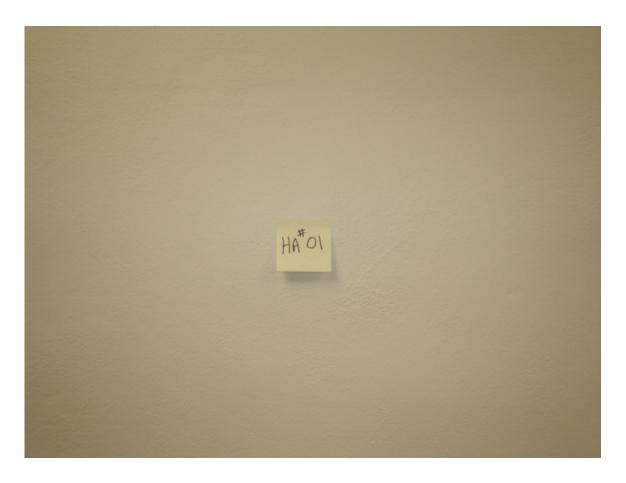
HA #1 – Non asbestos-containing plaster (wall and ceiling)

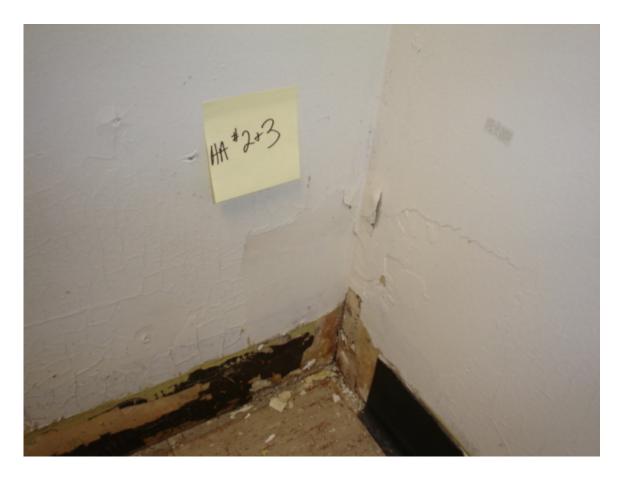
HA #2 – Non asbestos-containing drywall

HA #3 – Asbestos-containing drywall joint compound

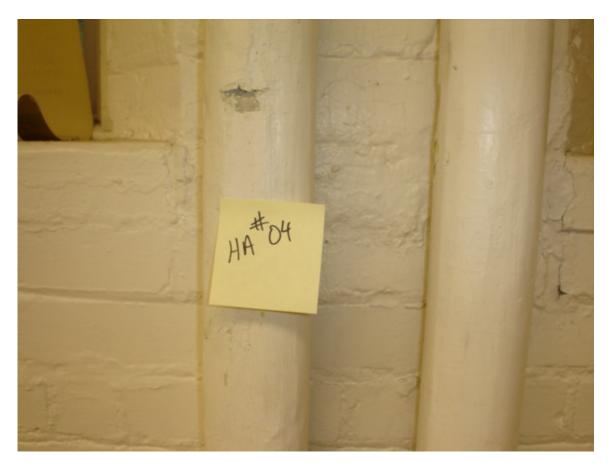
HA #4 – Asbestos-containing steam/condensate supply and return pipe straight insulation

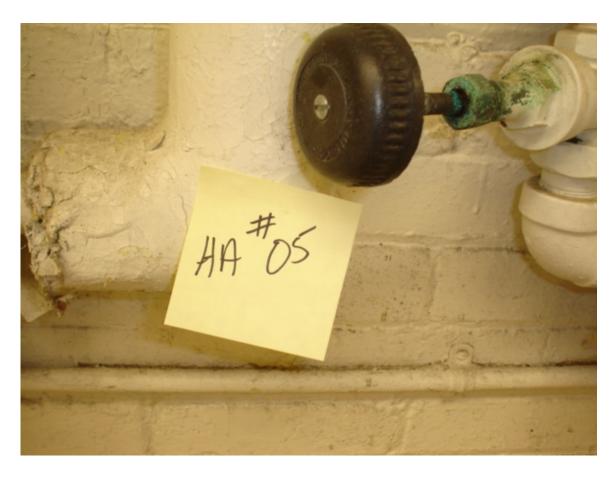
HA #5 – Asbestos-containing steam/condensate supply and return pipe joint and hanger insulation

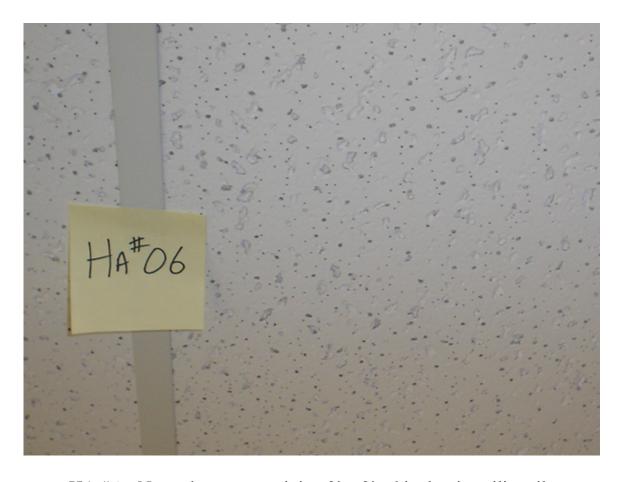
HA #6 – Non asbestos-containing 2' x 2' white lay-in ceiling tile with pin holes and fissures

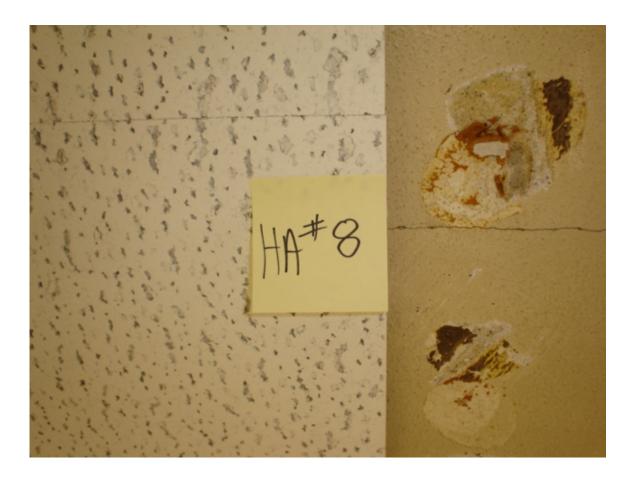
HA #8 – Non asbestos-containing 12" x 12" white ceiling tile with gouges and associated glue pods

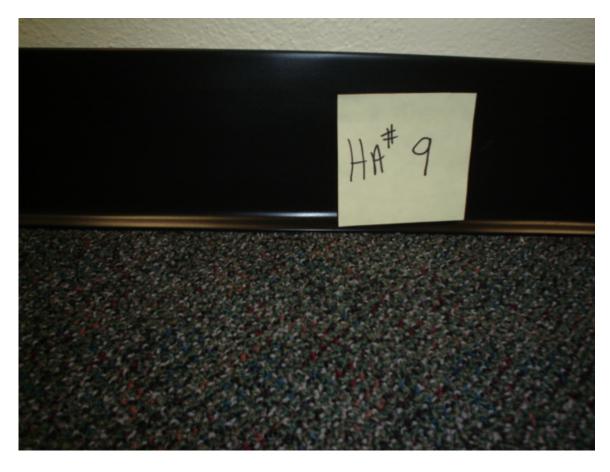
HA #9 – Non asbestos-containing 4" black cove molding and associated non-asbestos containing mastic

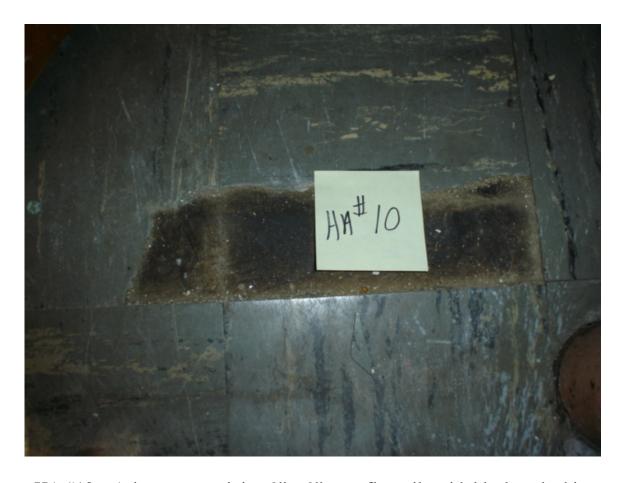
HA #10 – Asbestos-containing 9" x 9" gray floor tile with black and white streaks and associated non asbestos-containing mastic

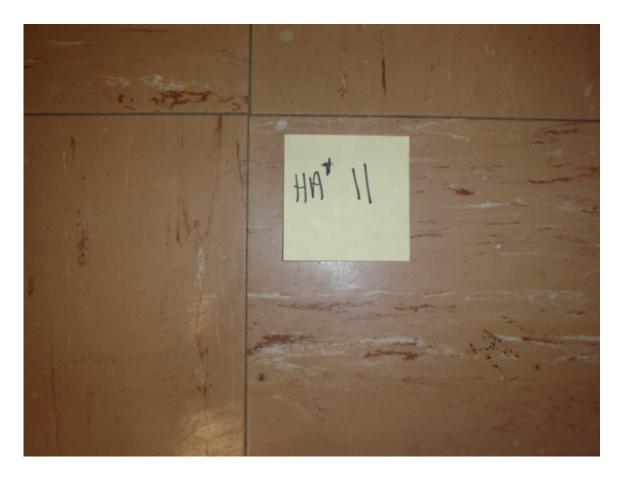
HA #11 – Asbestos-containing 9" x 9" light brown floor tile with white and rust streaks and associated mastic

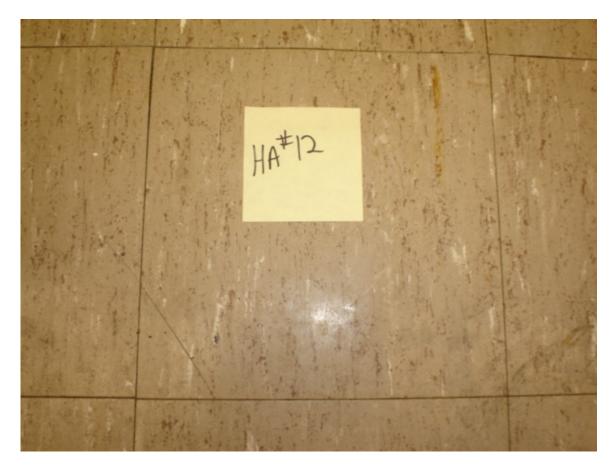
HA #12 – Asbestos-containing 9" x 9" tan floor tile with white and rust streaks and associated non asbestos-containing mastic

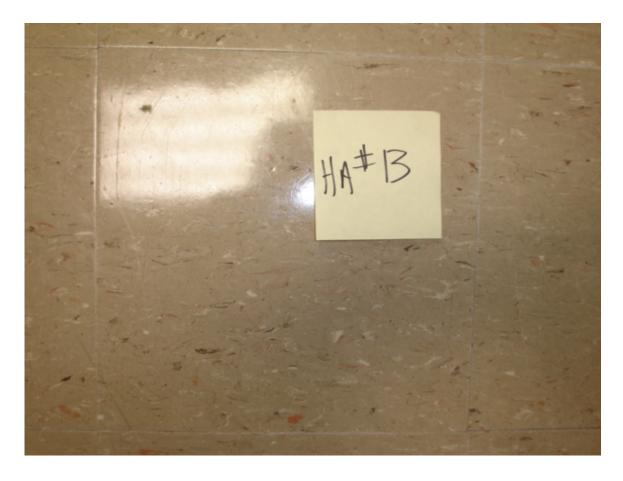
HA #13 – Asbestos-containing 9" x 9" beige floor tile with pink, white and brown streaks and associated non asbestos-containing mastic

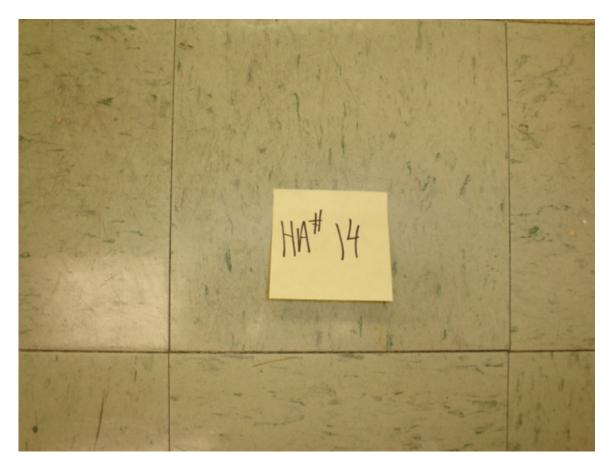
HA #14 – Non asbestos-containing 9" x 9" green floor tile with green streaks and associated asbestos-containing mastic

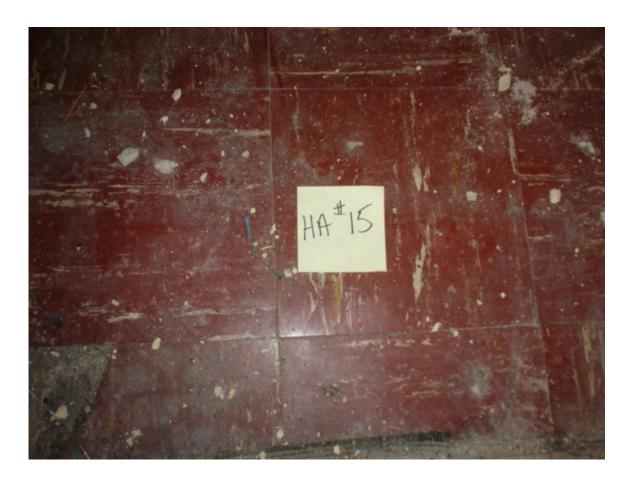
HA #15 – Asbestos-containing 9" x 9" red floor tile with cream streaks and associated non asbestos-containing mastic

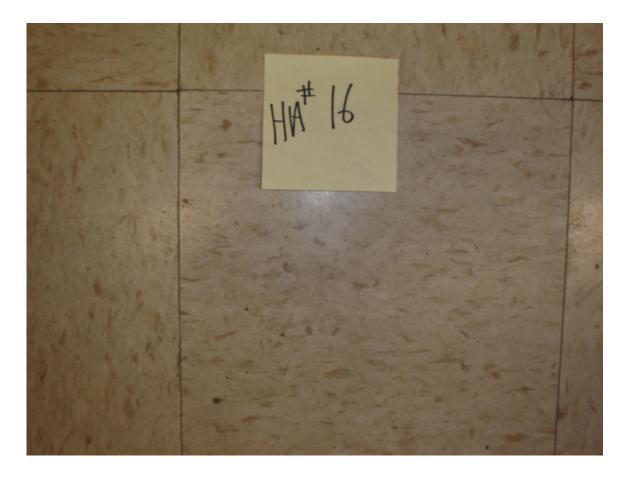
HA #16 – Non asbestos-containing 9" x 9" white floor tile with tan marble pattern and associated asbestos containing mastic

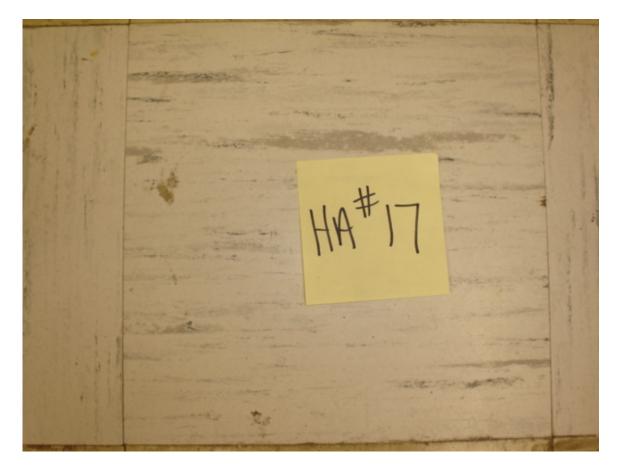
HA #17 – Non asbestos-containing 9" x 9" white floor tile with black streaks and associated asbestos containing mastic

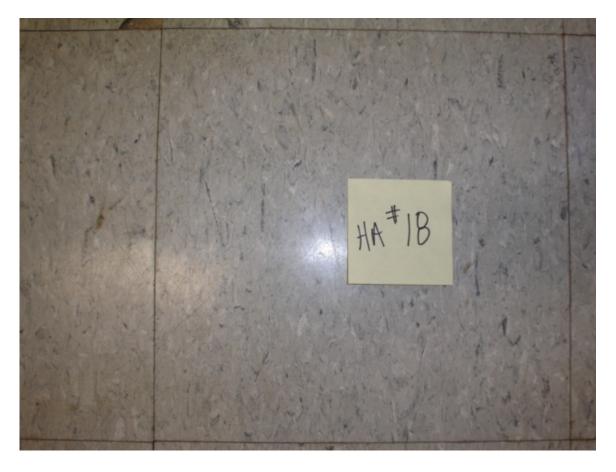
HA #18 – Non asbestos-containing 12" x 12" gray floor tile with gray and white marble pattern and associated mastic

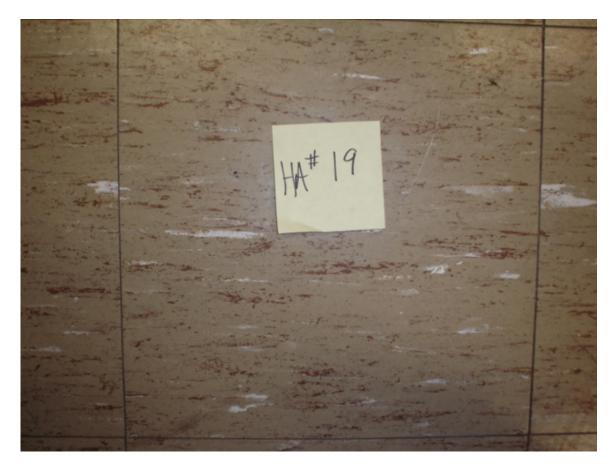
HA #19 – Asbestos-containing 12" x 12" tan floor tile with white and rust streaks and associated non asbestos-containing mastic

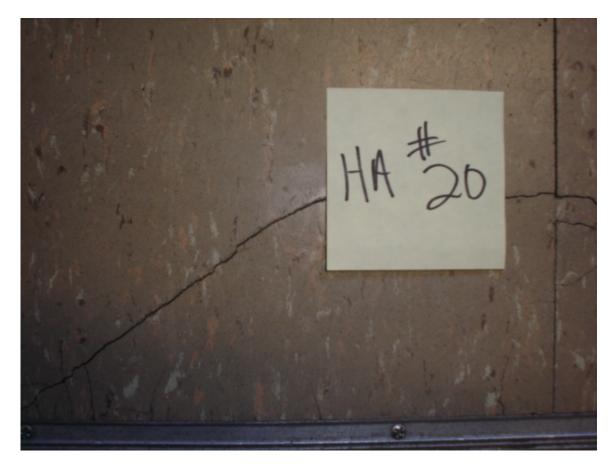
HA #20 – Non asbestos-containing 12" x 12" beige floor tile with pink, white and brown streaks and associated mastic

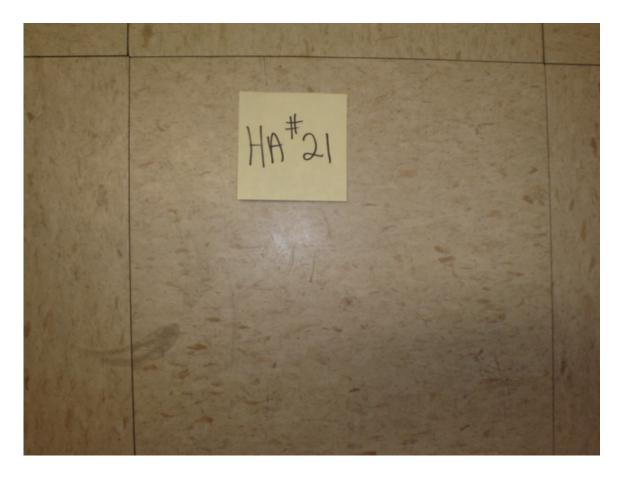
HA #21 – Non asbestos-containing 12" x 12" white floor tile with tan marble pattern and associated mastic

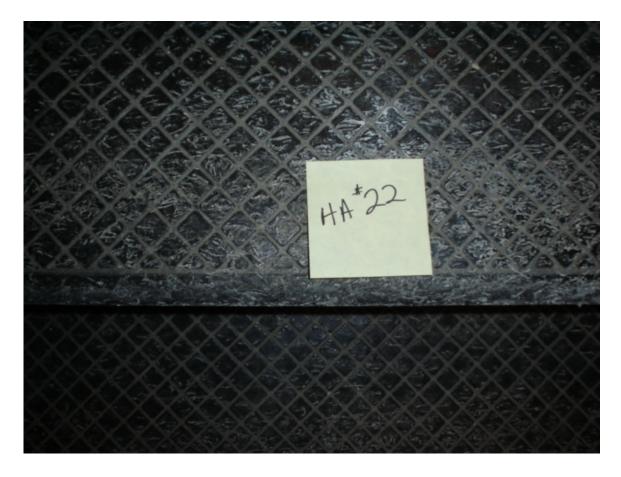
HA #22 - Non asbestos-containing black stair tread and associated mastic

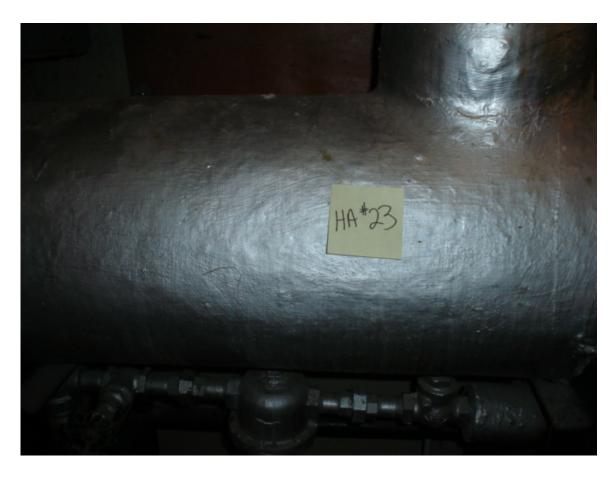
HA #23 – Asbestos-containing steam/condensate heat exchange tank insulation

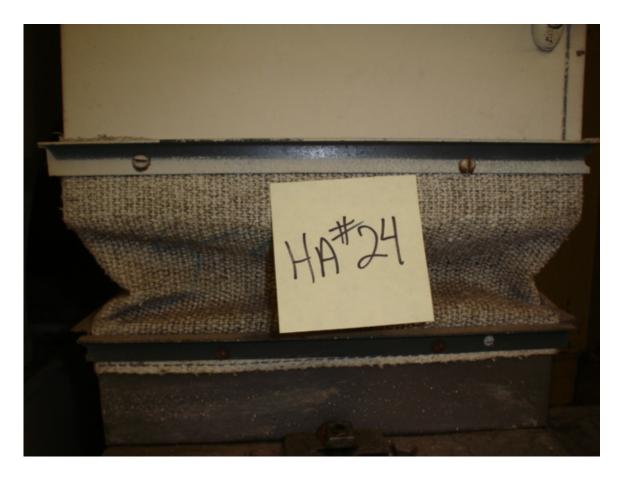
HA #24 – Asbestos-containing ventilation duct expansion cloth

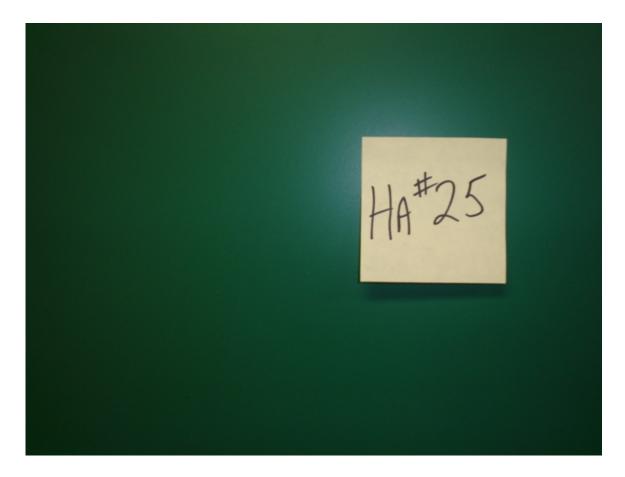
HA #25 – Assumed asbestos-containing chalkboards and associated glue pods

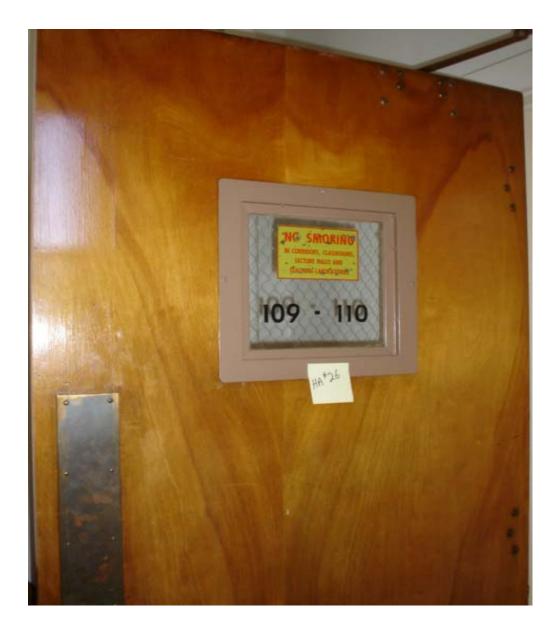
HA #26 – Assumed asbestos-containing fire door and frame

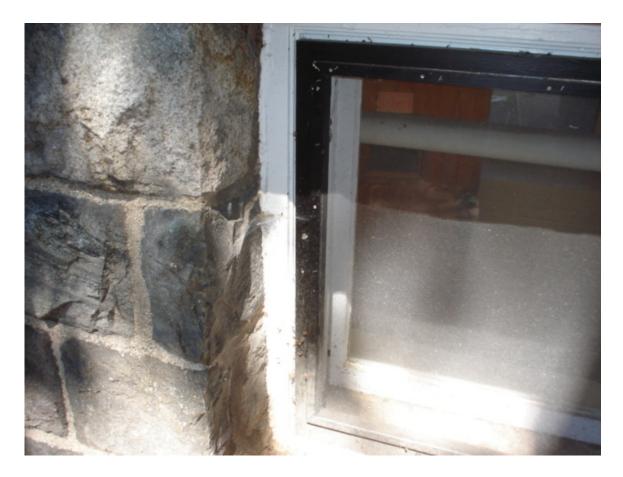
HA #27 – Assumed asbestos-containing window and door frame caulk compound

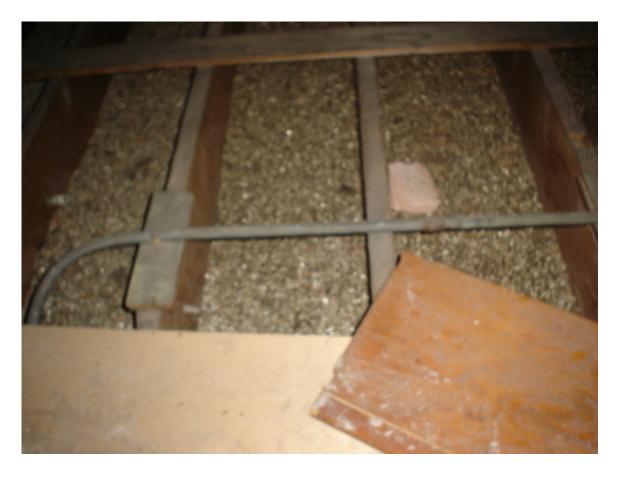
HA #30 – Non asbestos-containing attic insulation

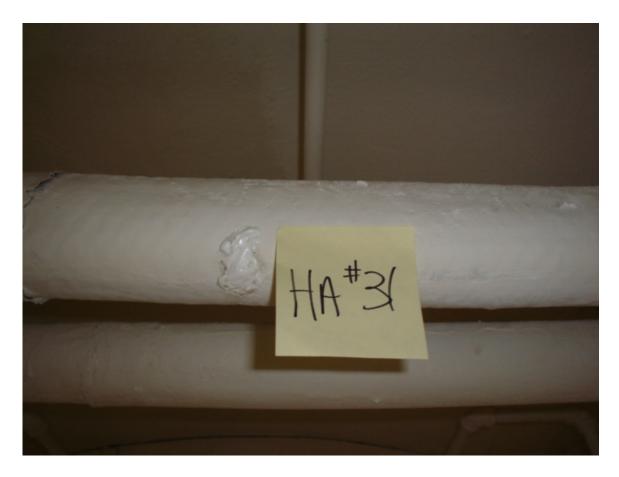
HA #31 – Asbestos-containing domestic water supply pipe straight insulation

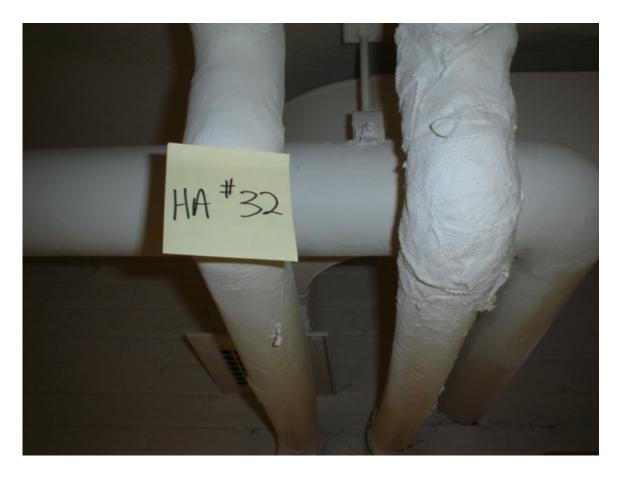
HA #32 – Asbestos-containing domestic water supply pipe joint and hanger insulation

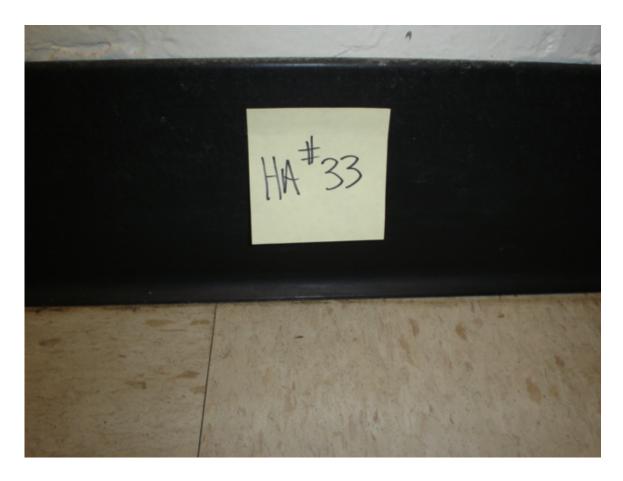
HA #33 – Non asbestos-containing 6" black cove molding and associated mastic
