Auditorium Photo Log

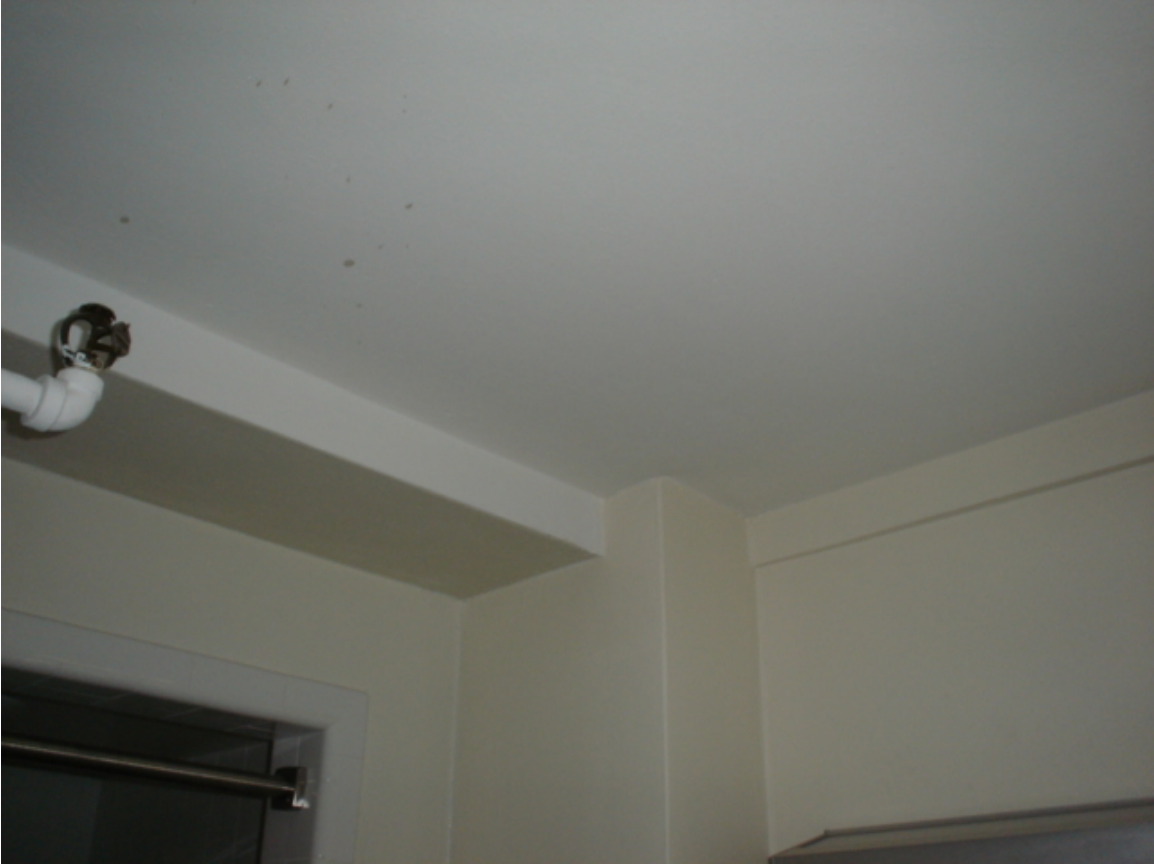
HA #1 – Non asbestos-containing plaster

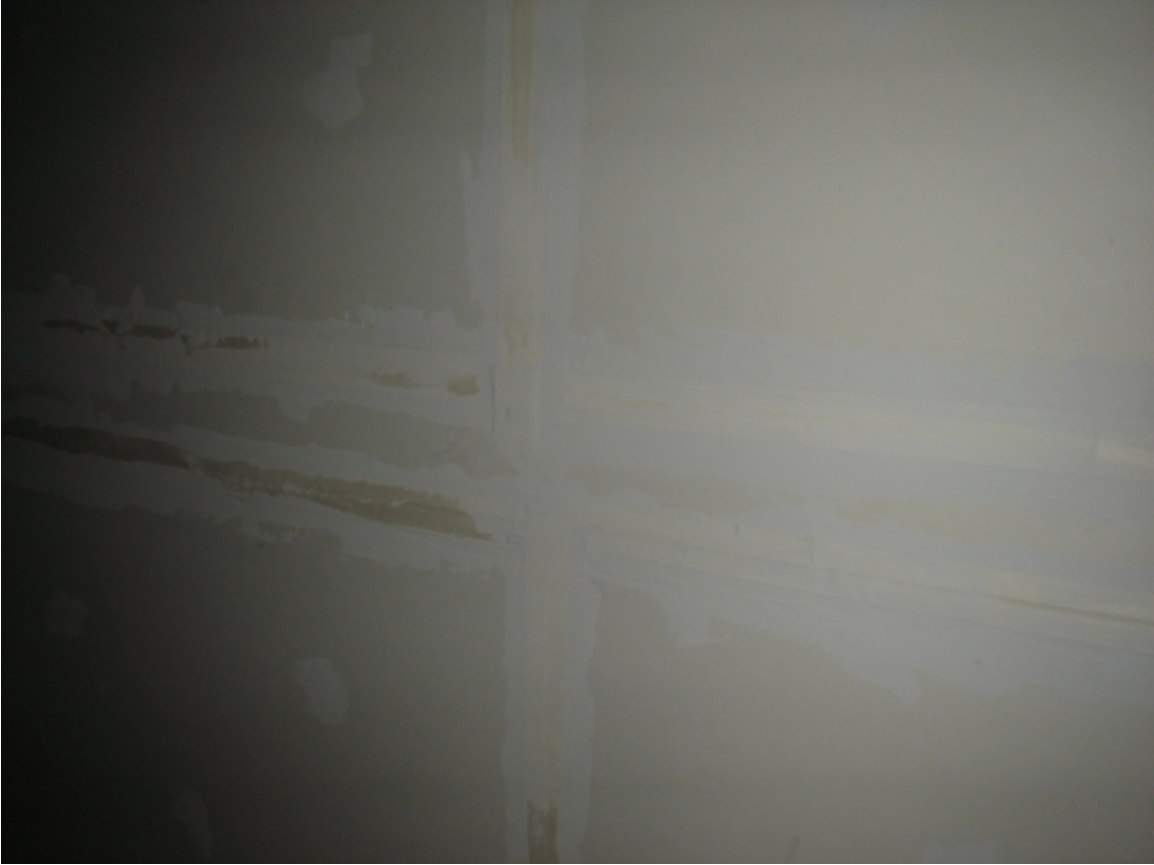
HA #2 – Non asbestos-containing drywall

HA #3 – Asbestos-containing drywall joint compound

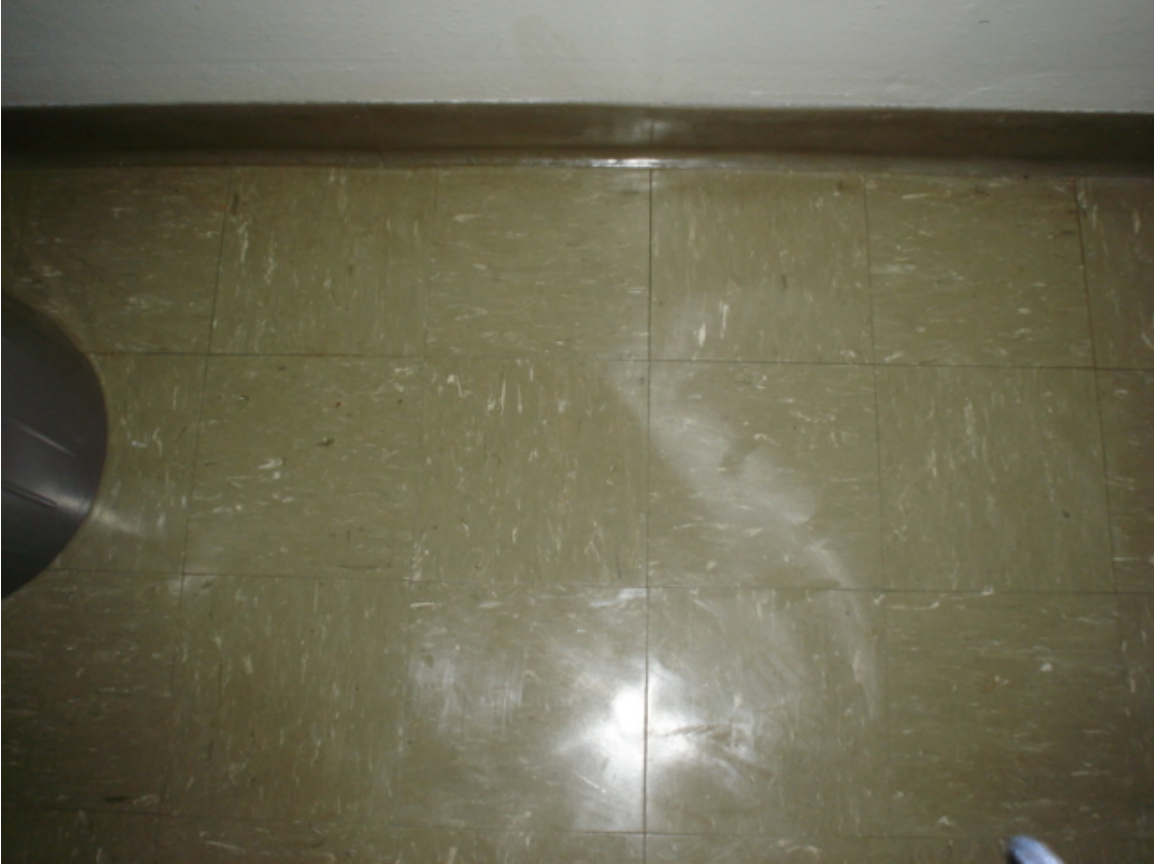
HA #4 – Asbestos-containing 9" x 9" light green floor tile with cream and gray streaks and associated non asbestos-containing mastic

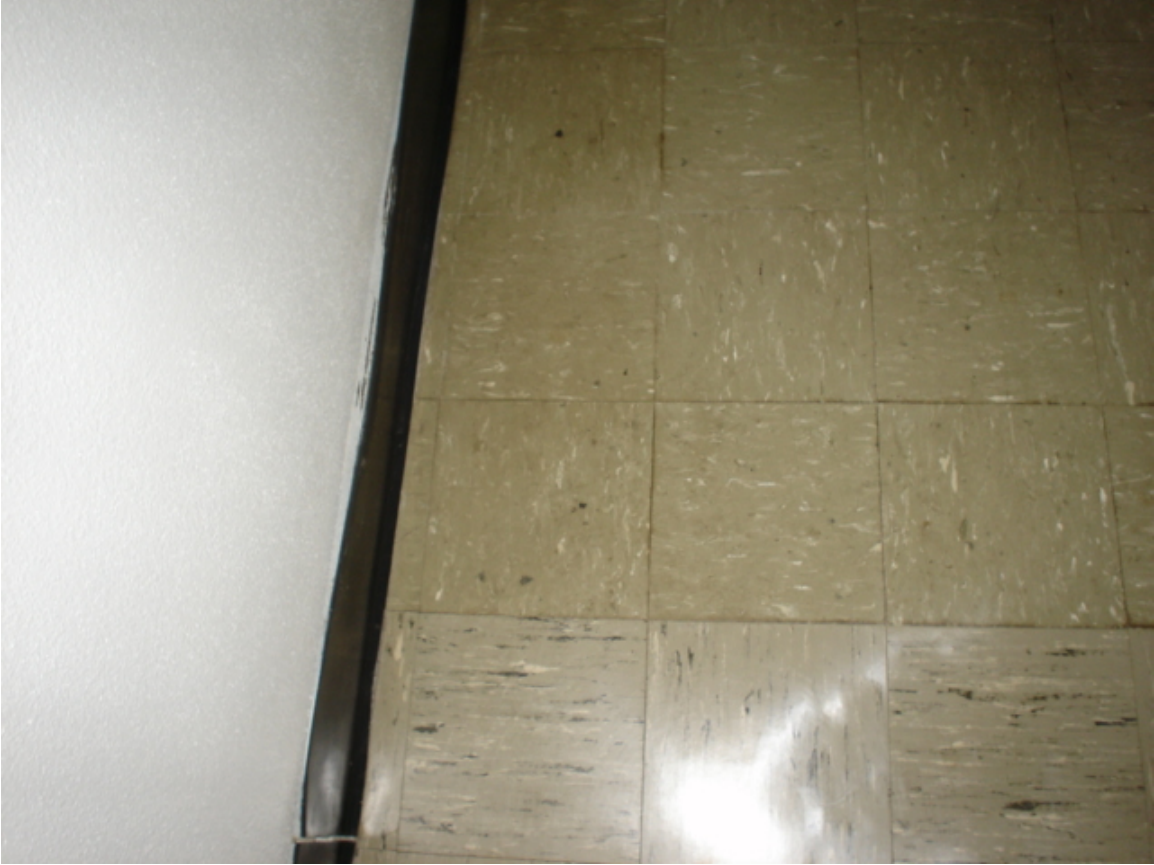
HA #5 – Asbestos-containing 9" x 9" light green floor tile  
with cream and black streaks and associated mastic

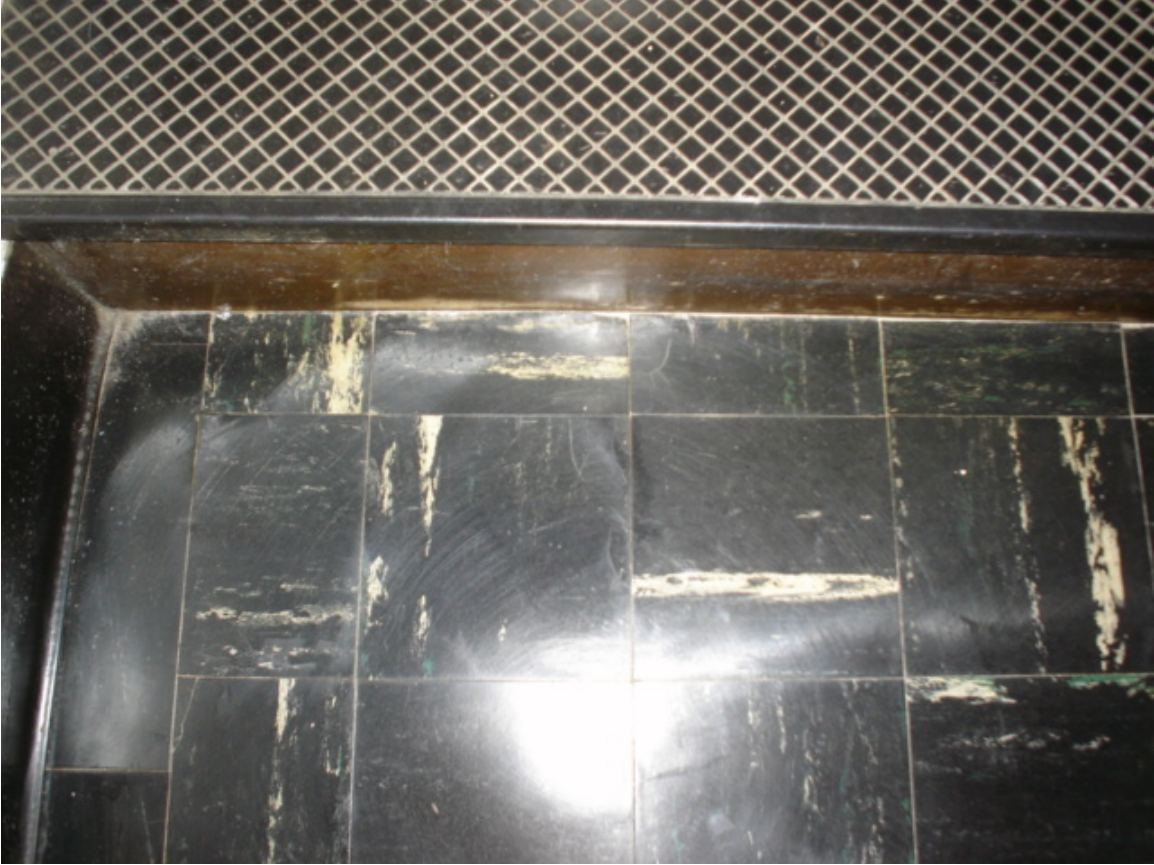
HA #6 – Asbestos-containing 9" x 9" black floor tile with cream and green streaks and associated non asbestos-containing mastic

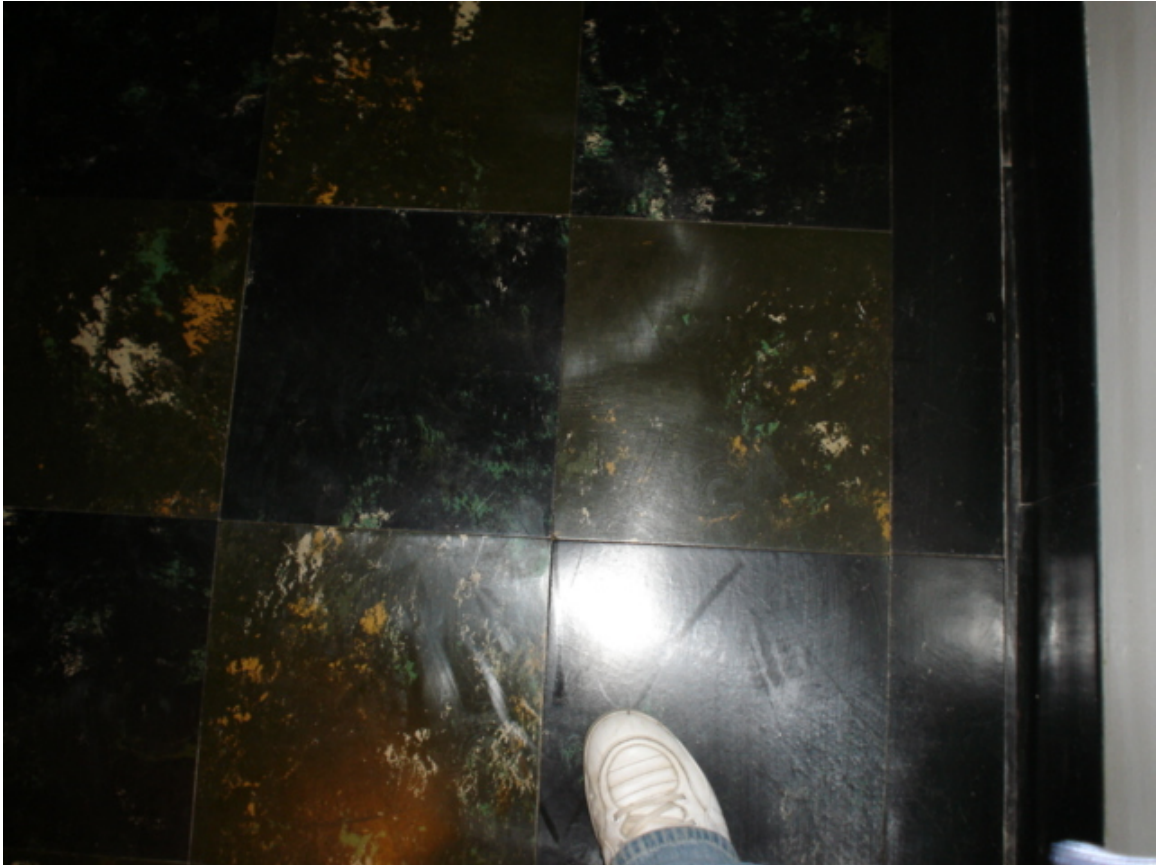
HA #7 – Asbestos-containing 12" x 12" dark green floor tile with cream, orange and green swirls and associated non asbestos-containing mastic

HA #8 – Asbestos-containing 12" x 12" black floor tile with cream and green streaks and associated non asbestos-containing mastic

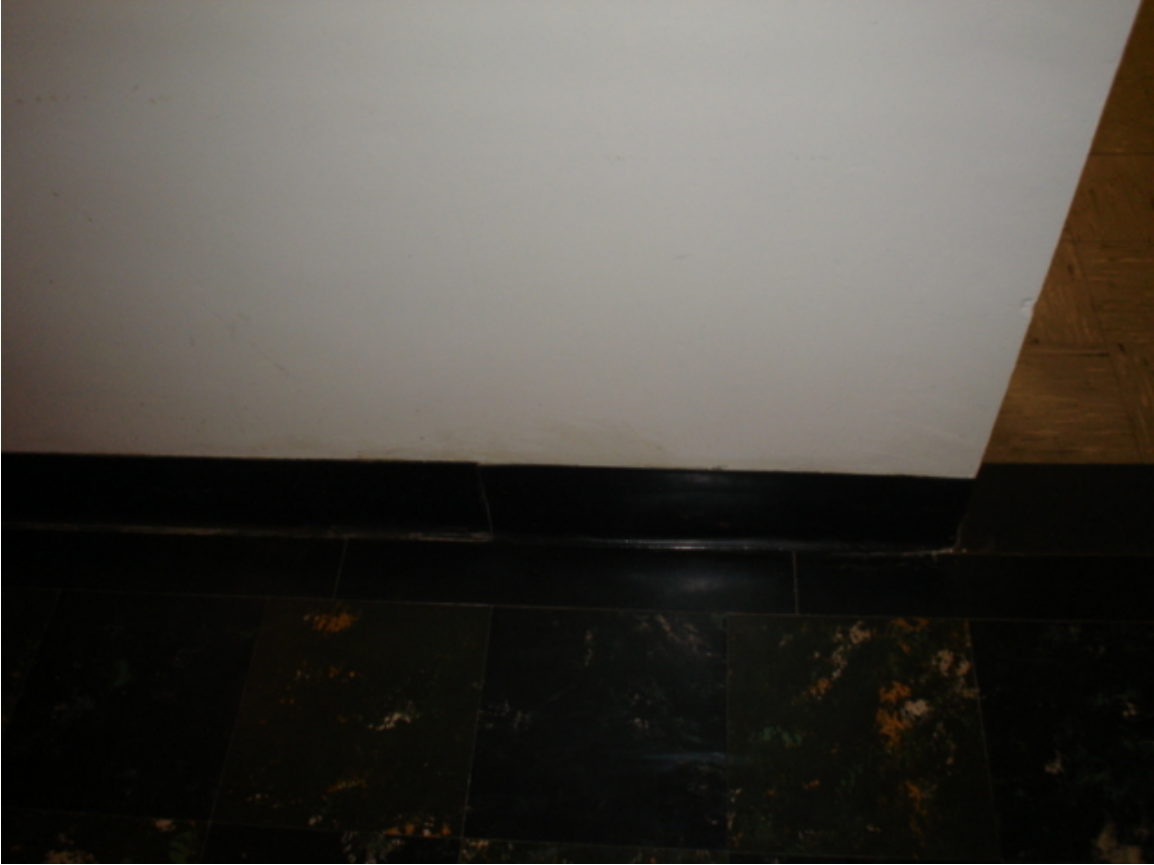
HA #9 – Non asbestos-containing 6" black cove molding  
and associated mastic

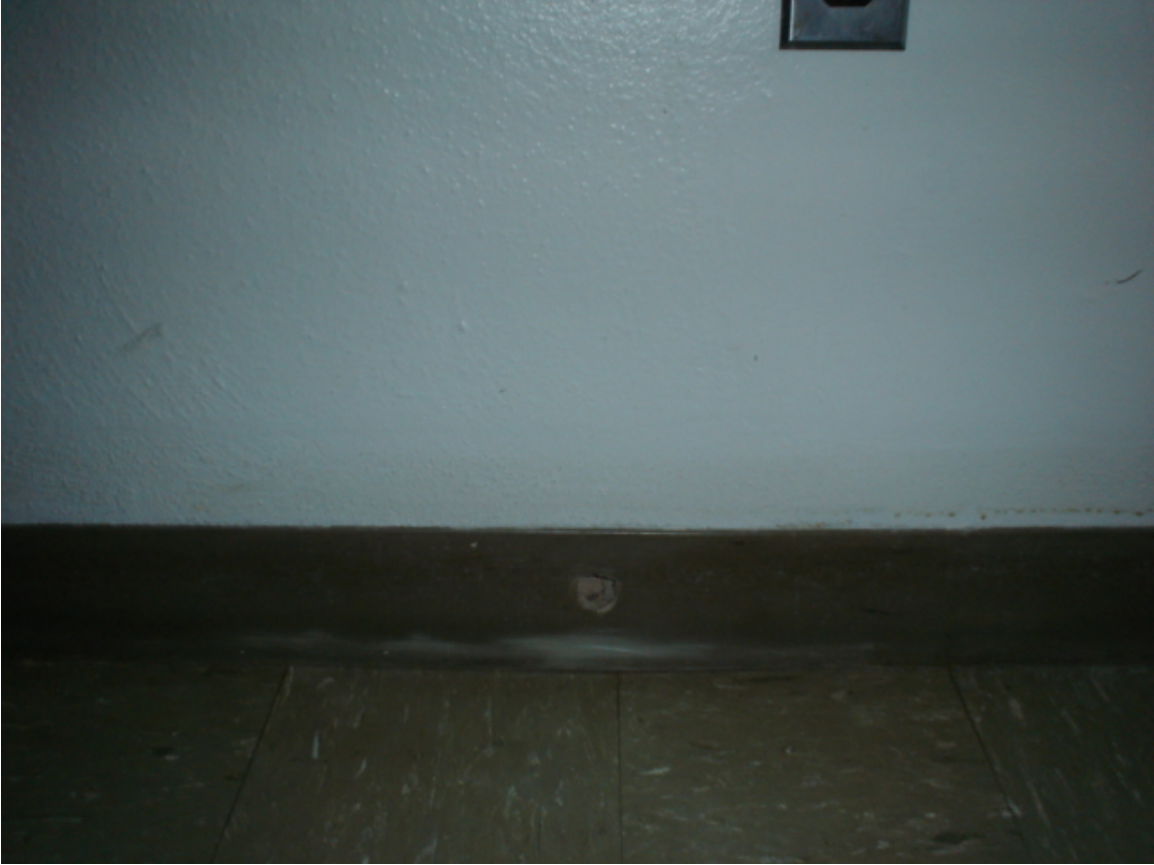
HA #10 – Non asbestos-containing 4" olive cove molding  
and associated mastic

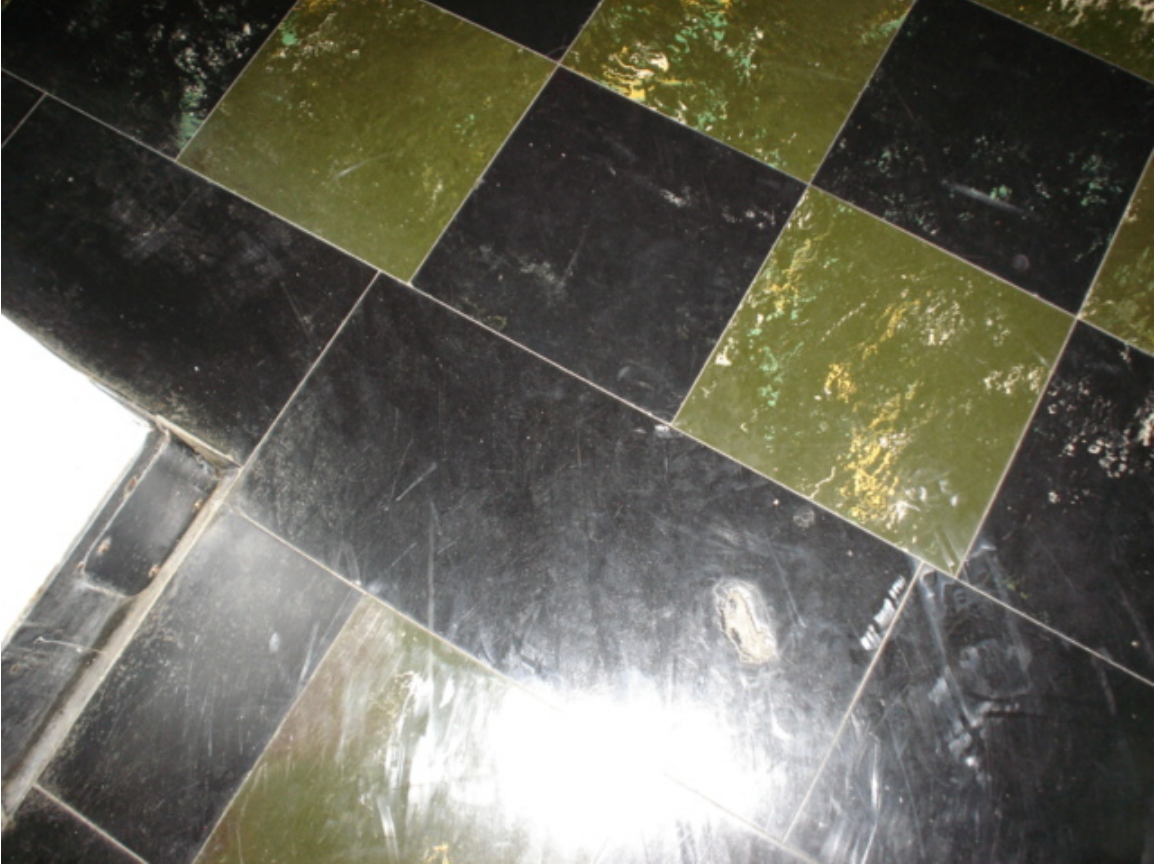
HA #13 – Asbestos-containing 1' x 2' black border floor tile  
and associated mastic

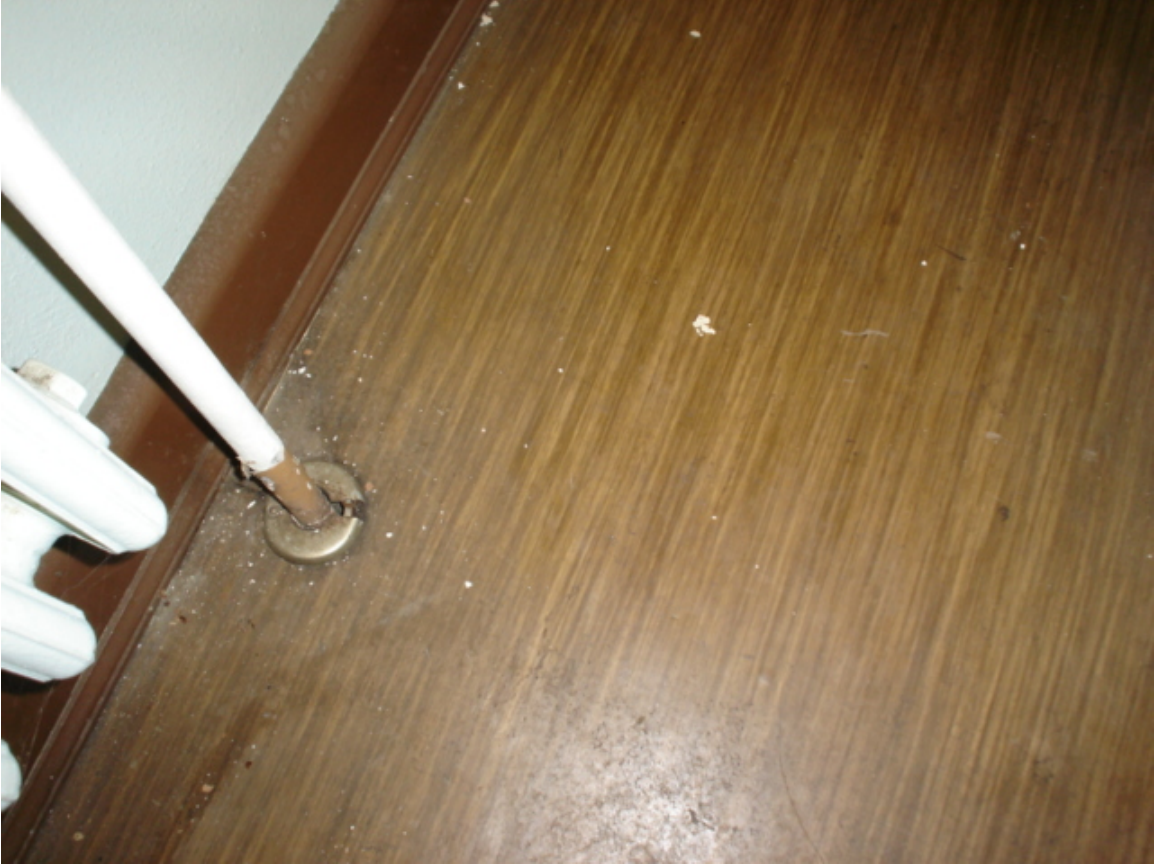
HA #14 – Non asbestos-containing brown linoleum flooring  
with wood grain pattern and associated backing

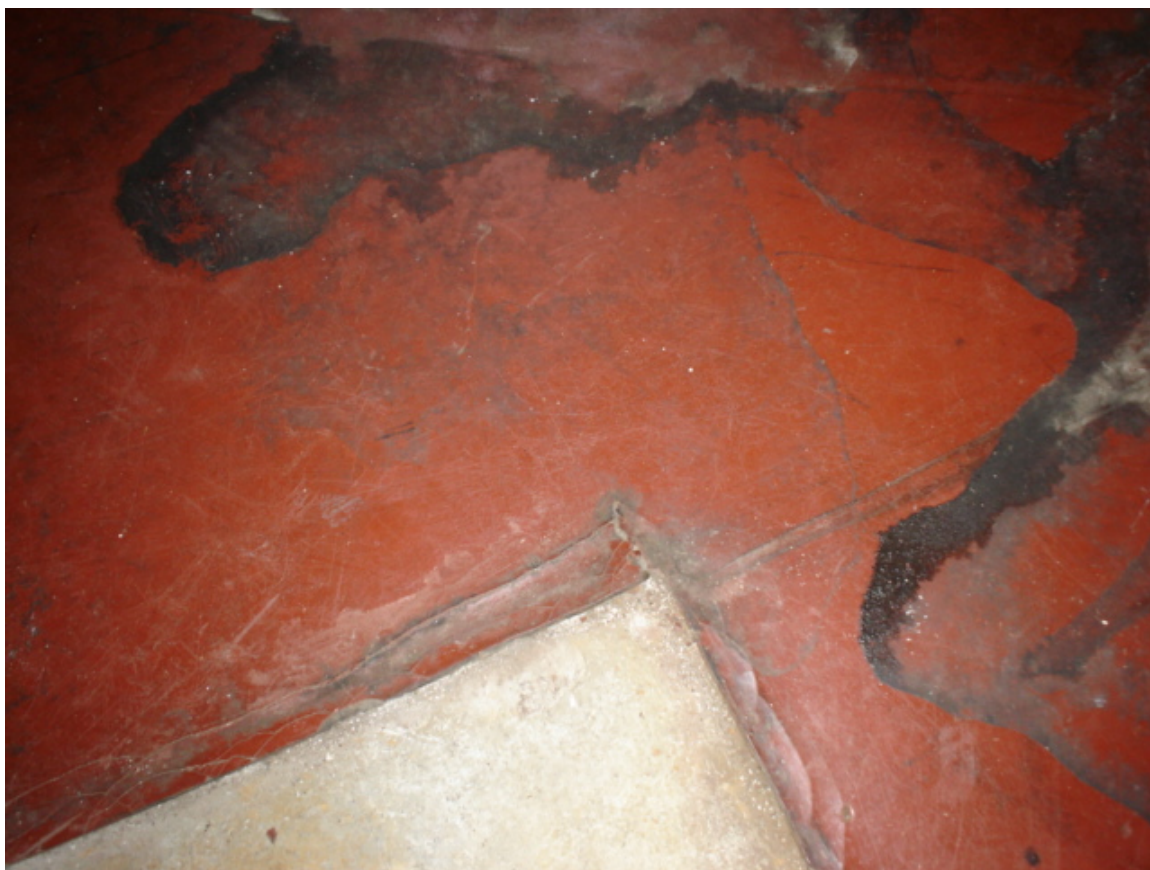
HA #15 – Non asbestos-containing red linoleum flooring  
and associated backing

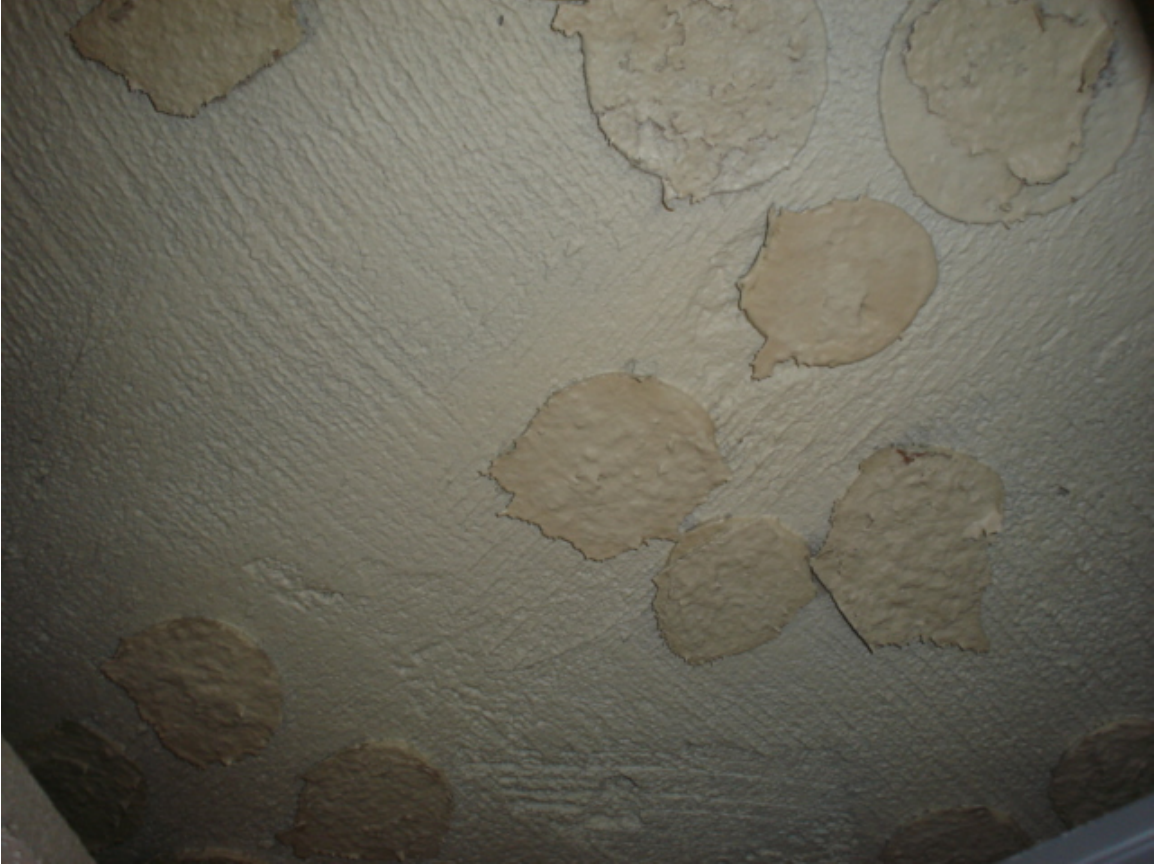
HA #17 – Asbestos-containing brown glue pods

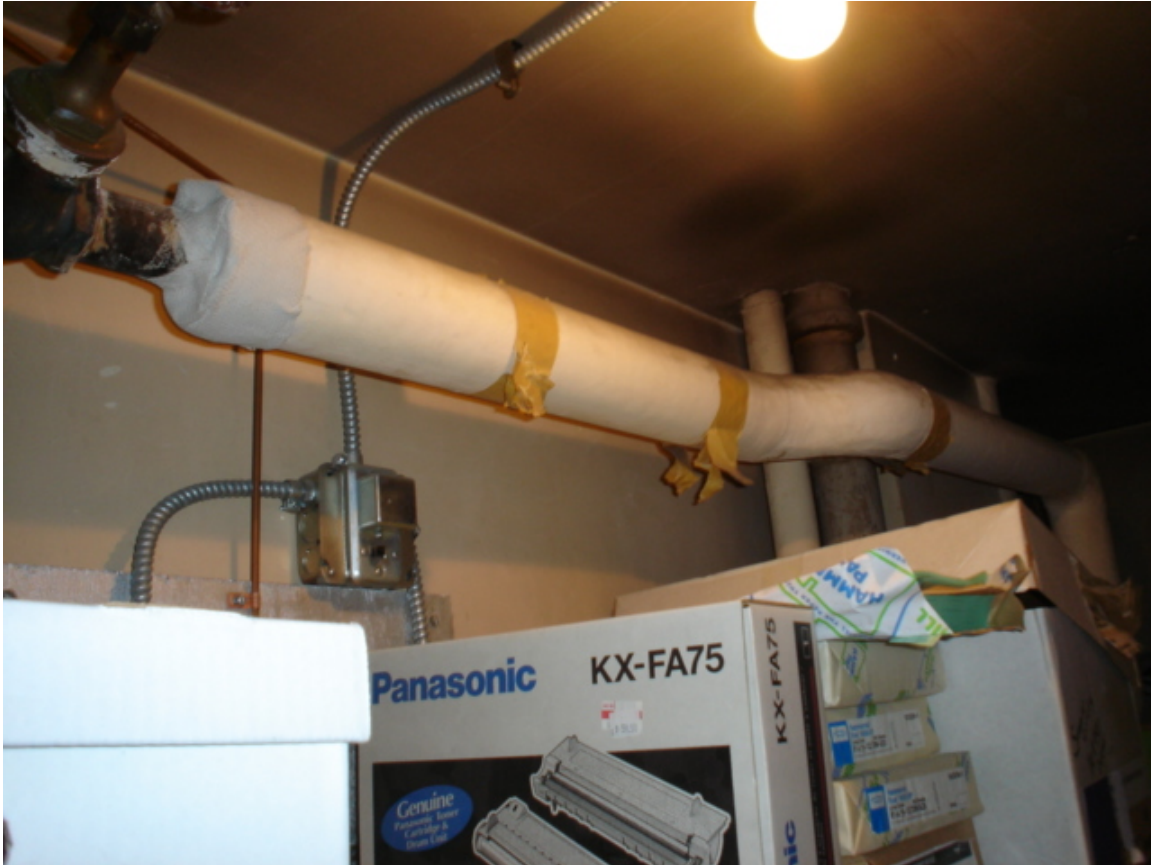
HA #18 – Asbestos-containing steam/condensate supply and return pipe straight insulation

HA #19 – Asbestos-containing steam/condensate supply and return pipe joint and hanger insulation

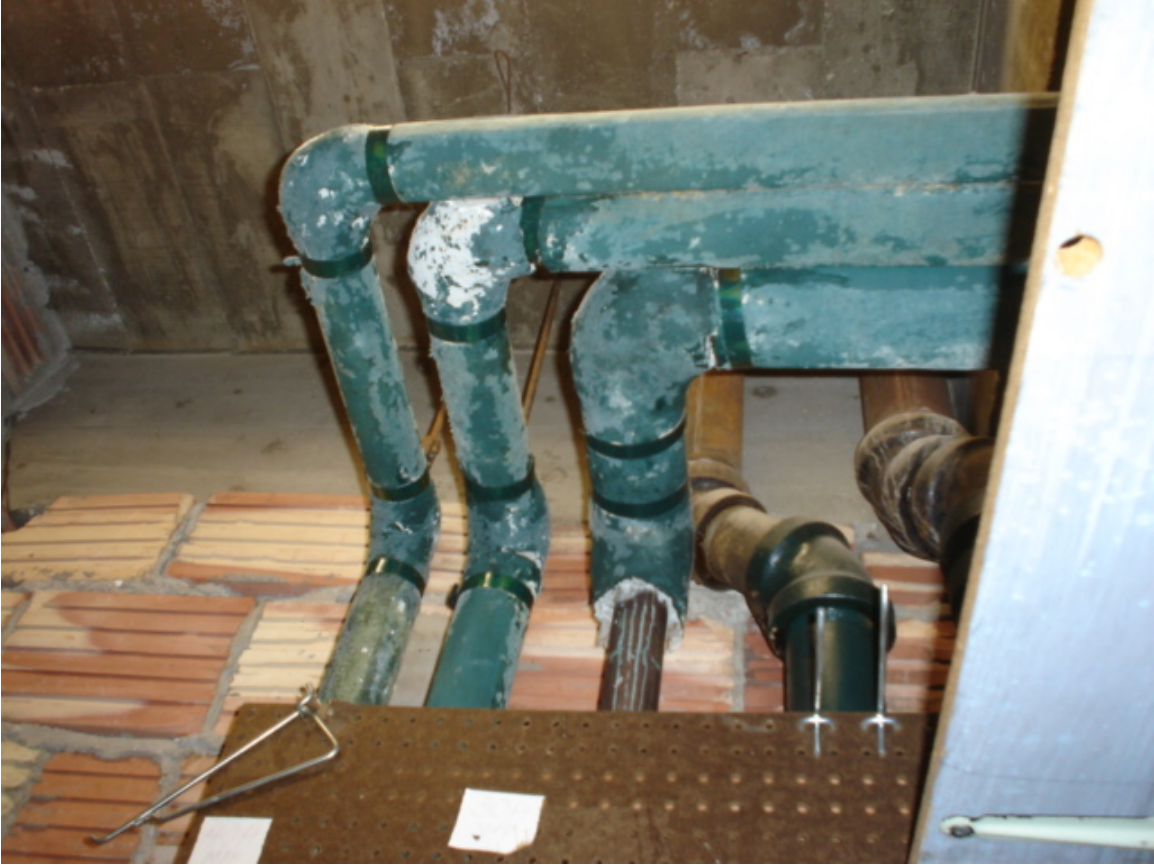
HA #21 – Asbestos-containing domestic water supply and return pipe straight insulation

HA #22 – Asbestos-containing domestic water supply and return pipe joint and hanger insulation

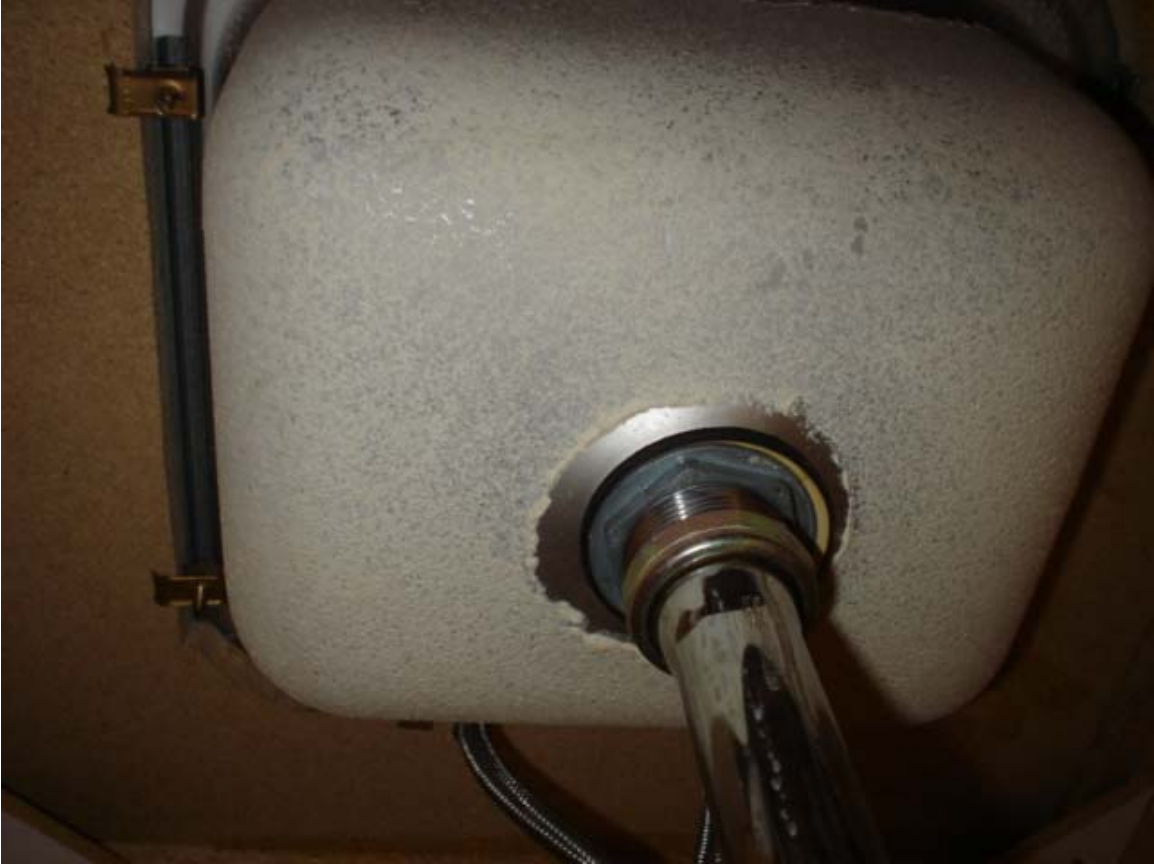
HA #25 – Non asbestos-containing white sink undercoating

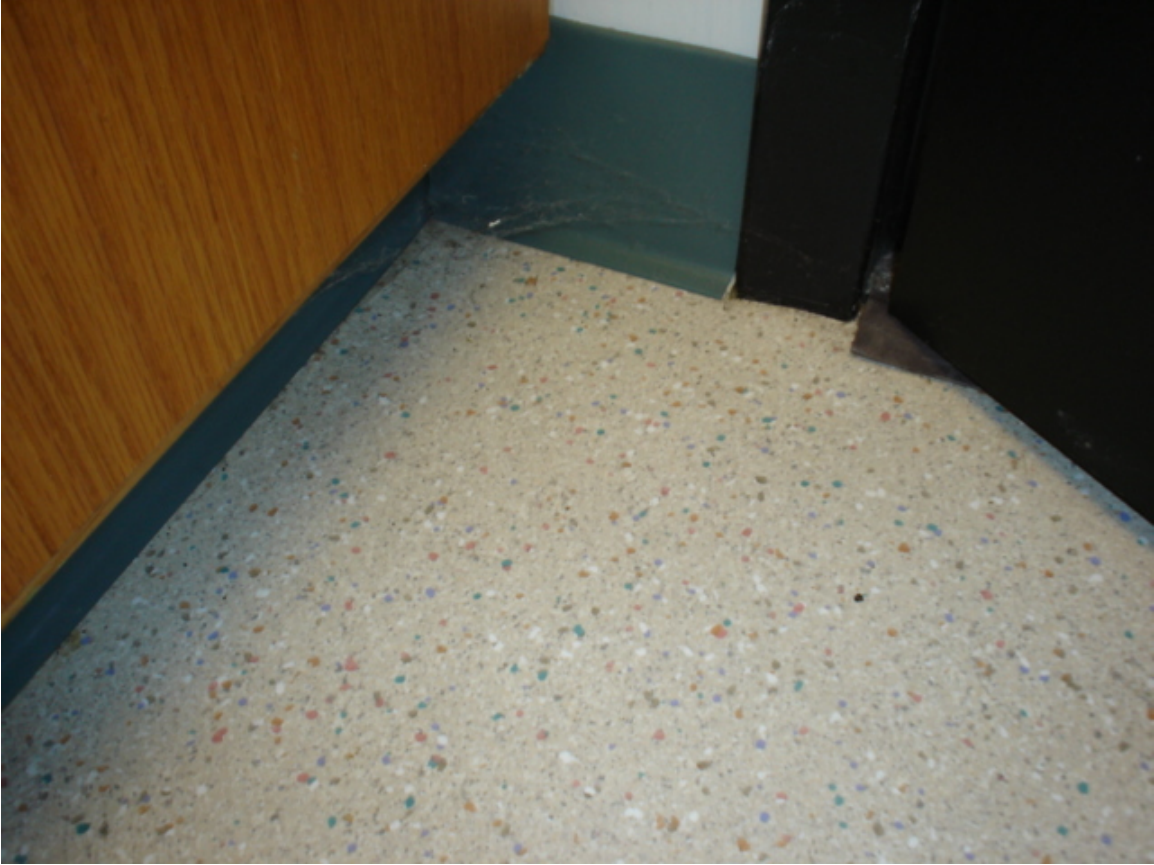
HA #27 – Non asbestos-containing cream mosaic pattern linoleum  
and associated backing

HA #28 – Non asbestos-containing 4" aqua cove molding  
and associated mastic

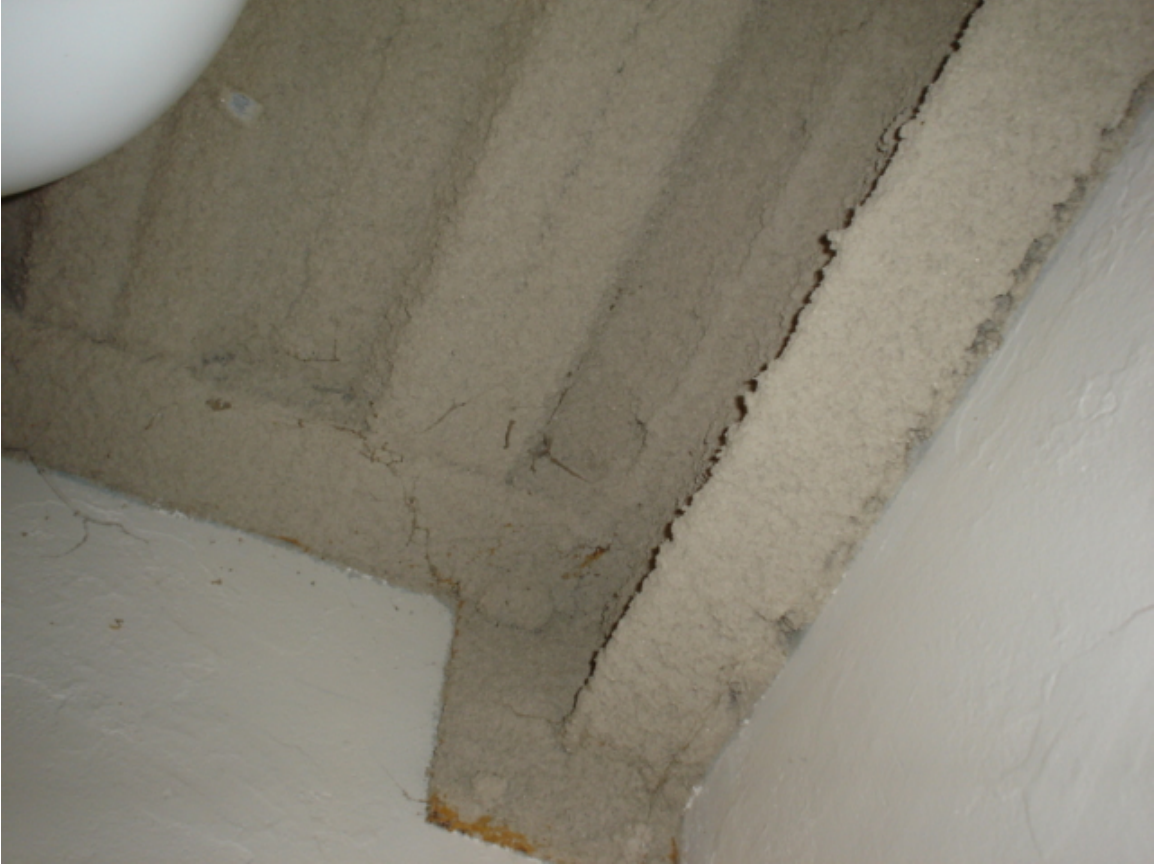
HA #31 – Non asbestos-containing spray-on fireproofing

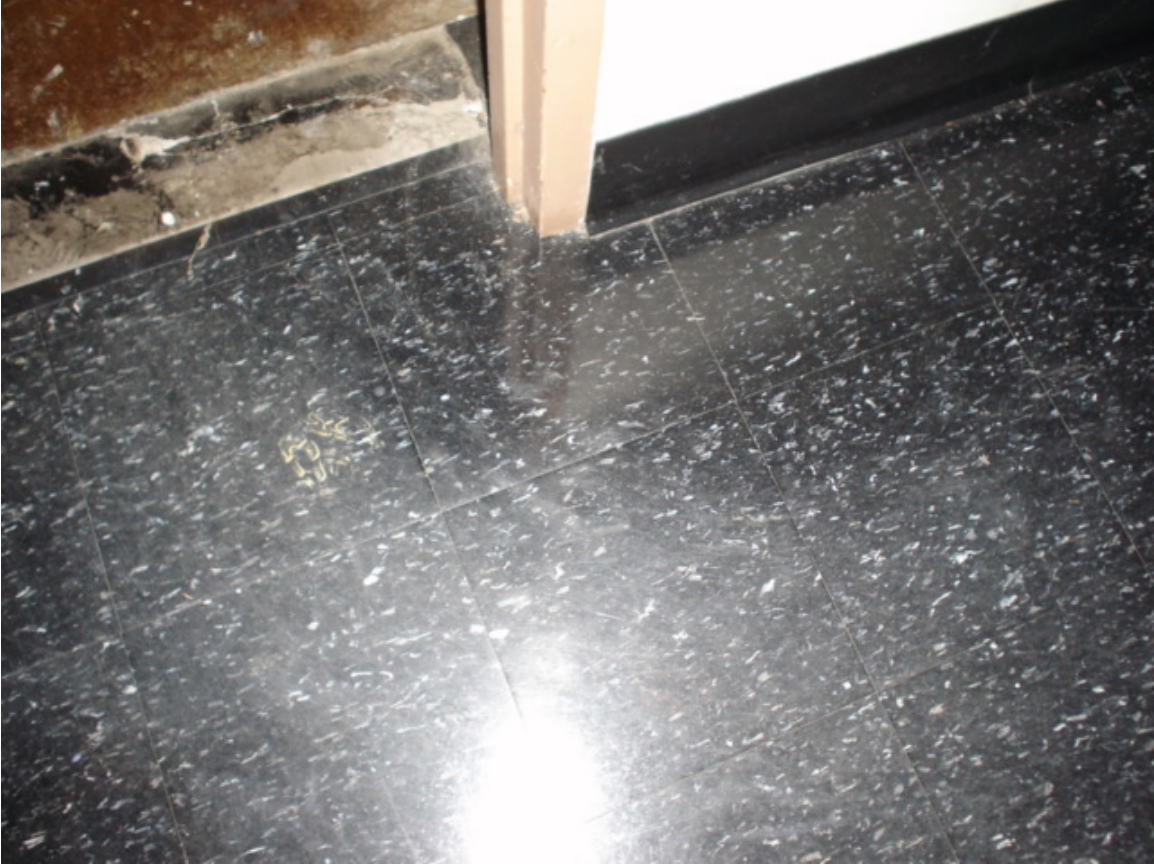
HA #32 – Non asbestos-containing 12" x 12" black floor tile with white specks and associated asbestos-containing mastic

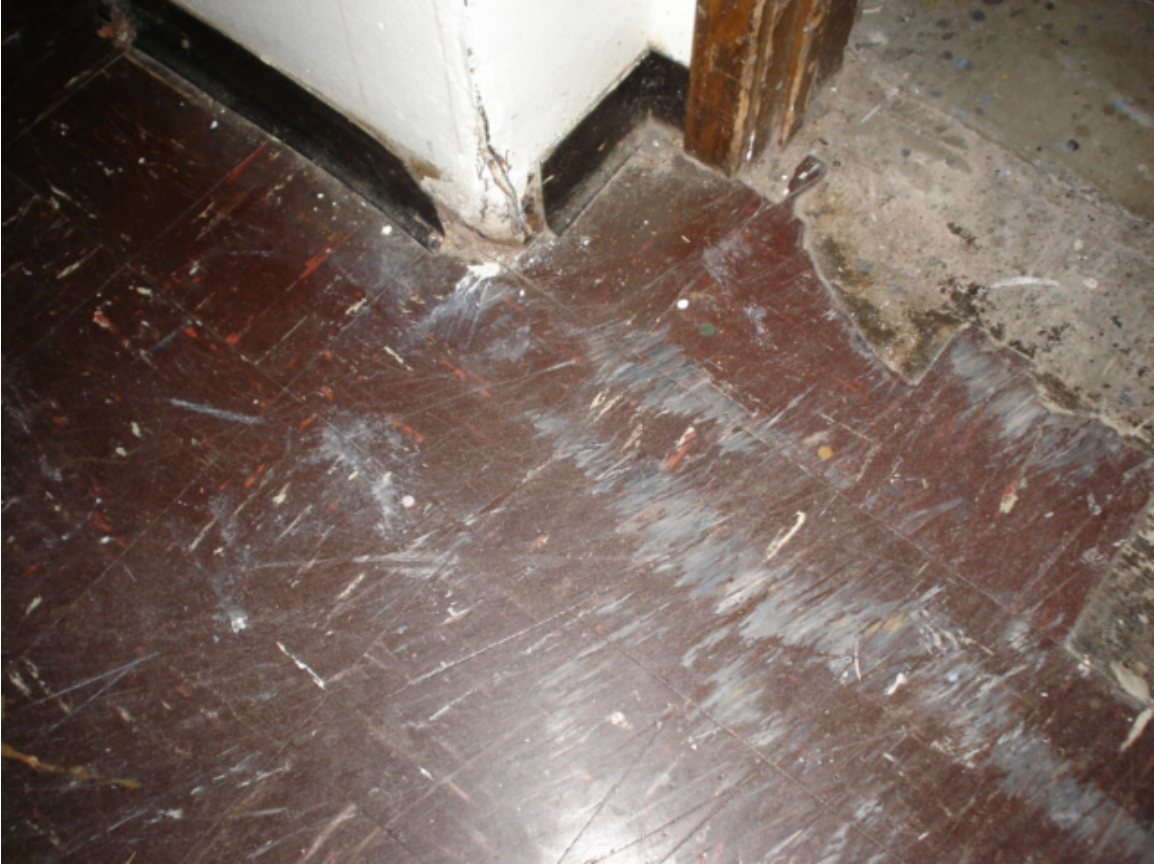
HA #33 – Asbestos-containing 9" x 9" brown floor tile  
with cream and red streaks and associated mastic

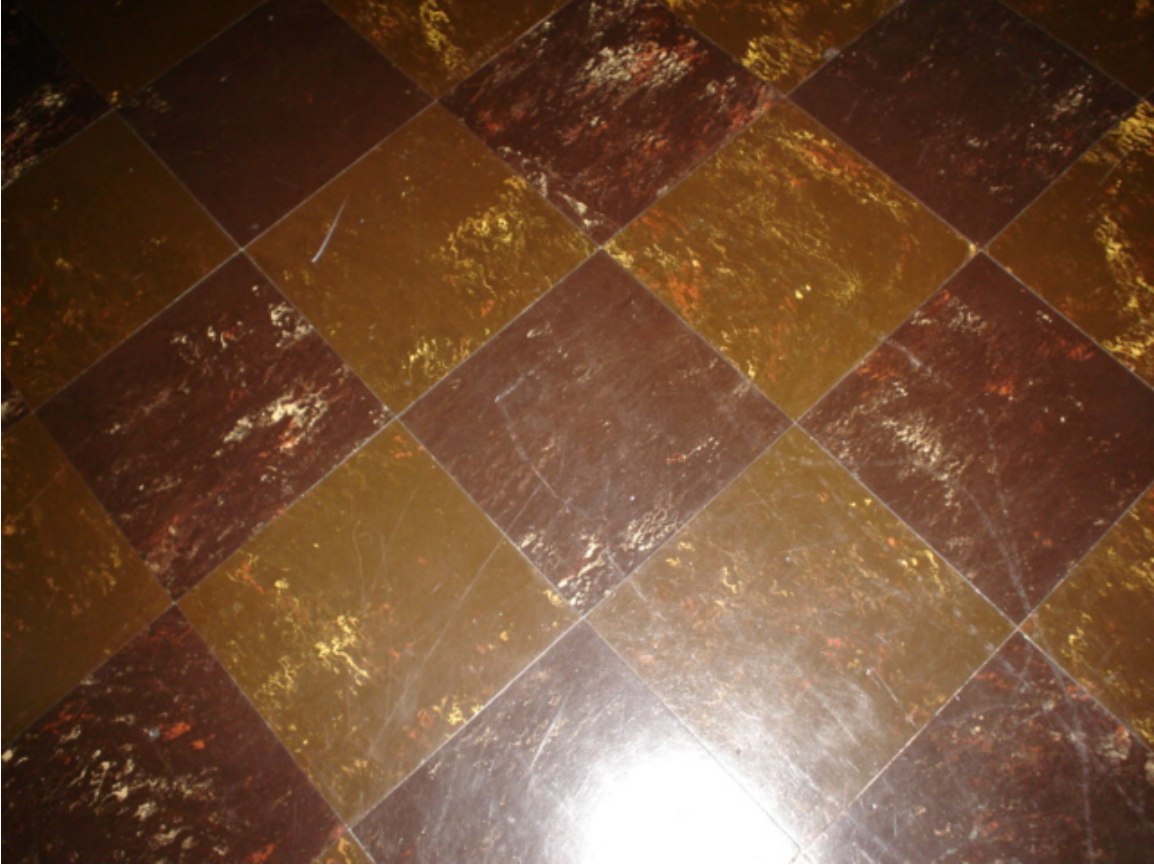
HA #35 – Asbestos-containing 12" x 12" light brown floor tile  
with cream and red swirls and associated mastic

HA #36 – Asbestos-containing 12" x 12" dark brown floor tile  
with cream and red streaks and associated mastic

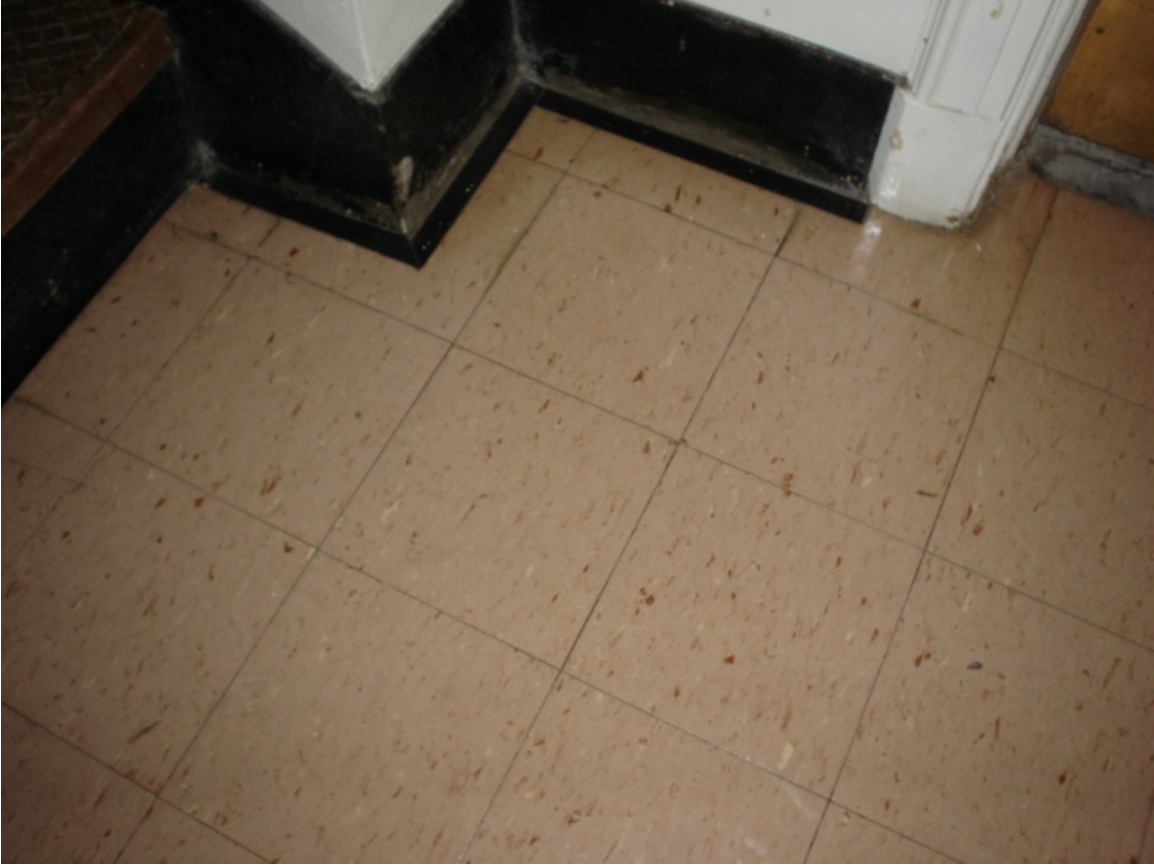
HA #37 – Asbestos-containing 9" x 9" pink floor tile  
with cream and red streaks and associated mastic

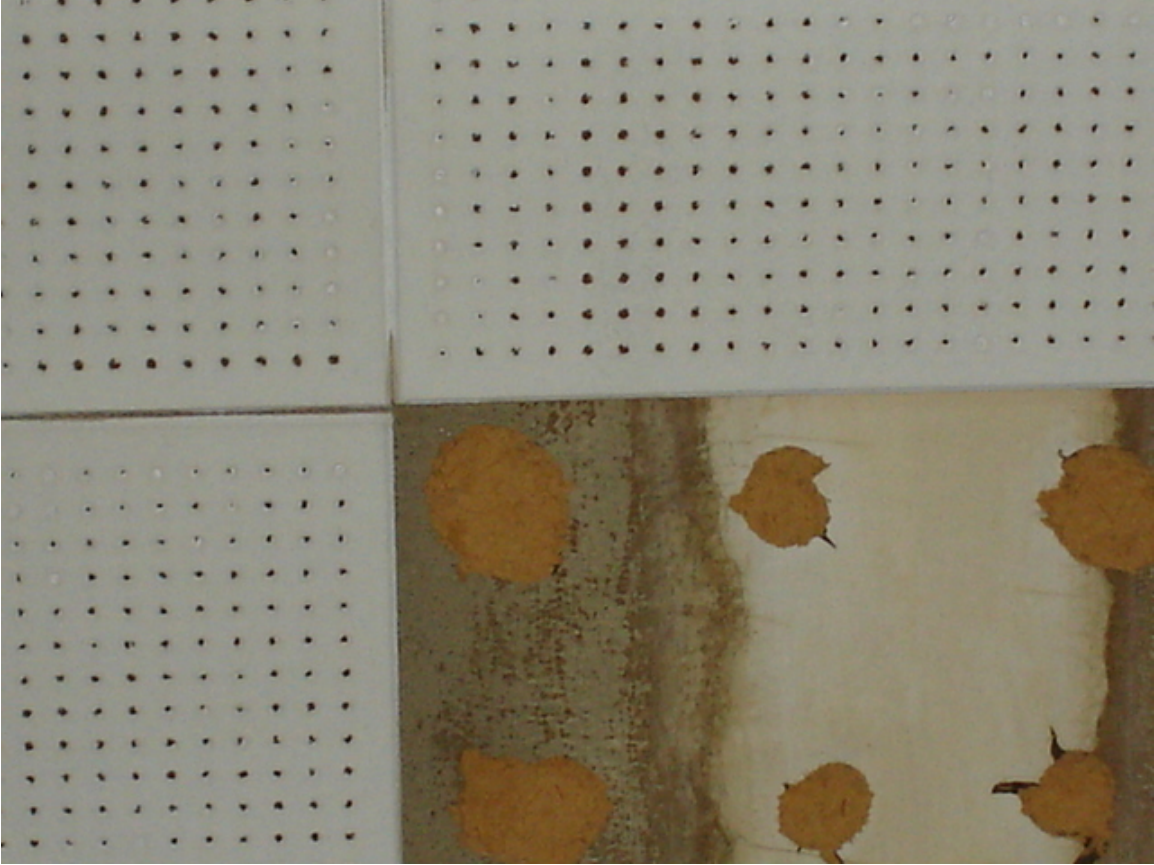
HA #39 – Non asbestos-containing 12" x 12" white ceiling tile with uniform holes and associated asbestos-containing glue pods
