Auditorium Photo Log

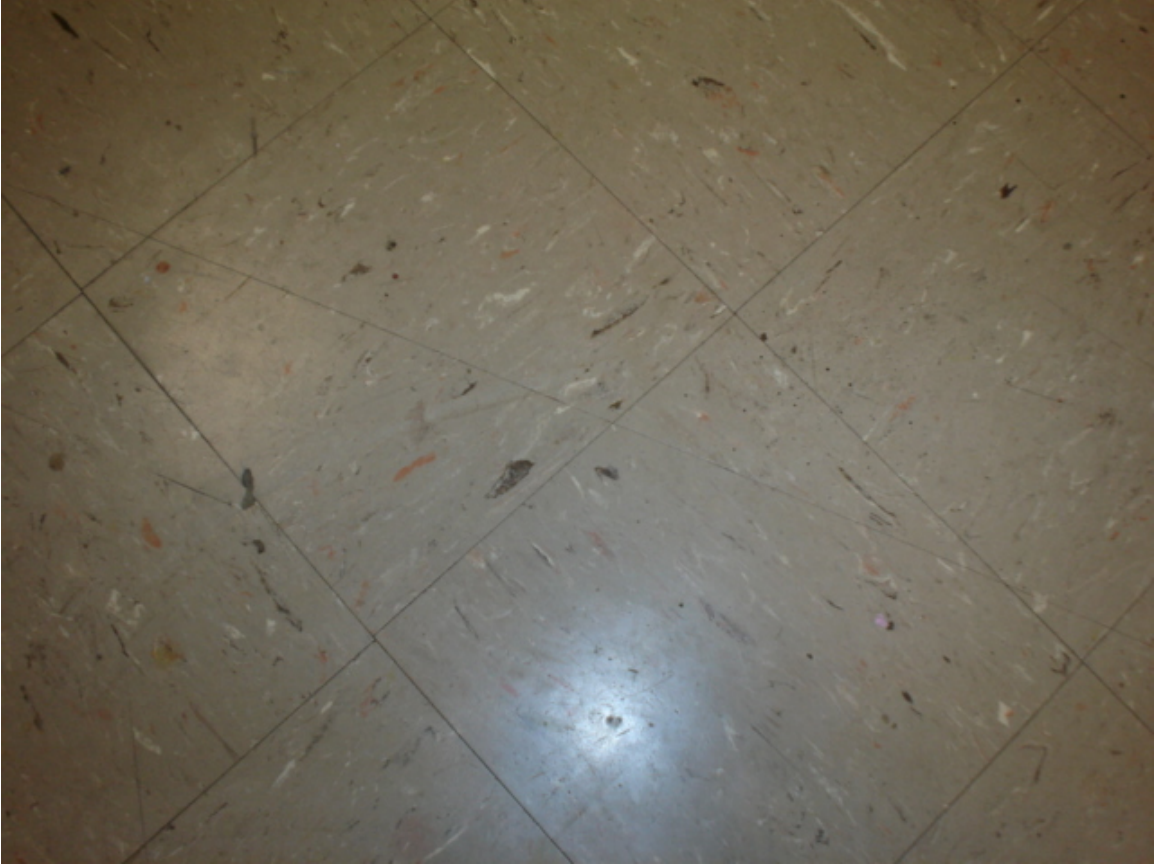
HA #40 – Asbestos-containing 9" x 9" tan floor tile with cream, pink and black streaks and associated non asbestos-containing mastic

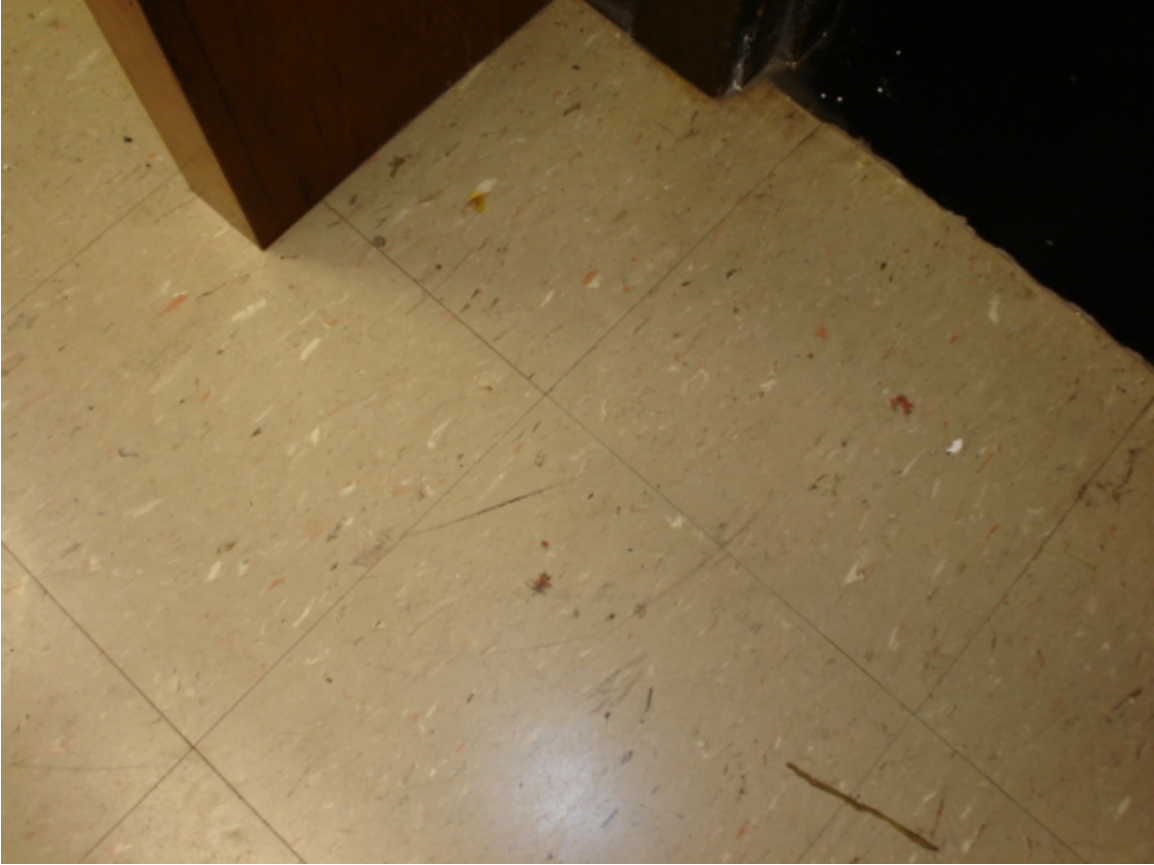
HA #47 – Asbestos-containing 12" x 12" tan floor tile with cream, pink and black streaks and associated non asbestos-containing mastic

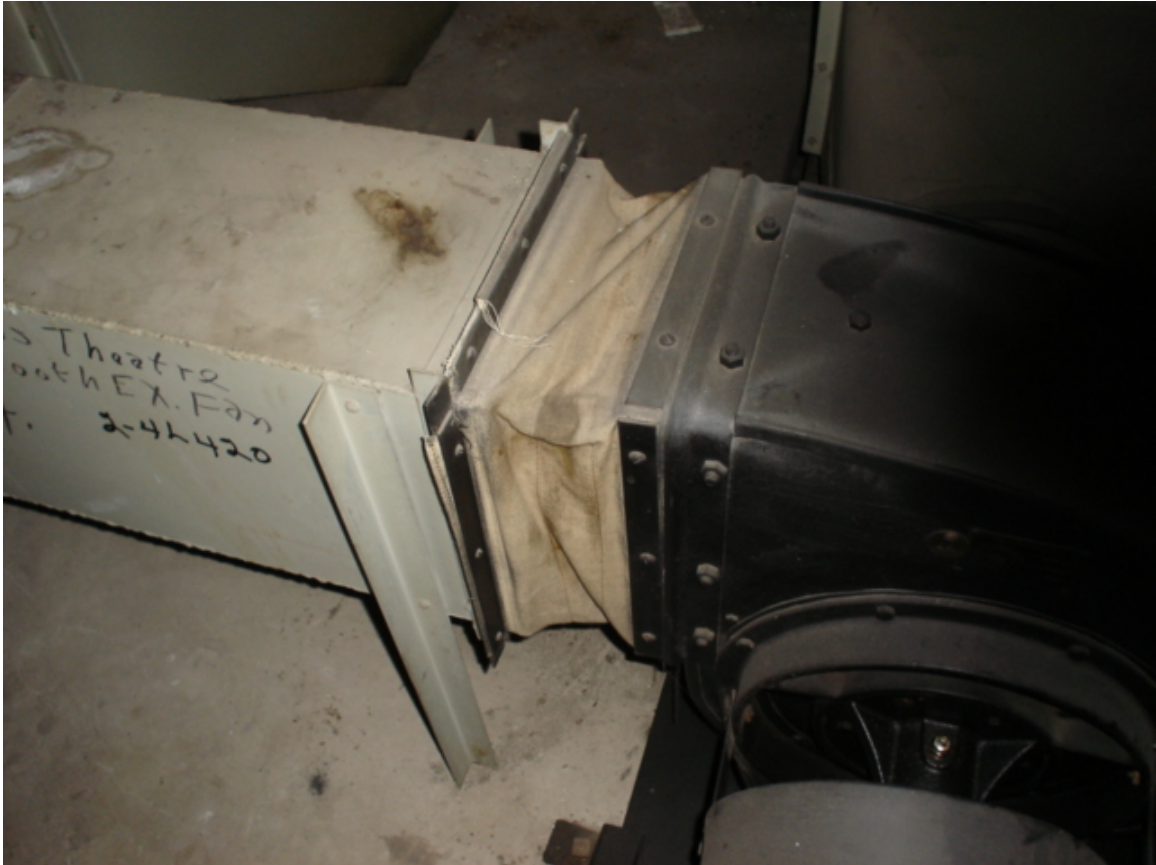
HA #57 – Non asbestos-containing ventilation duct expansion cloth
