MSU, Computer Center Building

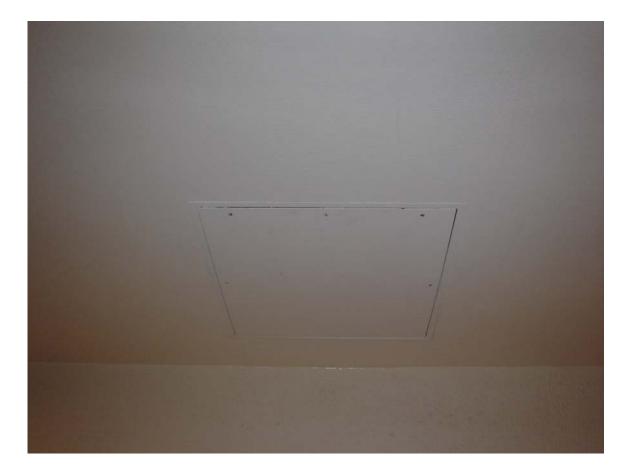
HA #1 – Non asbestos containing smooth plaster

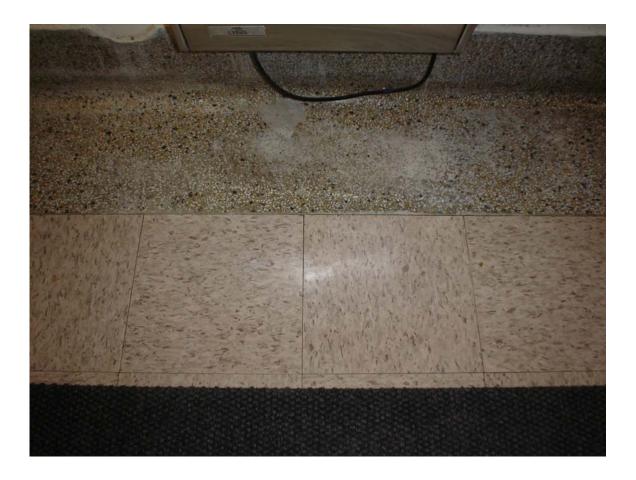
HA #2 – Non asbestos 12" x 12" tan marble pattern floor tile and associated asbestos containing mastic

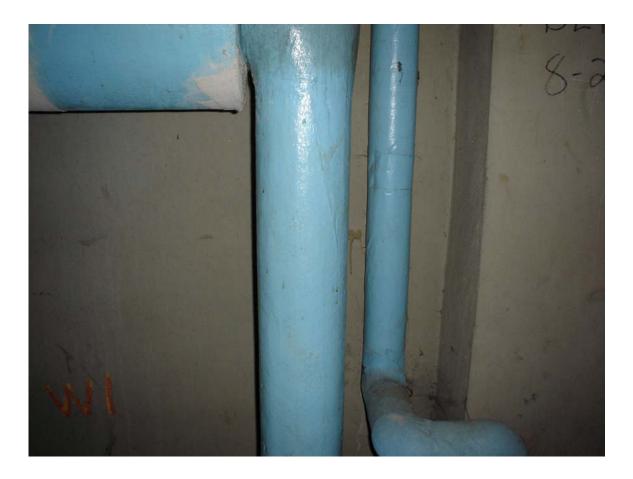
HA #3 – Non asbestos containing domestic water supply pipe straight insulation

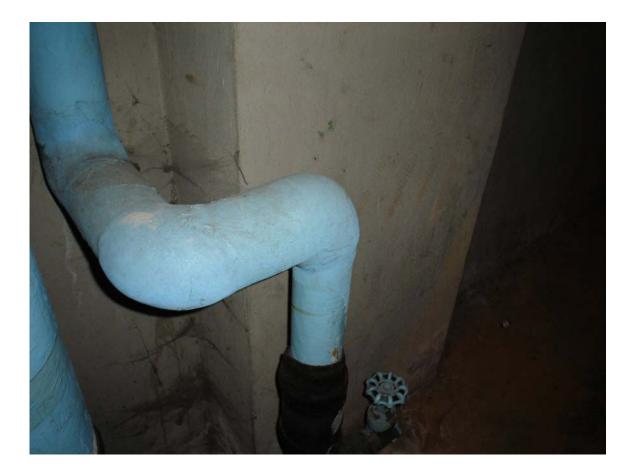
HA #4 – Asbestos containing domestic water supply pipe joint and hanger insulation

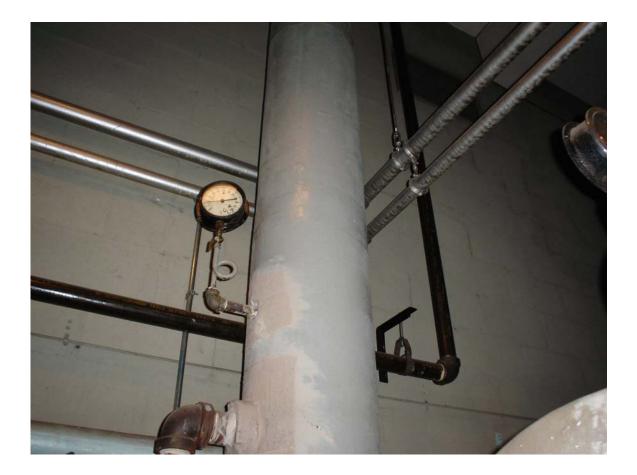
HA #5 – Asbestos containing steam/condensate supply and return pipe straight insulation

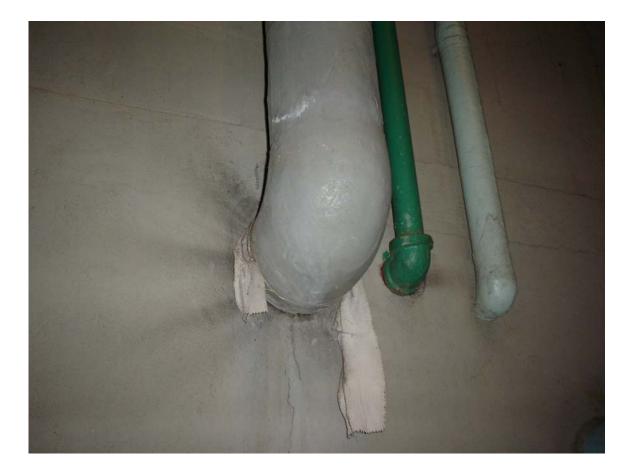
HA #6 – Asbestos containing steam/condensate supply and return pipe joint and hanger insulation

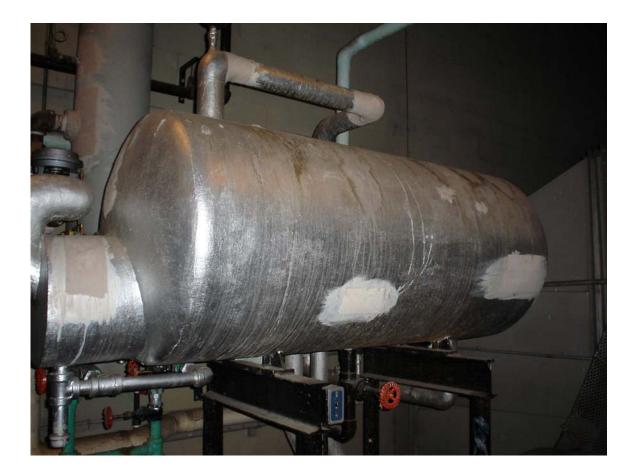
HA #7 – Asbestos containing hot water holding tank insulation

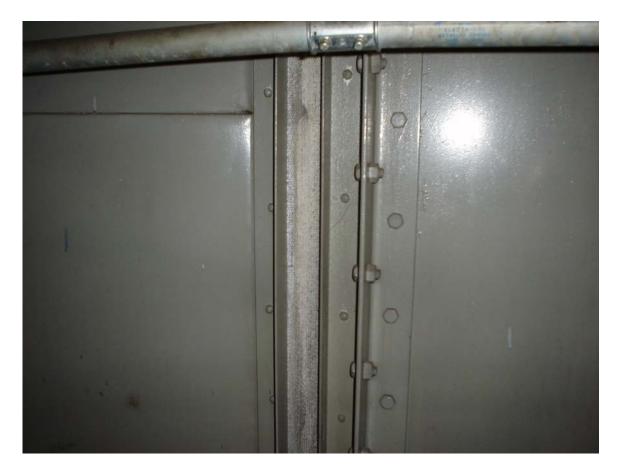
HA #8 – Asbestos containing ventilation duct expansion cloth

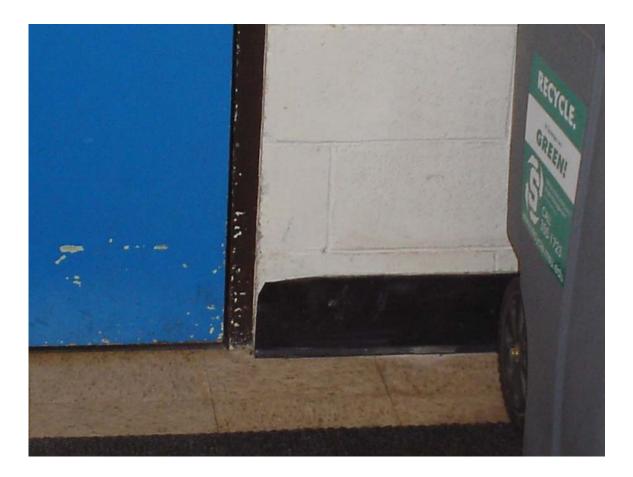
HA #9 – Asbestos containing 6" black cove molding and associated non asbestos containing mastic

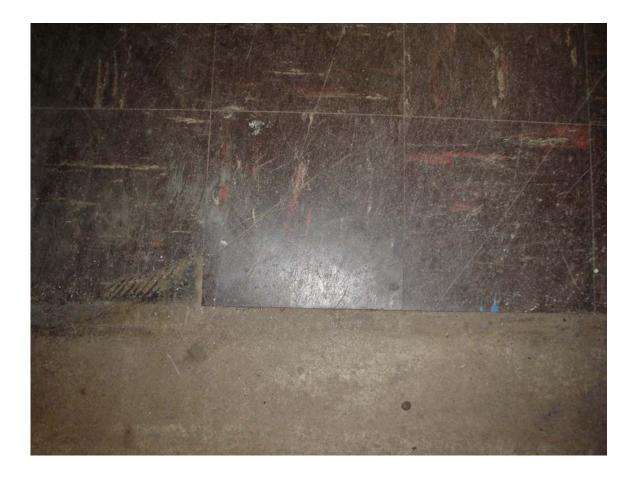
HA #10 – Asbestos containing 9" x 9" brown floor tile with cream and red streaks and associated non asbestos containing mastic

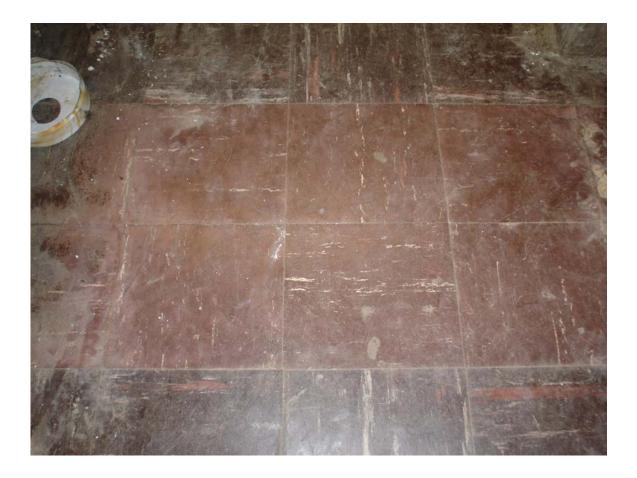
HA #11 – Asbestos containing 9" x 9" rust floor tile with cream and red streaks and associated non asbestos containing mastic

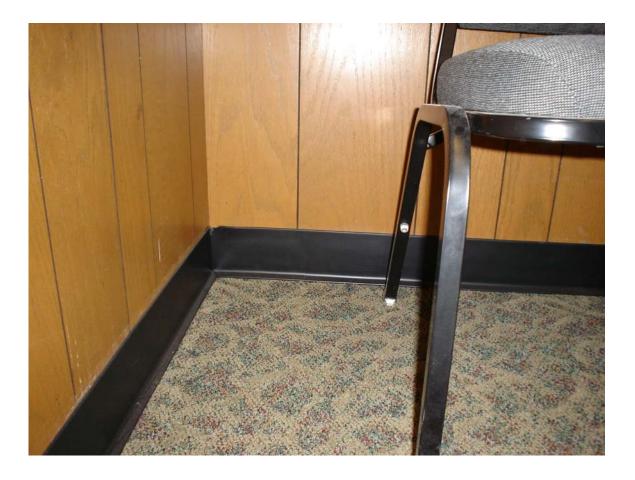
HA #13 – Non asbestos containing 4" black cove molding and associated mastic

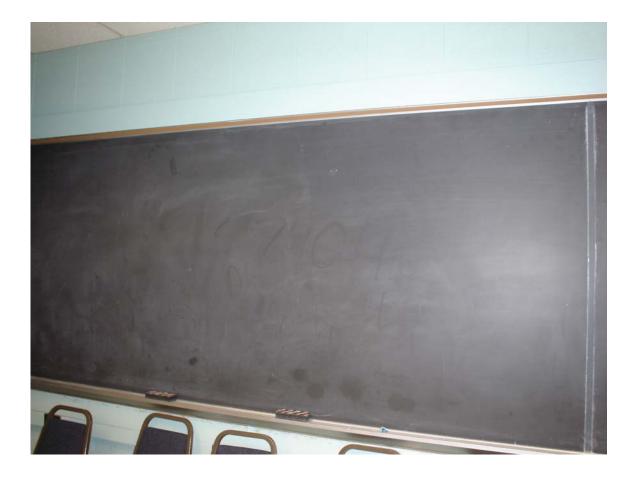
HA #19 – Assumed asbestos containing chalkboards and associated glue pods

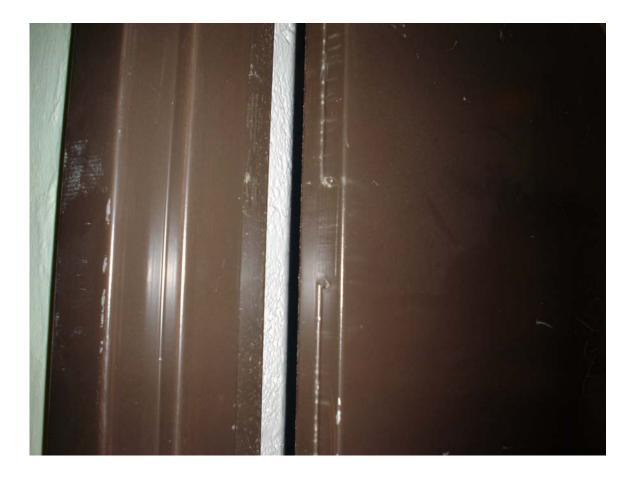
HA #20 – Assumed asbestos containing fire door and frame

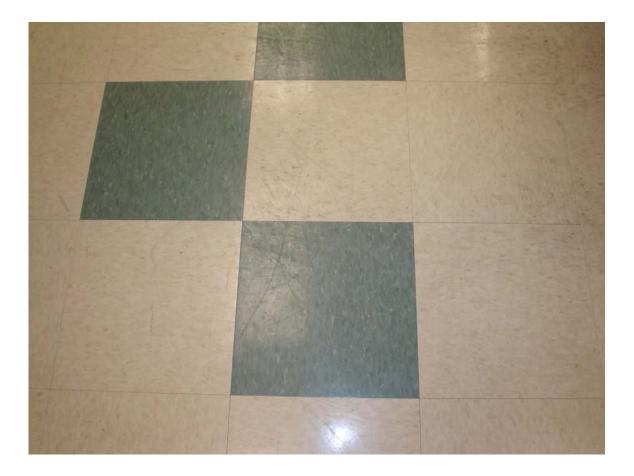
HA #22 – Non asbestos containing 12" x 12" blue marble pattern floor tile and associated mastic

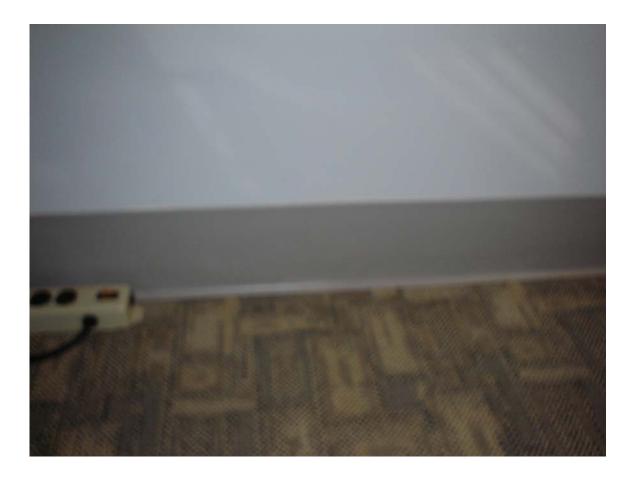
HA #23 – Non asbestos containing 6" gray cove molding and associated mastic

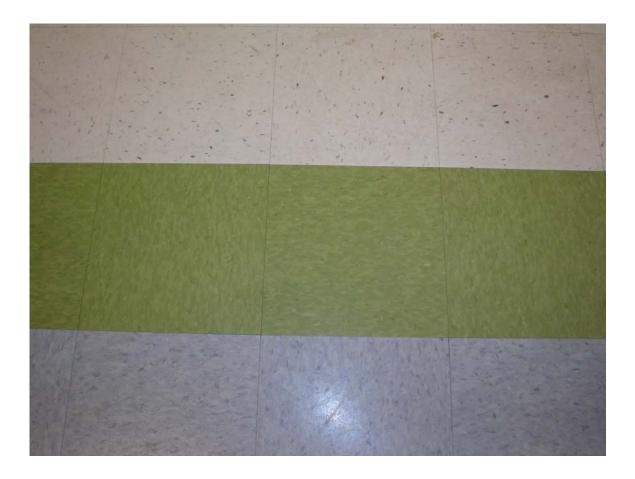
HA #28 – Non asbestos containing 12" x 12" apple green floor tile with marble pattern and associated mastic

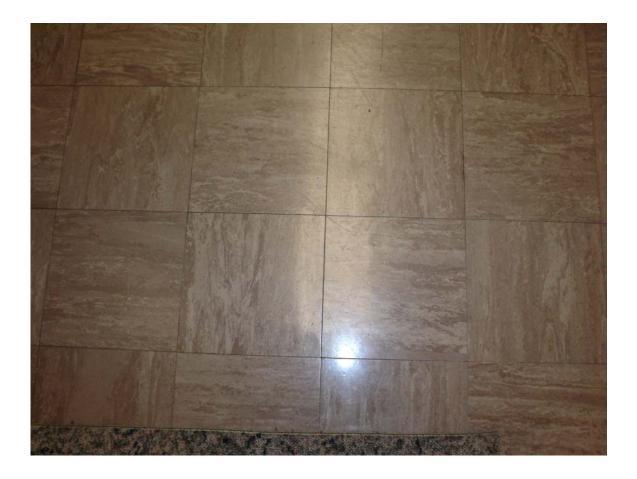
HA #29 – Asbestos containing 9" x 9" tan floor tile with swirl pattern and associated non asbestos containing mastic

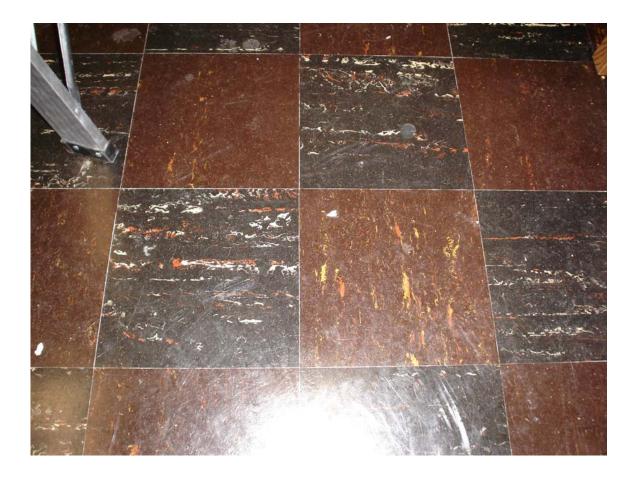
HA #31 – Asbestos containing 12" x 12" black floor tile with cream and red streaks and associated non asbestos-containing mastic

HA #32 – Asbestos containing 12" x 12" dark brown floor tile with brown and red streaks and associated non asbestos containing mastic

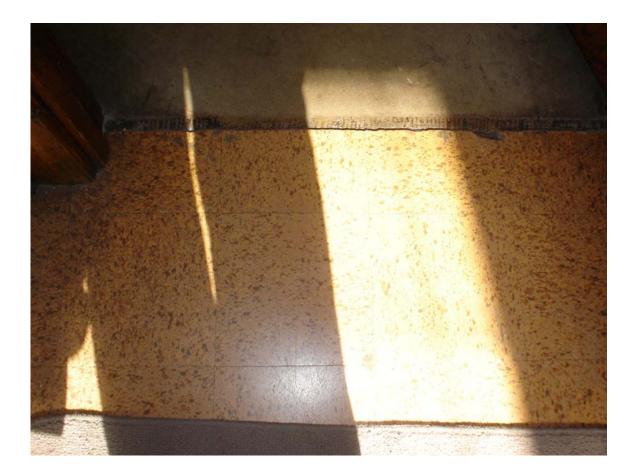
HA #44 – Asbestos containing 9" x 9" brown floor tile with multi-colored brown speckles and non asbestos containing associated mastic

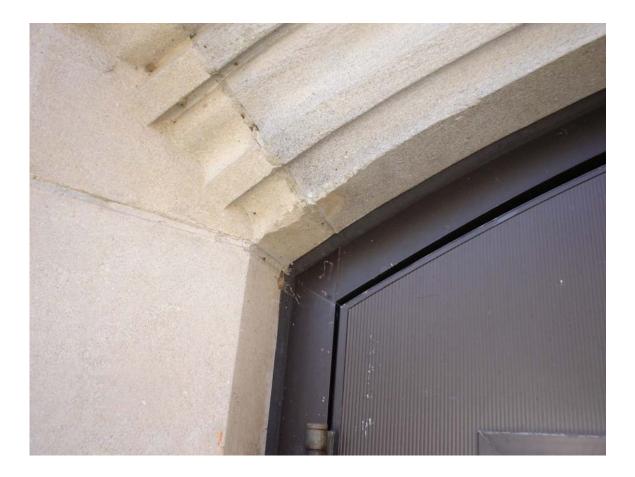
HA #46 – Assumed asbestos containing window and door frame caulk compound

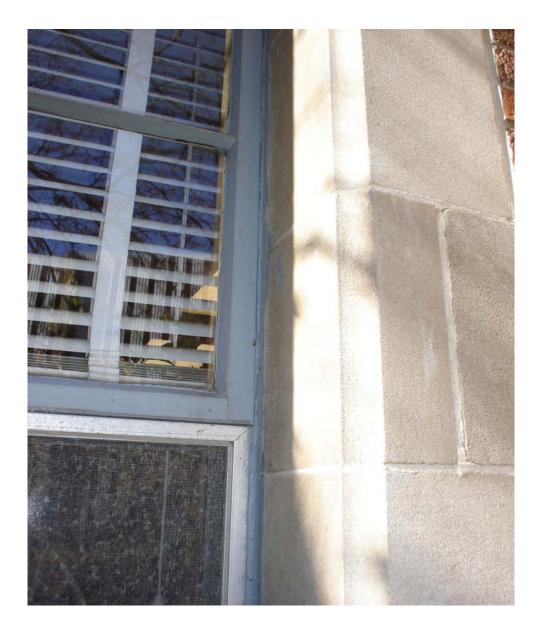
HA #46 – Assumed asbestos containing window and door frame caulk compound
