**Photo Log**  
**Michigan State University, Central Services Building**  
**Asbestos Containing Homogeneous Materials List**

**Photo Log**  
**Michigan State University, Central Services Building**  
**Significantly Damaged Materials**

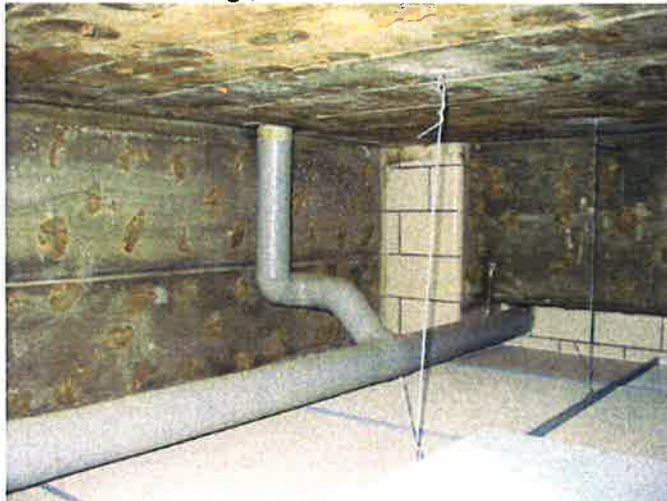
1. Mag pipe insulation and fittings, HA#'s 3 and 4.

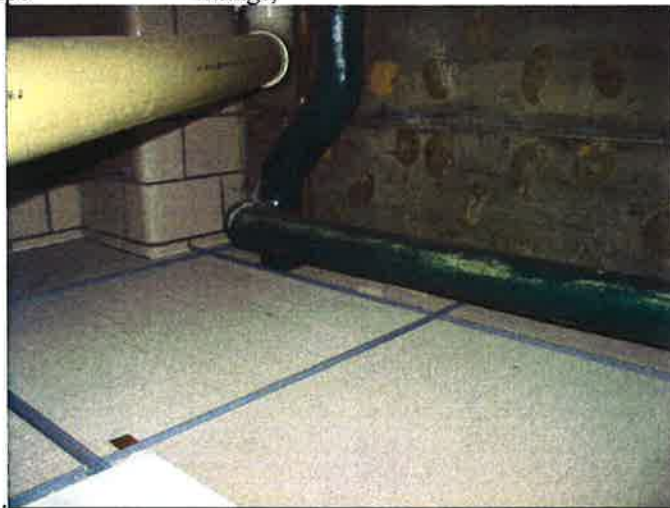
2. Aircell pipe insulation and fittings, HA#'s 5 and 6.

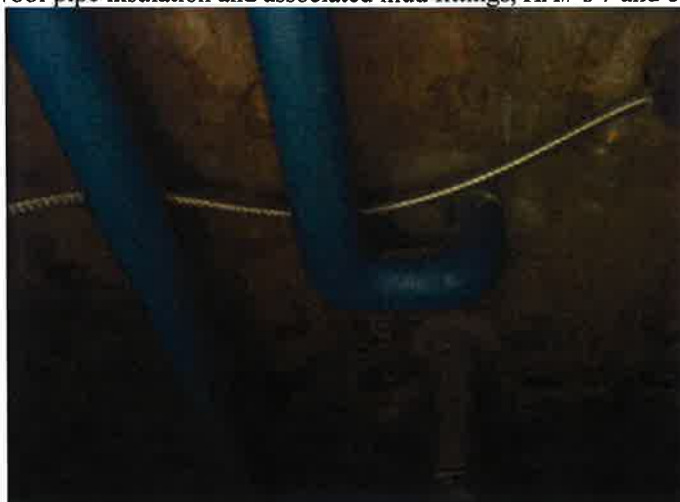
3. Brown wool pipe insulation and associated mud fittings, HA#'s 7 and 8.

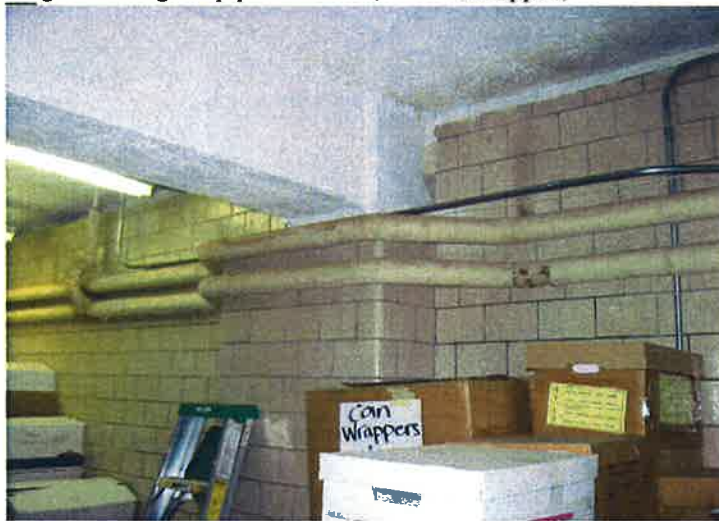
5. Mud fittings on fiberglass pipe insulation, canvas wrapped, HA# 10.

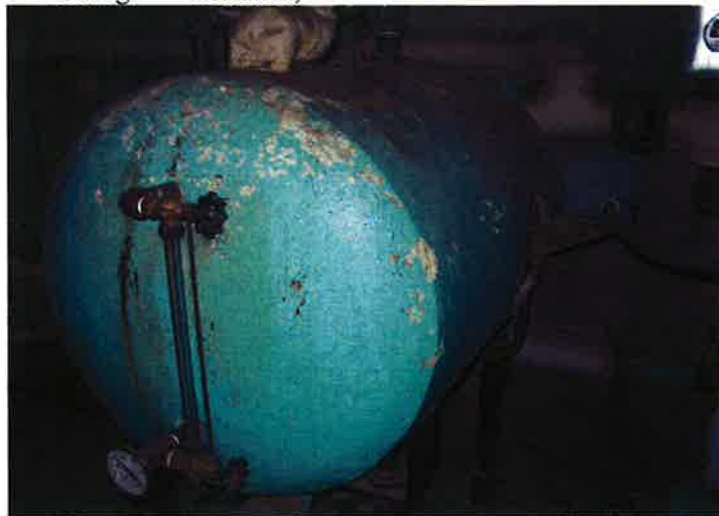
6. Hot water holding tank insulation, HA# 11.

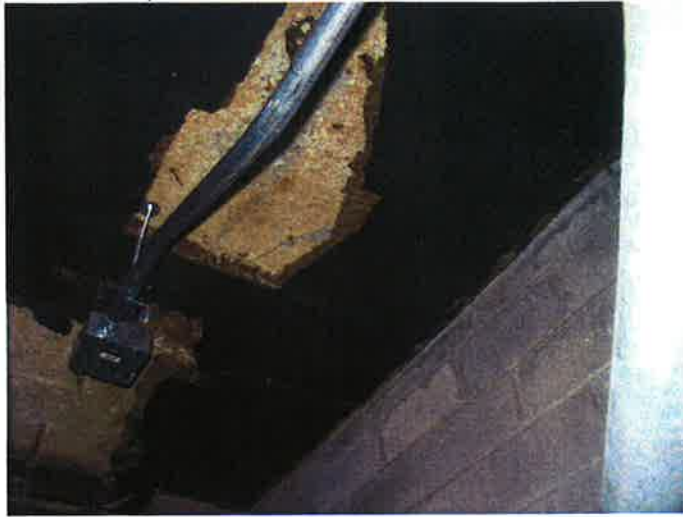
7. Cork and black mastic, HA# 12.

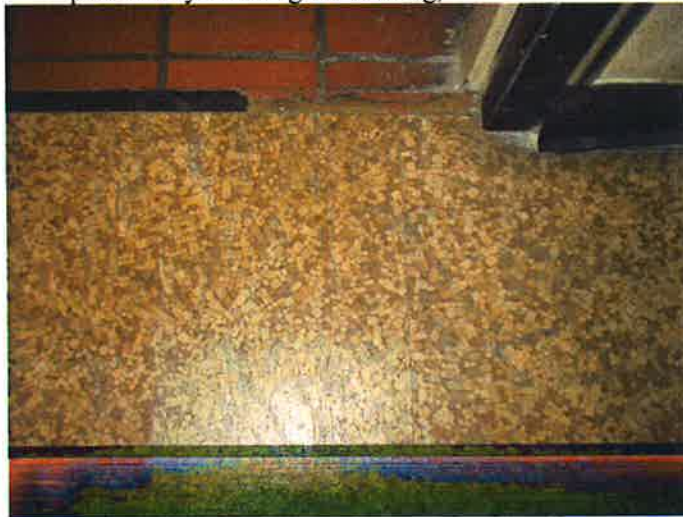
8. Brown mosaic pattern vinyl sheeting and backing, HA# 14.

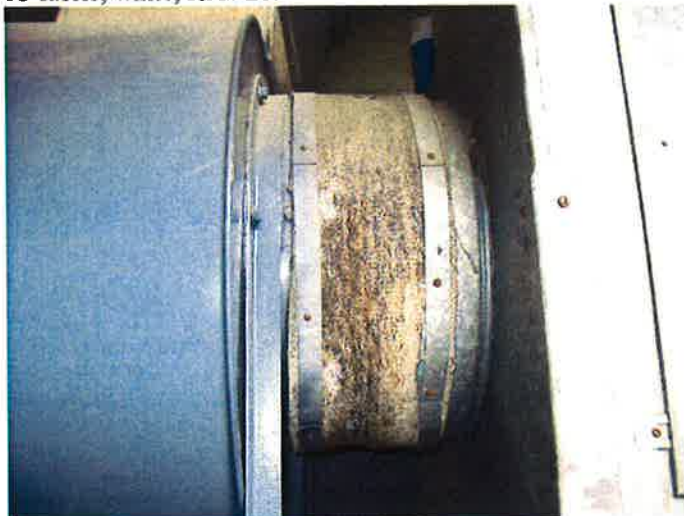
9. HVAC fabric, white, HA# 20.

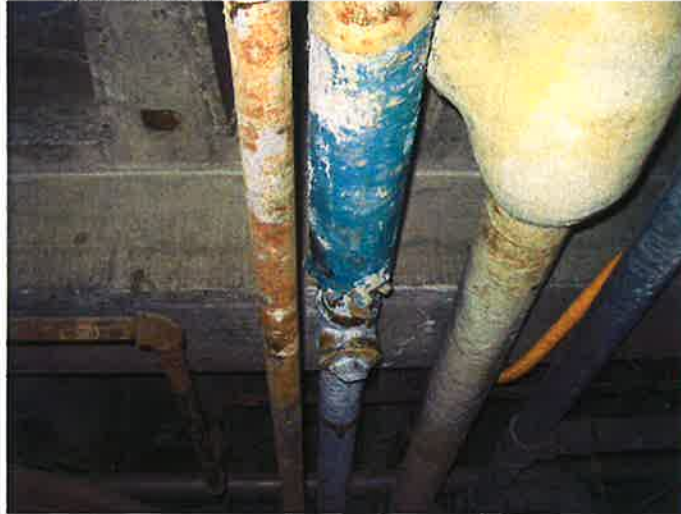
1. Brown Wool Pipe insulation, HA# 7, Rm. 15A.

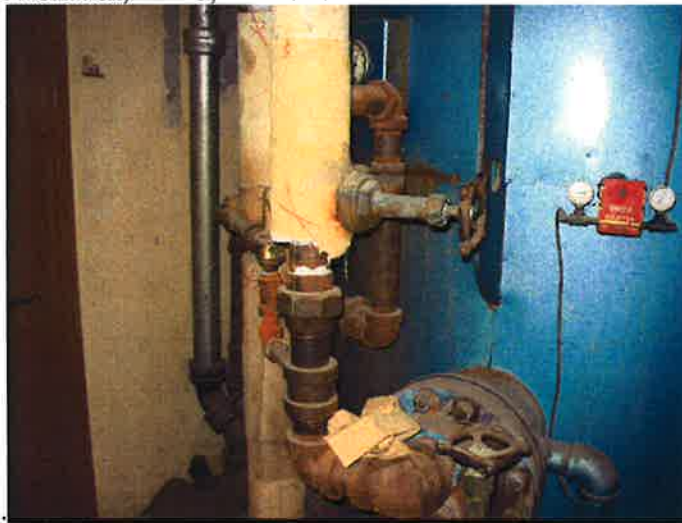
2. Mag. pipe insulation, HA# 3, Rm. 15A.

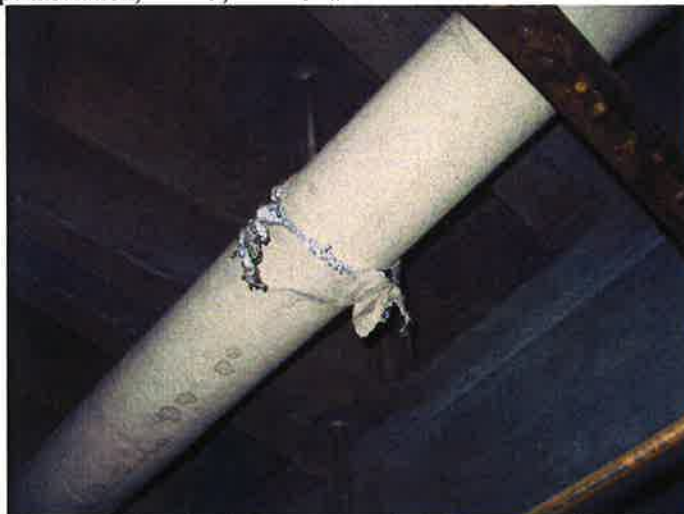
3. Mag. pipe insulation, HA# 3, Rm. 15A.

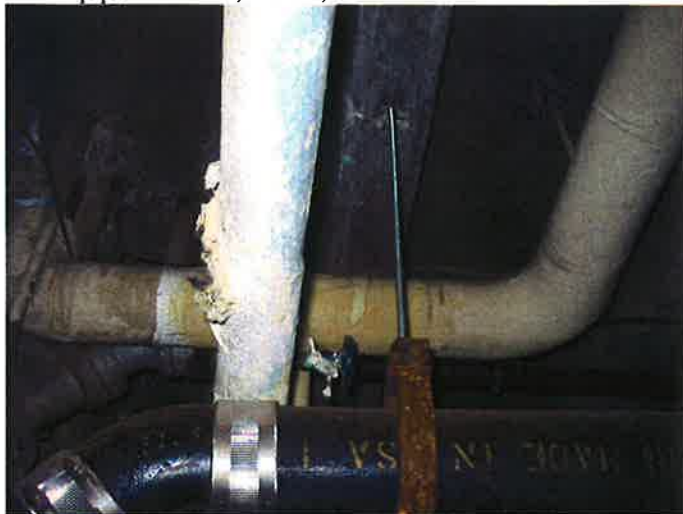
4. Brown Wool pipe insulation, HA# 7, Rm. 15A.

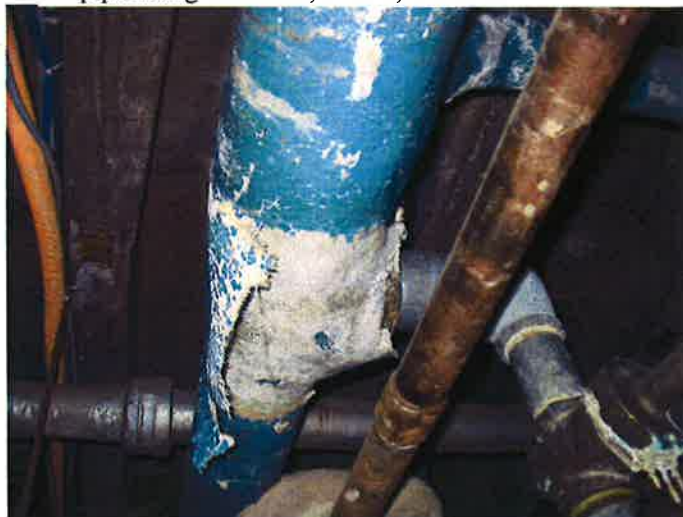
5. Brown Wool pipe fitting insulation, HA# 8, Rm.15A.
