MSU Engineering Building

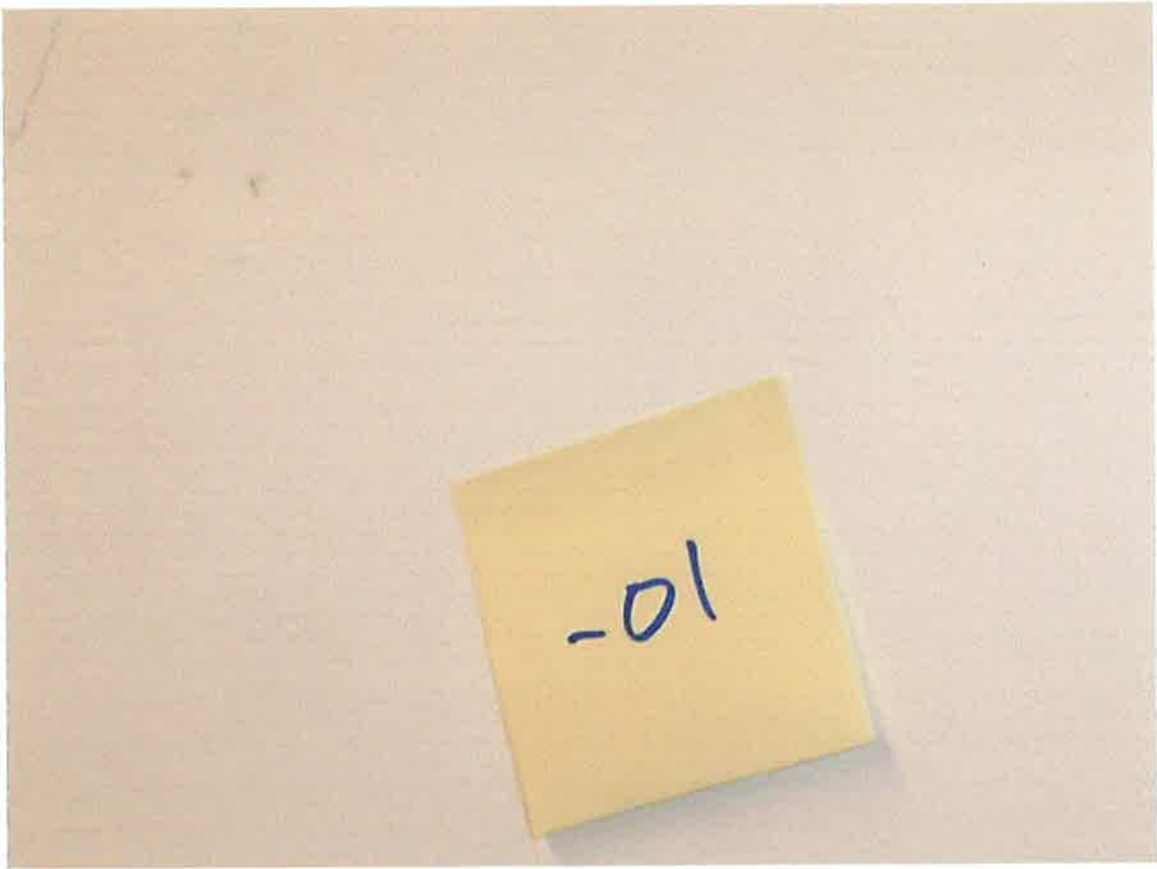
HA #1 – Non asbestos containing smooth plaster over drywall

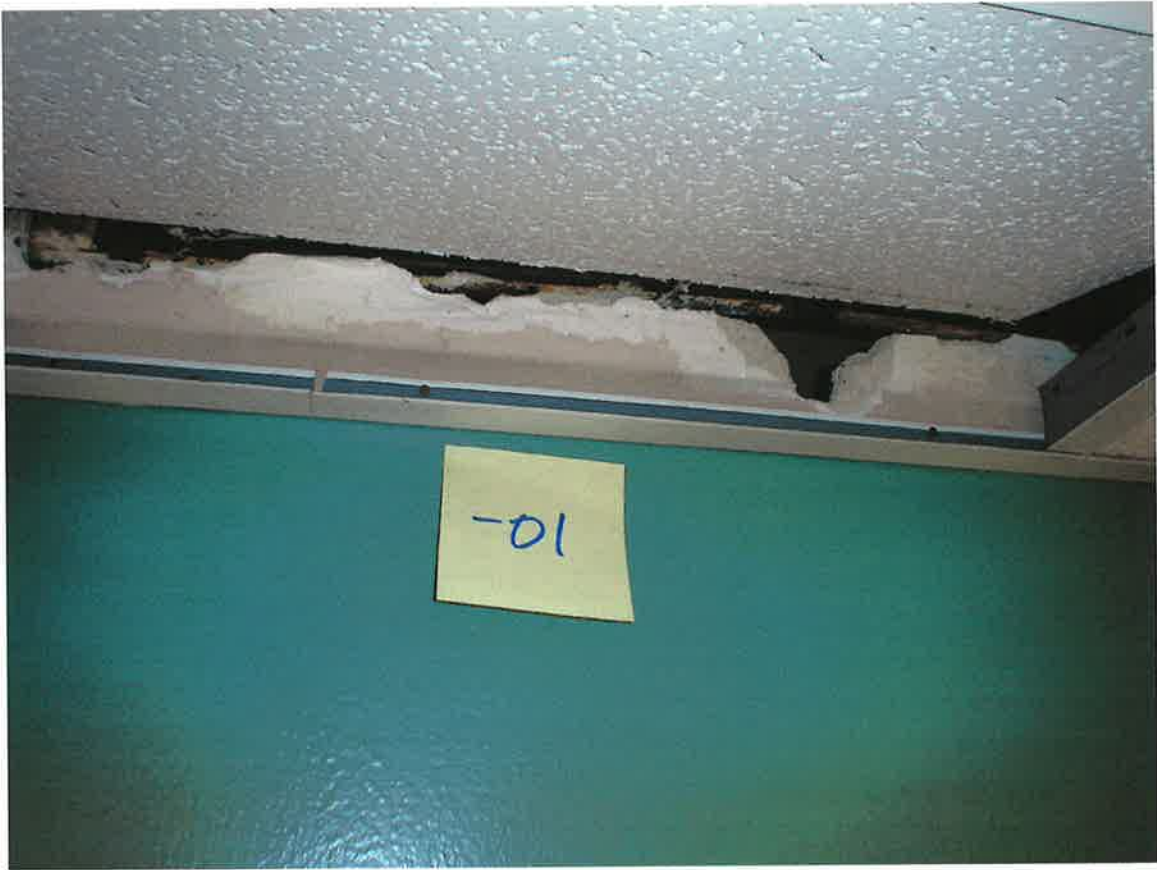
HA #1 – Non asbestos containing smooth plaster over drywall

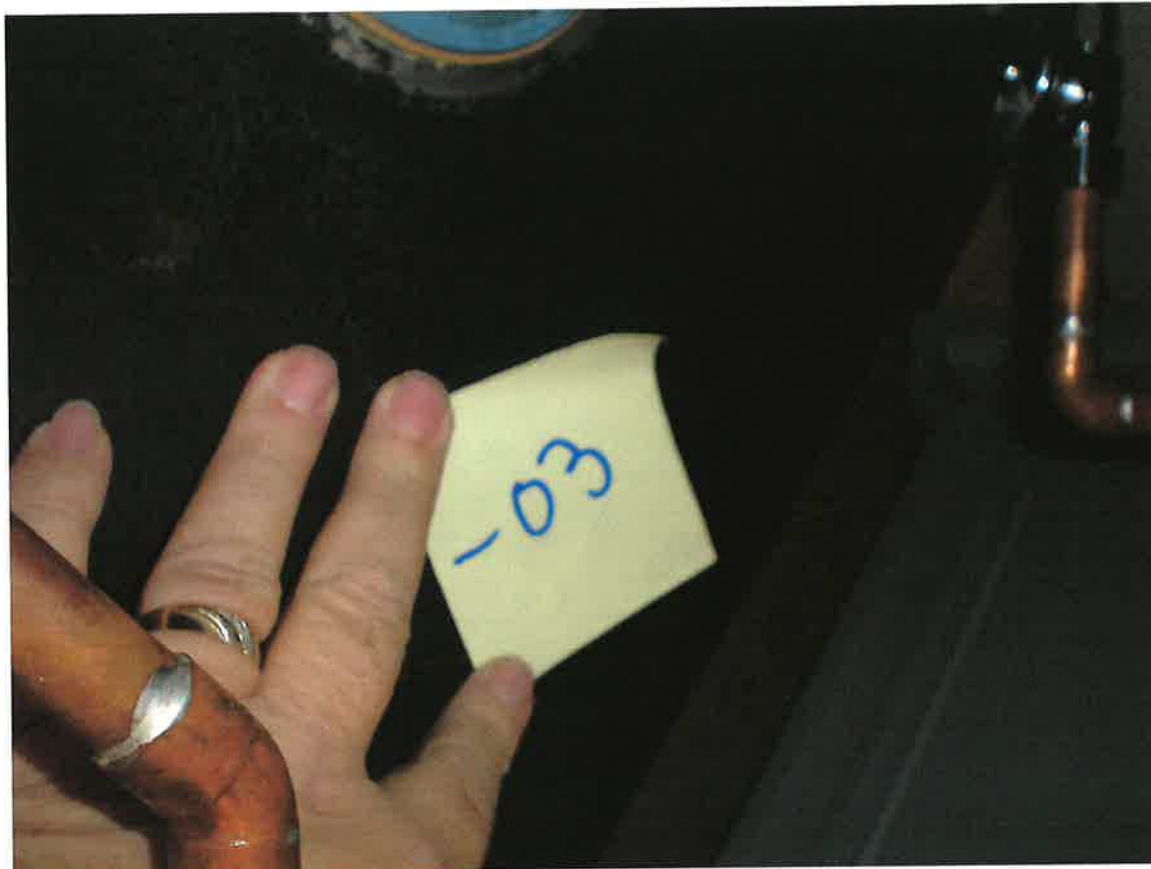
HA #3 – Non asbestos containing black sink undercoating

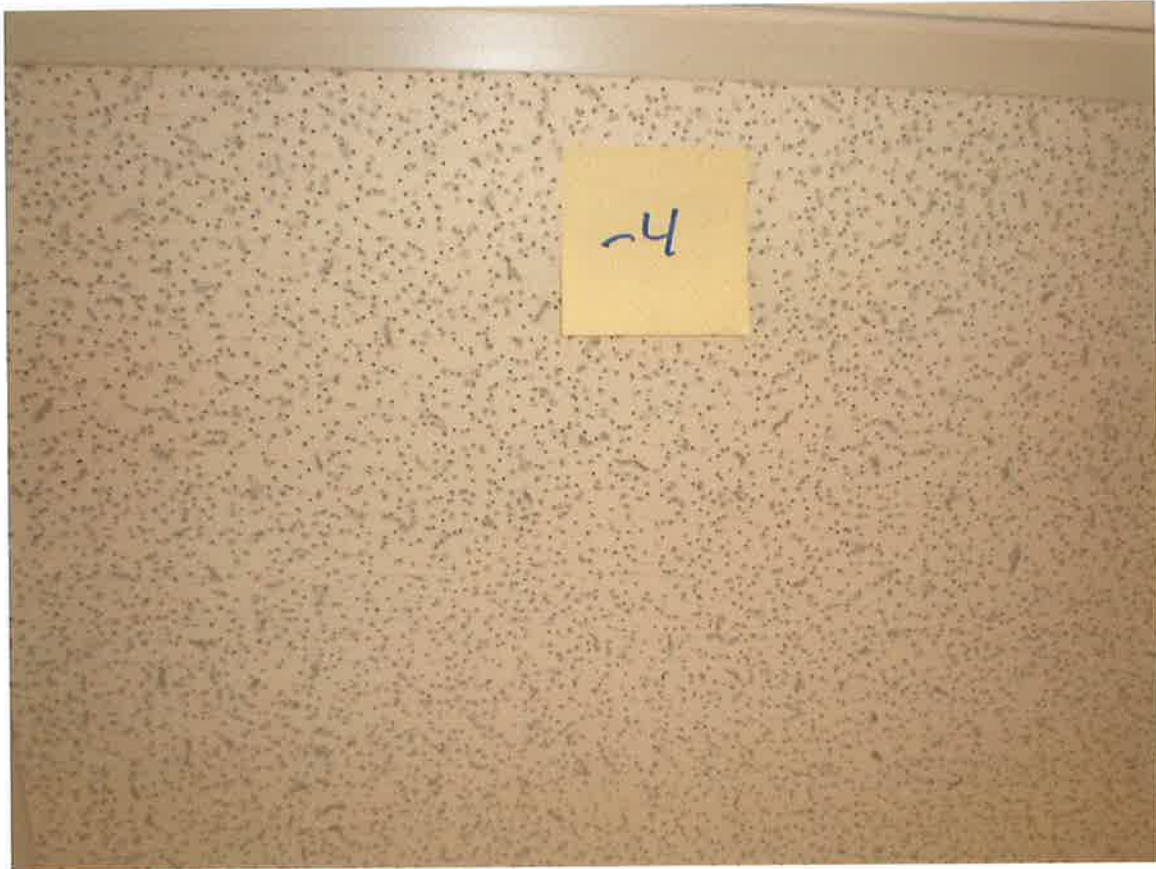
HA #4 – Non asbestos containing 2' x 2' white lay-in ceiling tile with pin holes and fissures

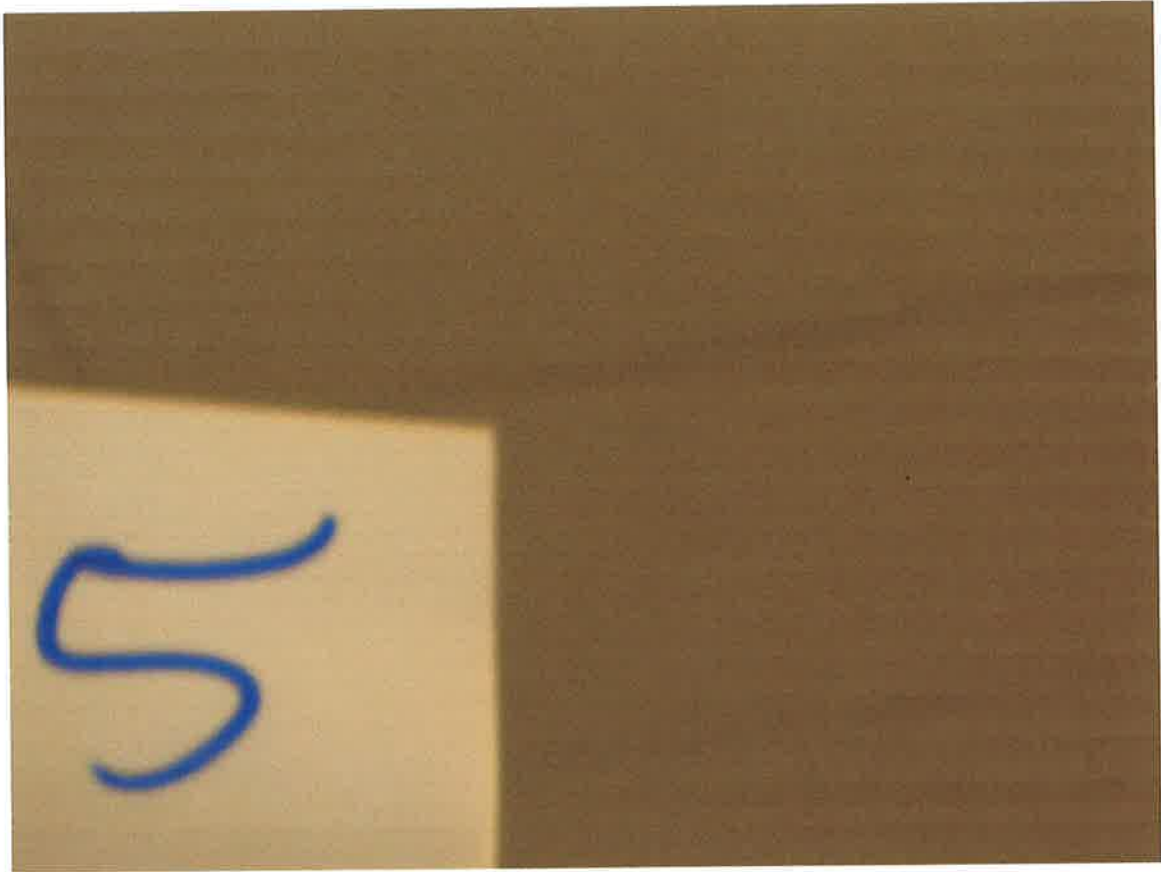
HA #5 – Non asbestos containing 2' x 4' white lay-in ceiling tile with pin holes

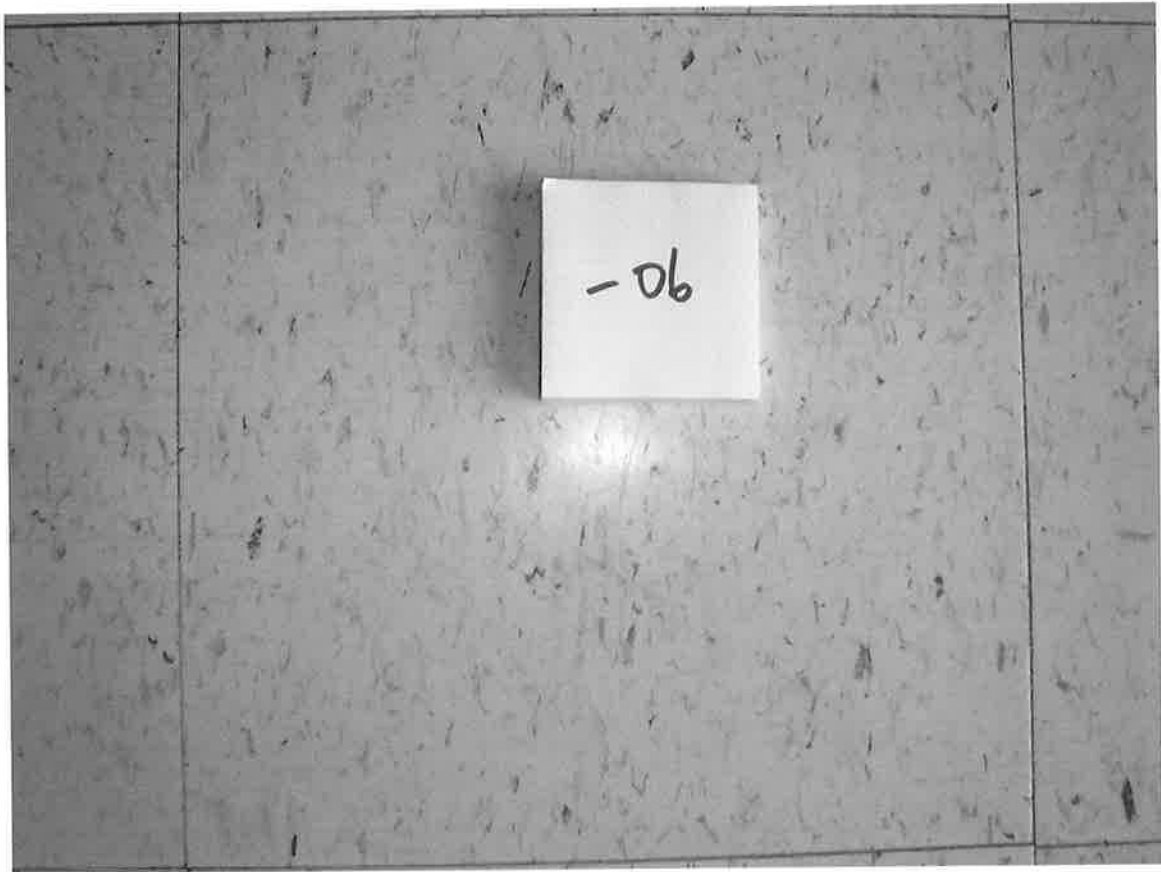
**HA #6 – Non asbestos containing 12” x 12” white floor tile with
black and gray marble pattern and associated mastic**

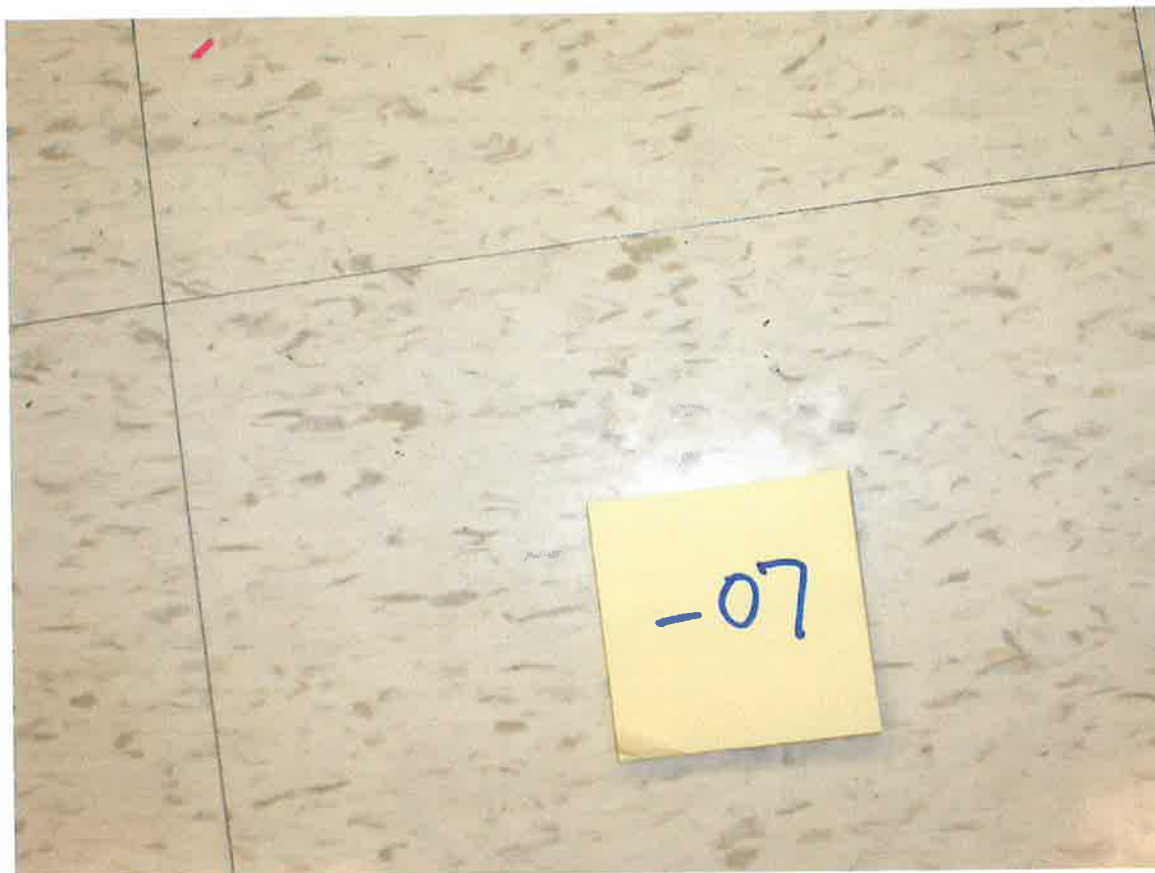
**HA #7 – Non asbestos containing 12” x 12” white floor
tile with green marble pattern and associated mastic**

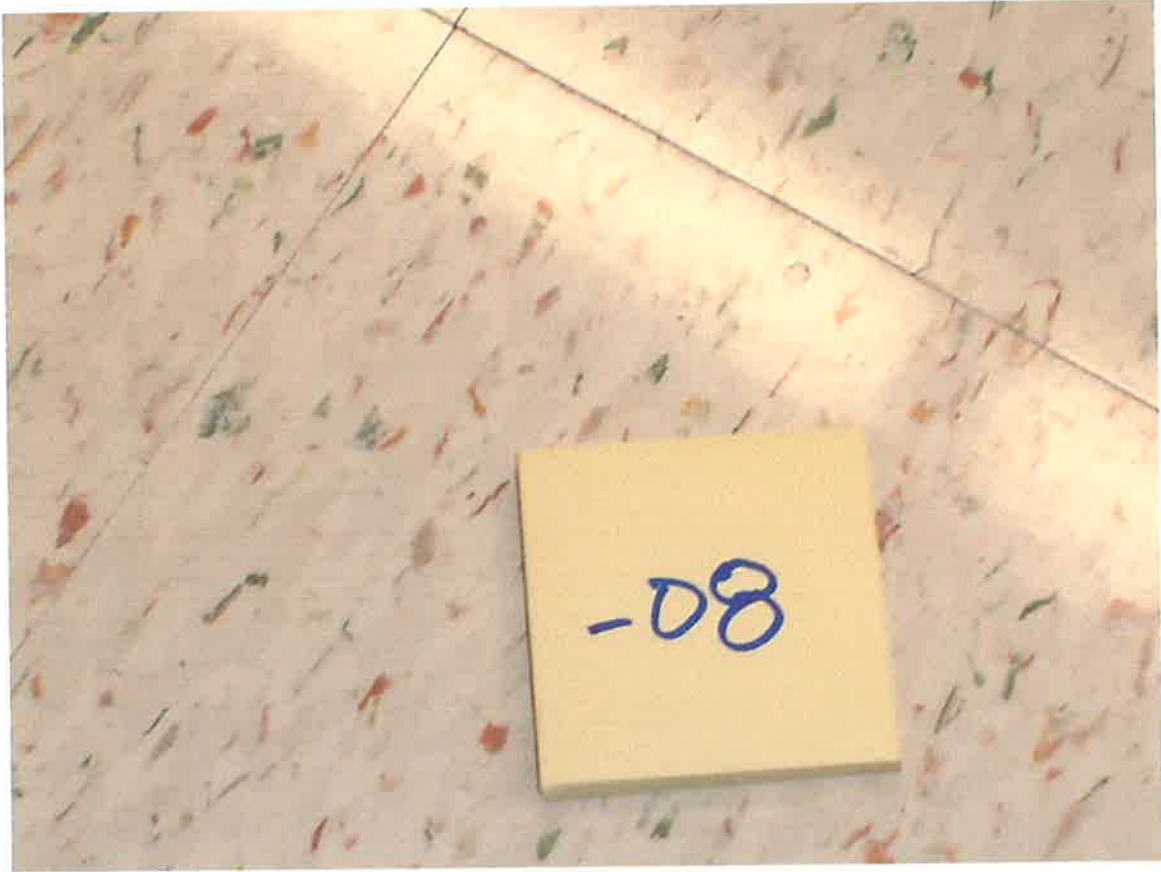
**HA #8 – Non asbestos containing 12” x 12” white floor tile
with green, rust and tan specks and associated mastic**

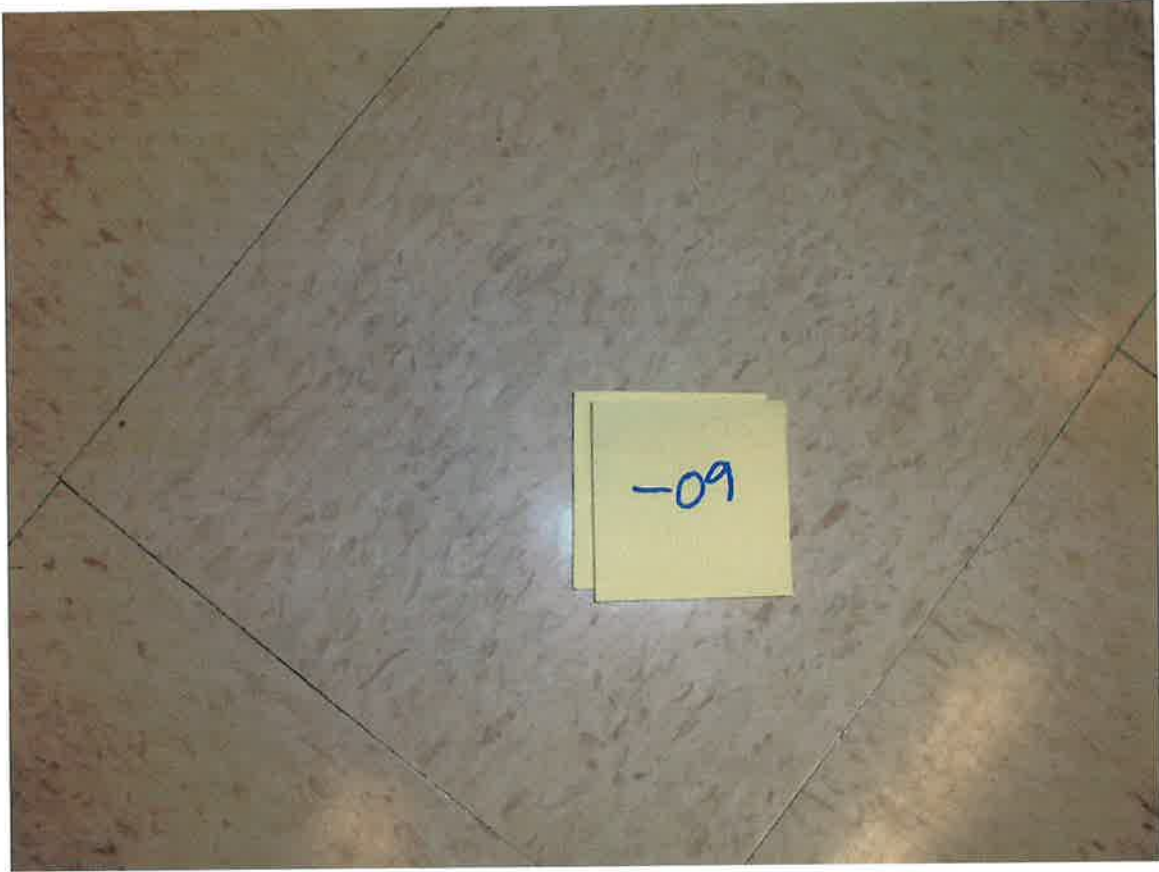
**HA #9 – Non asbestos containing 12” x 12” tan floor tile
with marble pattern and associated mastic**

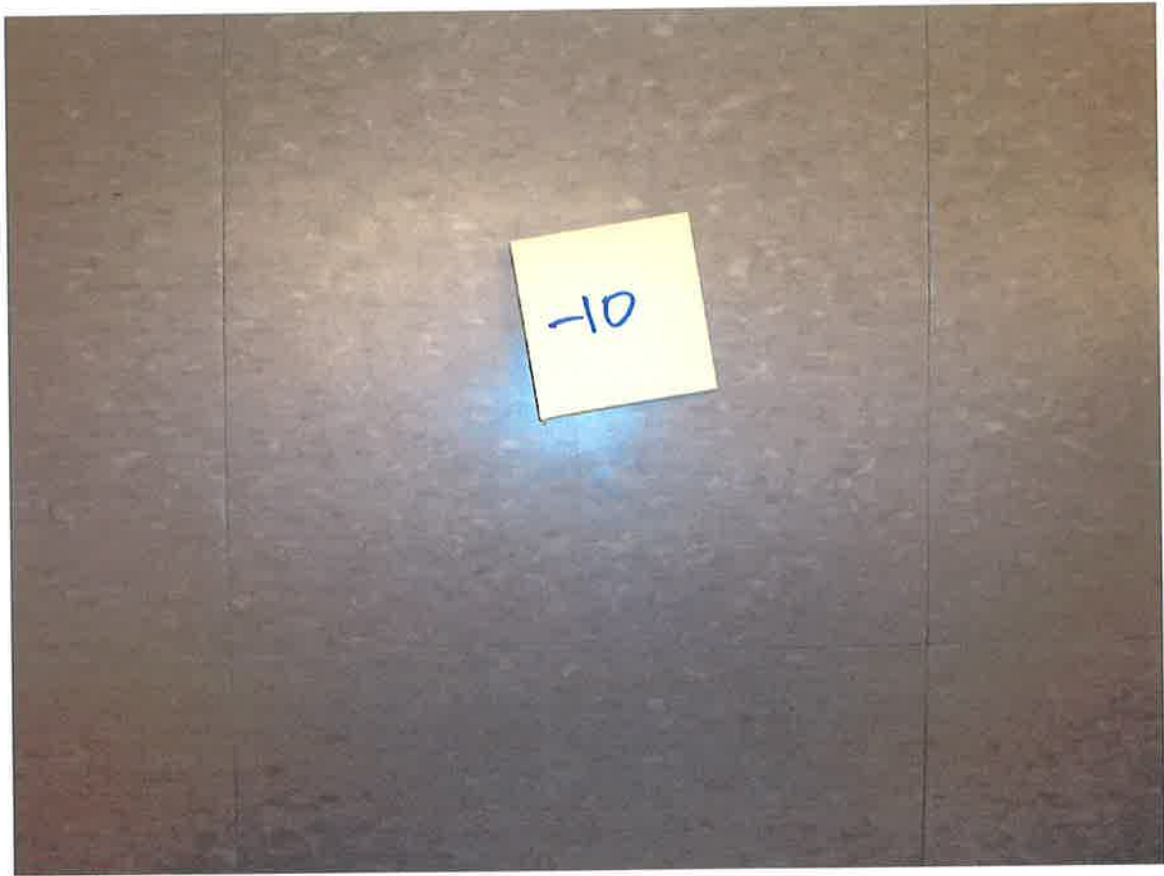
**HA #10 – Non asbestos containing 12” x 12” beige floor
tile with marble pattern and asbestos containing associated mastic**

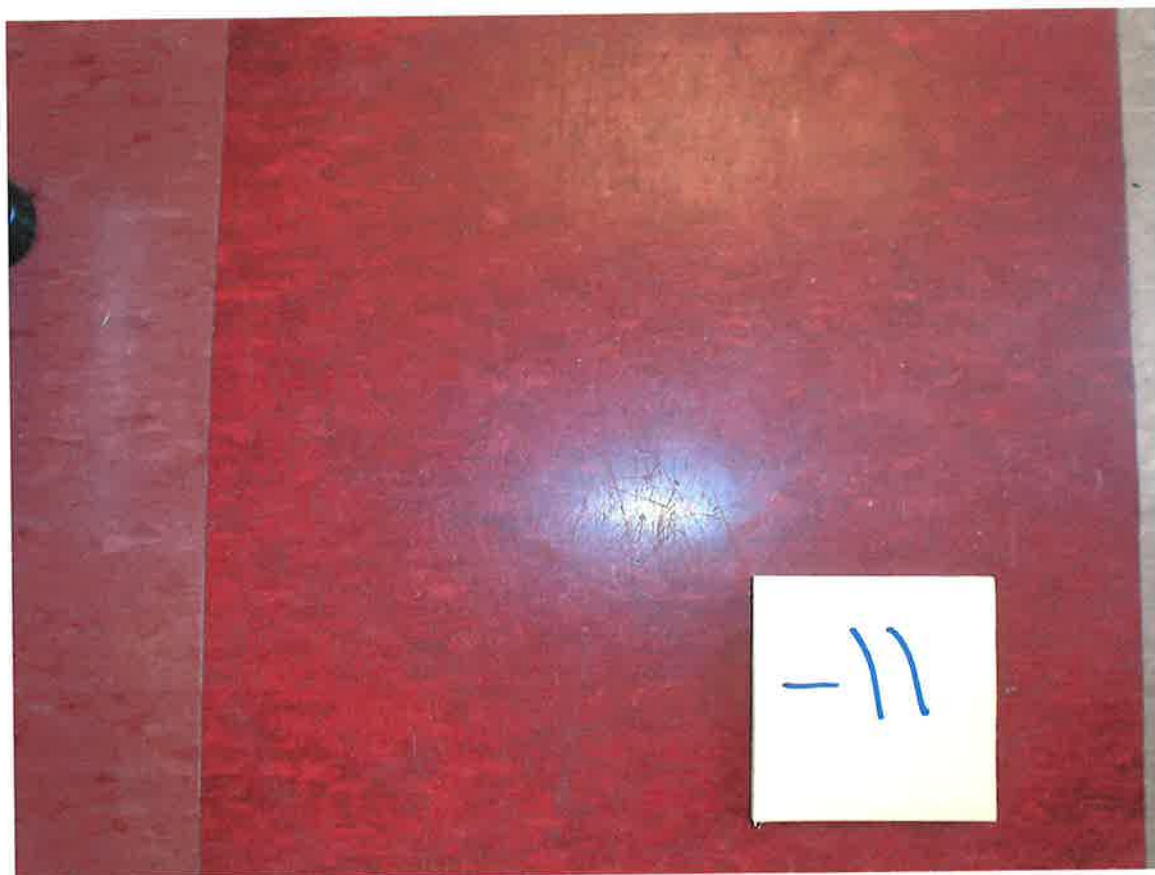
HA #11 – Non asbestos containing 12” x 12” red floor tile
with marble pattern and asbestos containing associated mastic

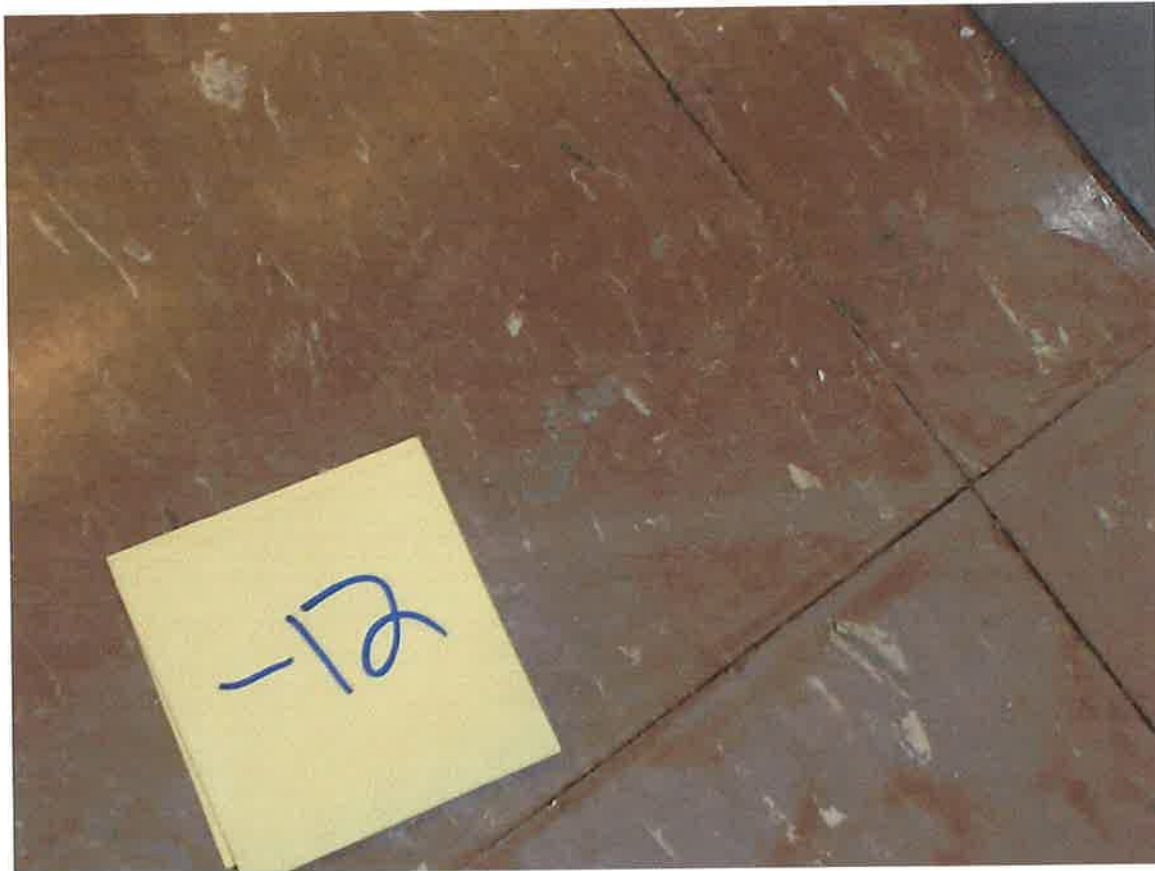
HA #12 – Asbestos containing 12” x 12” dark brown floor tile with cream and green streaks and non asbestos containing associated mastic

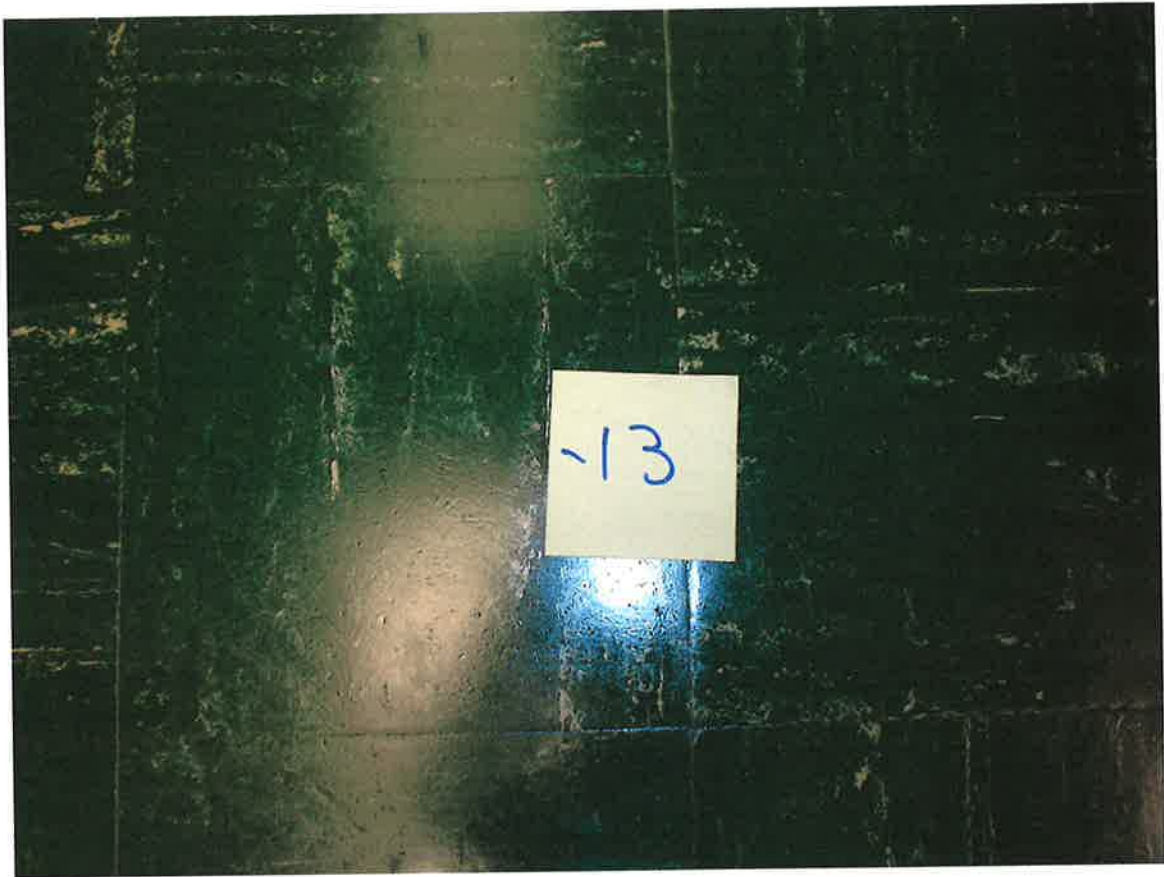
**HA #13 – Asbestos containing 9” x 9” green floor tile
with white streaks and non asbestos containing associated mastic**

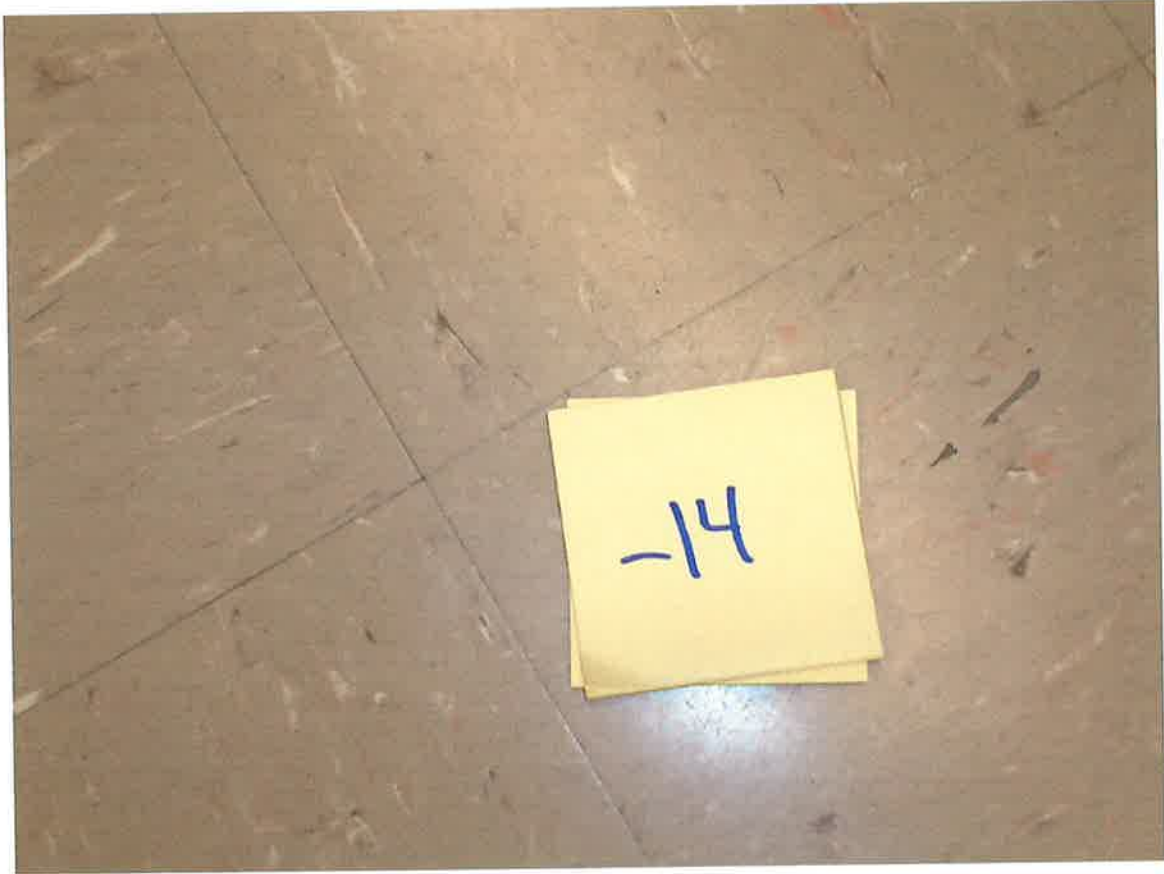
HA #14 – Asbestos containing 9” x 9” beige floor tile with pink, cream and brown swirl pattern and non asbestos containing associated mastic

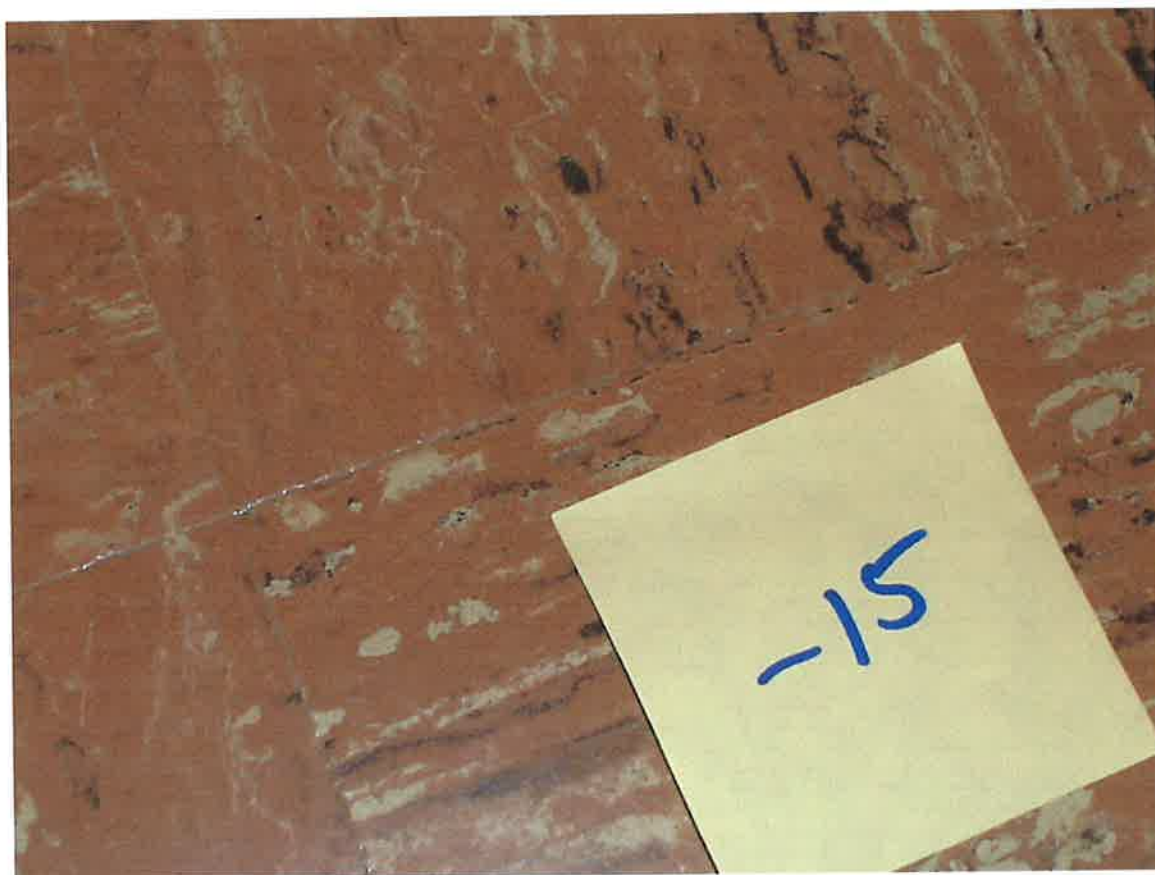
HA #15 – Asbestos containing 9” x 9” light brown floor tile with cream and brown streaks and non asbestos containing associated mastic

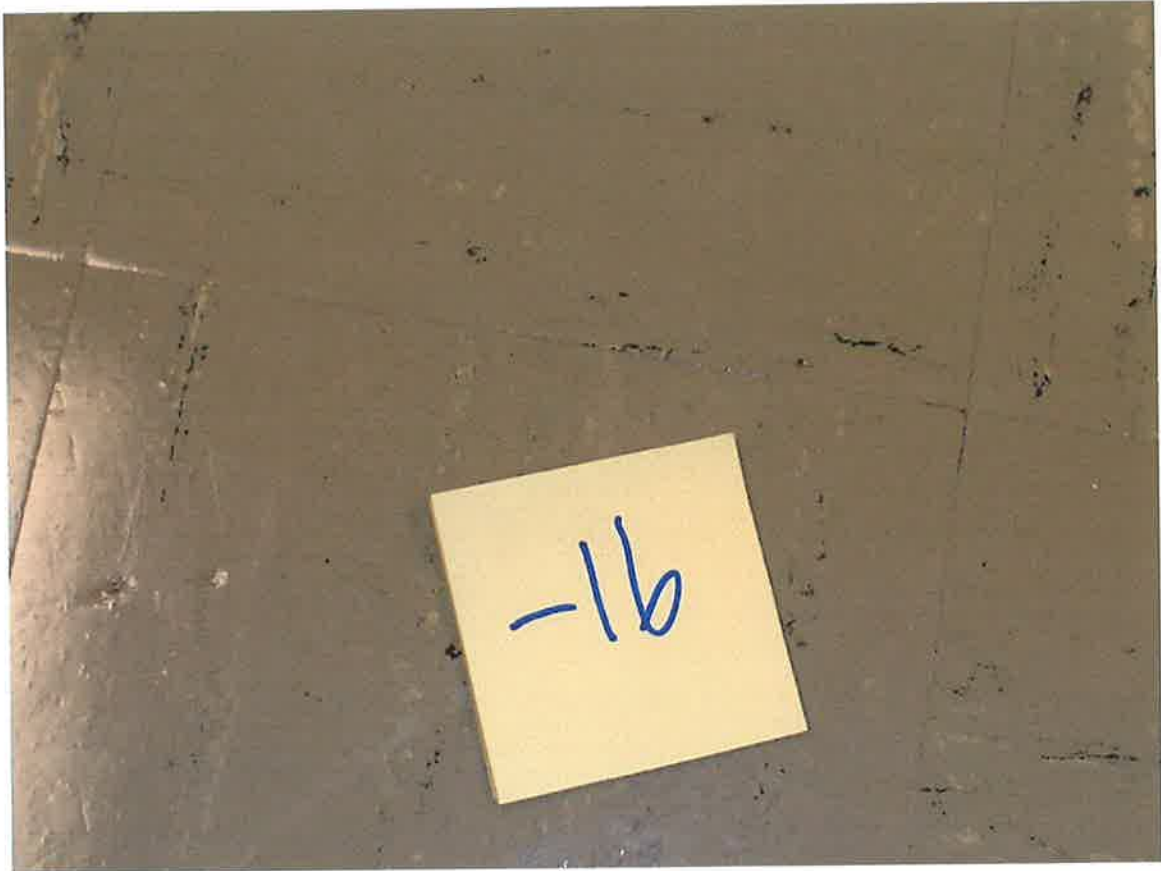
HA #16 – Asbestos containing 9” x 9” gray floor tile with black and cream streaks and non asbestos containing associated mastic

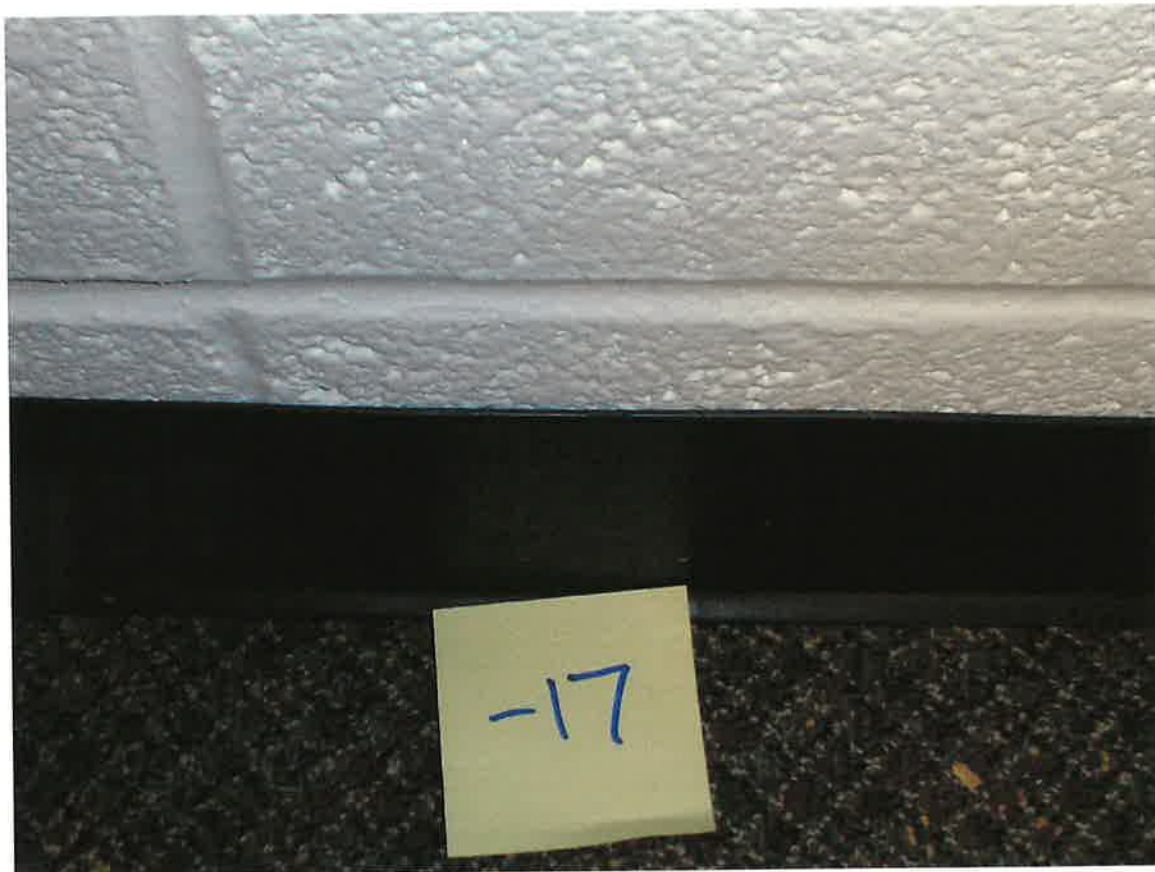
HA #17 – Non asbestos containing 4” black cove molding
and associated mastic

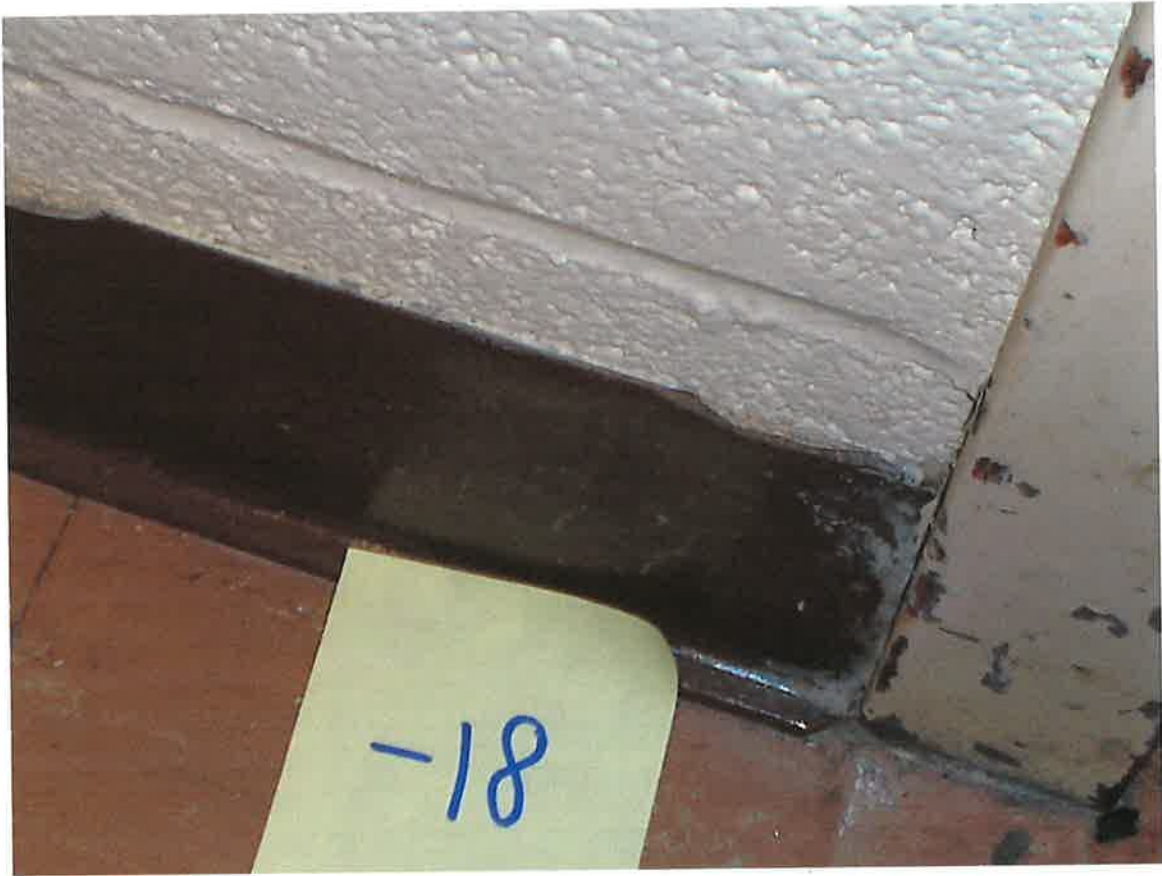
HA #18 – Non asbestos containing 4” brown cove molding
and associated mastic

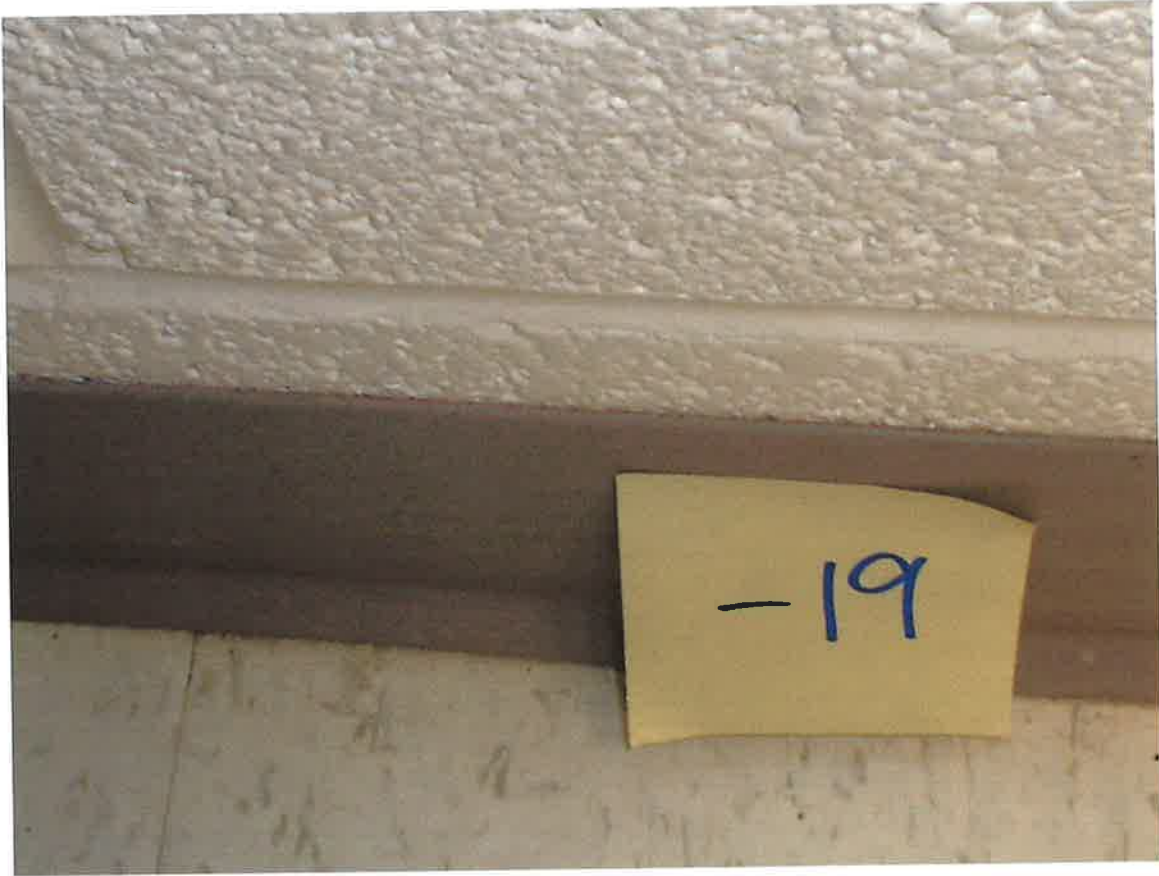
HA #19 – Non asbestos containing 4” gray cove molding
and associated mastic

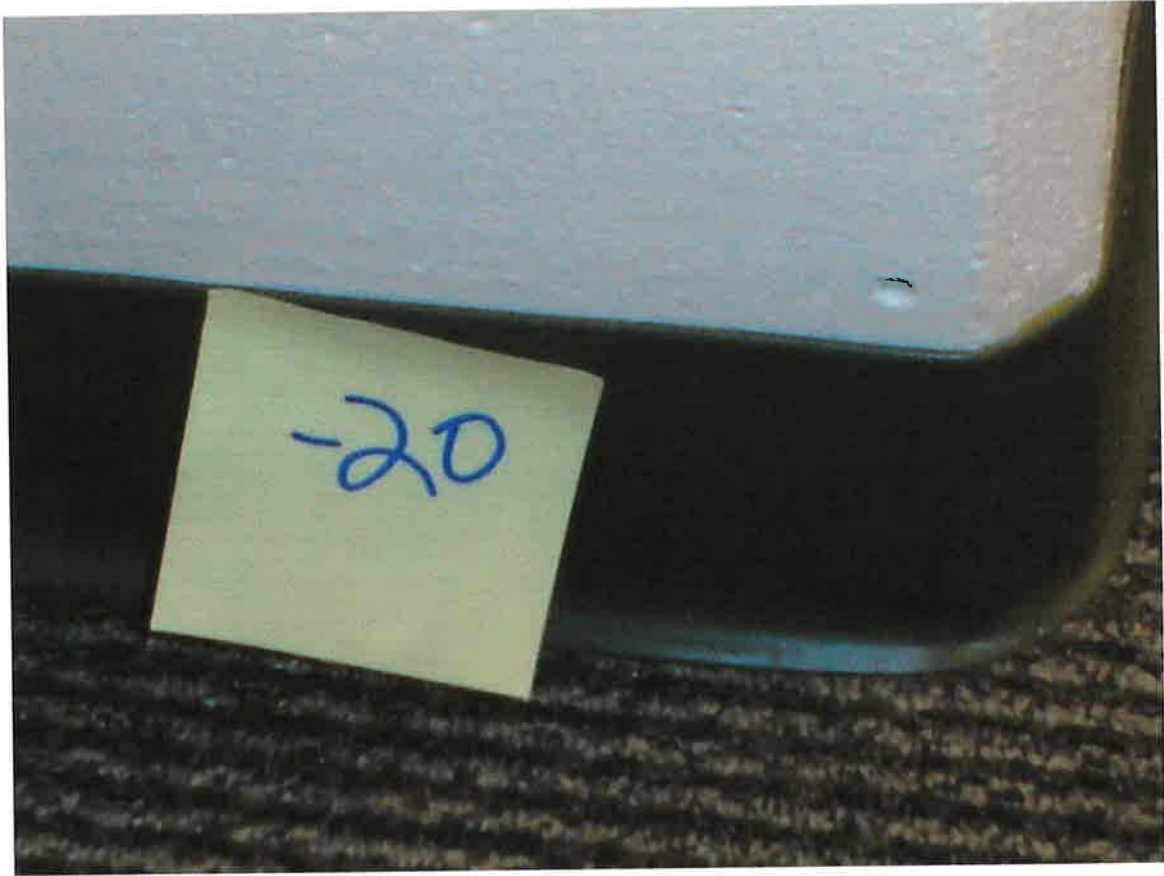
HA #20 – Non asbestos containing 4” olive green
cove molding and associated mastic

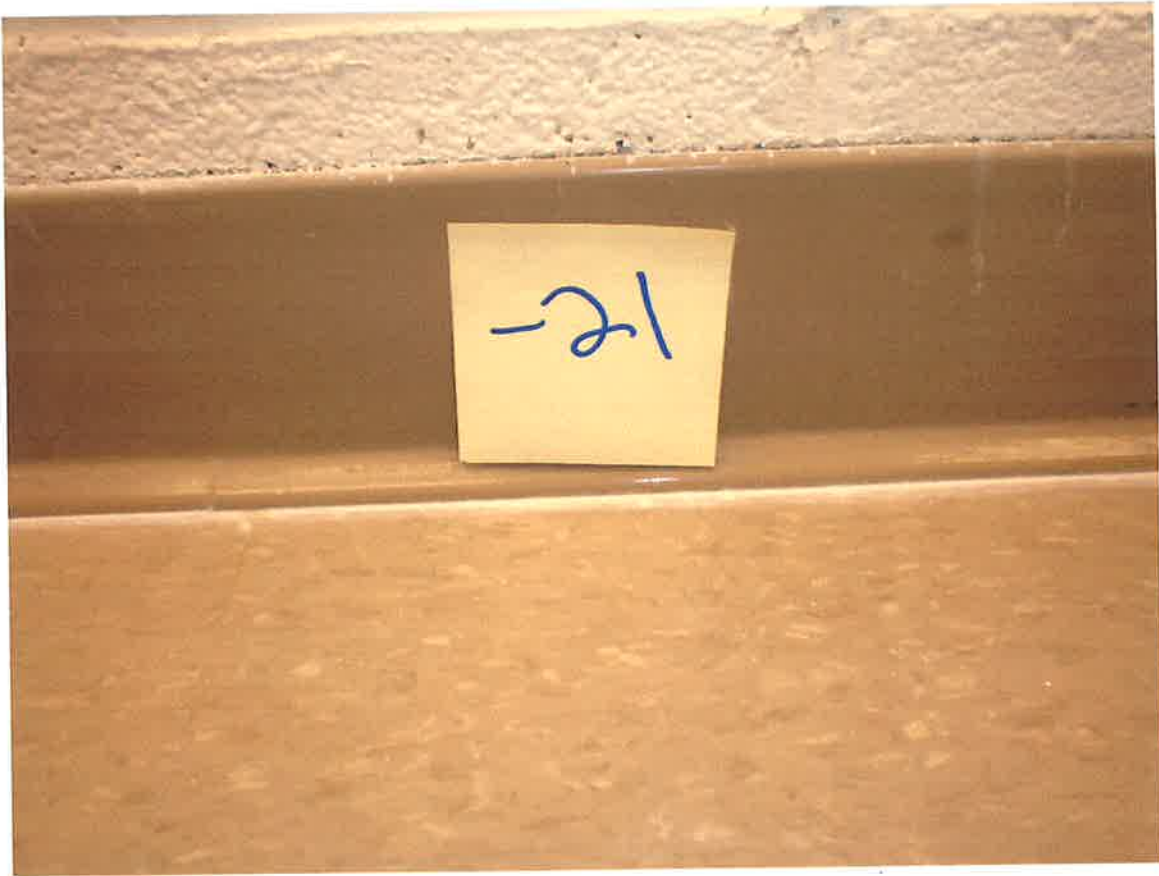
**HA #21 – Non asbestos containing 4” beige cove molding
and associated mastic**

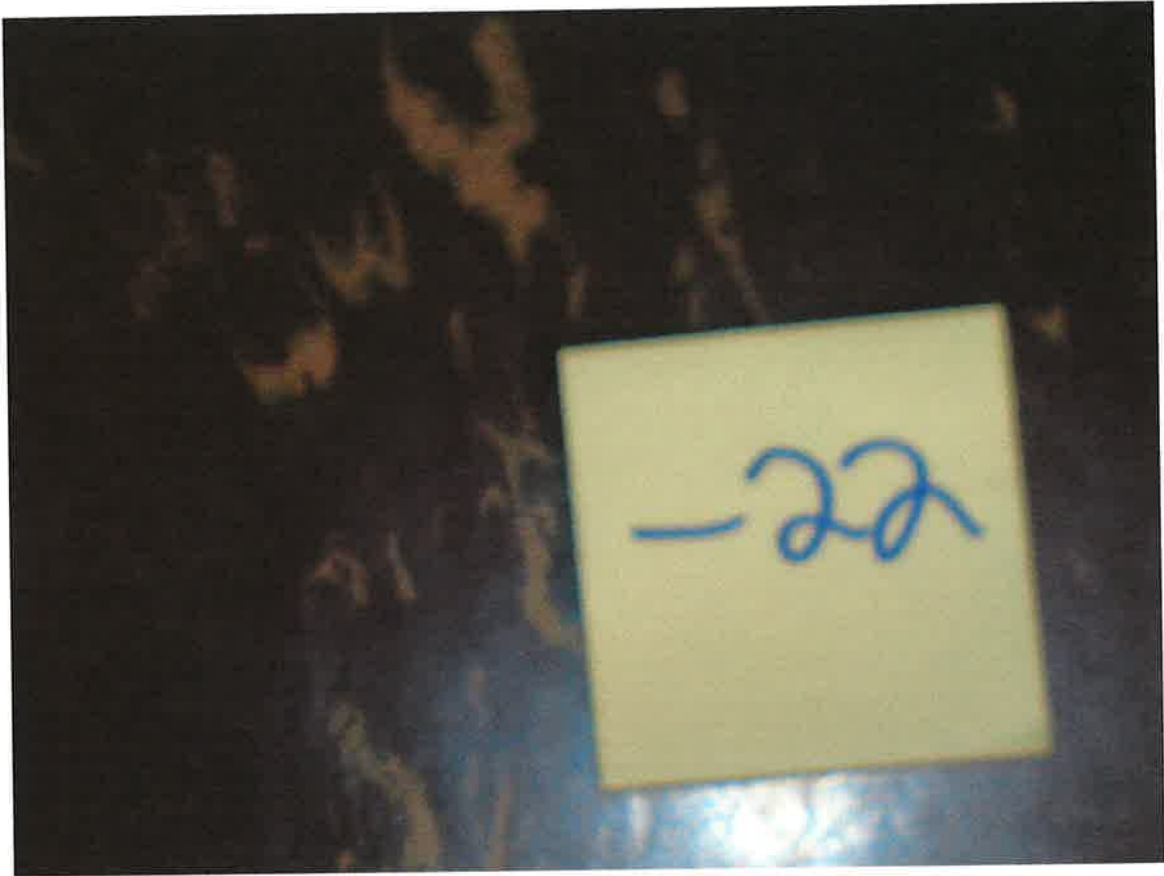
HA #22 – Non asbestos containing brown linoleum flooring
with tan streaks and associated mastic
