MSU Engineering Building

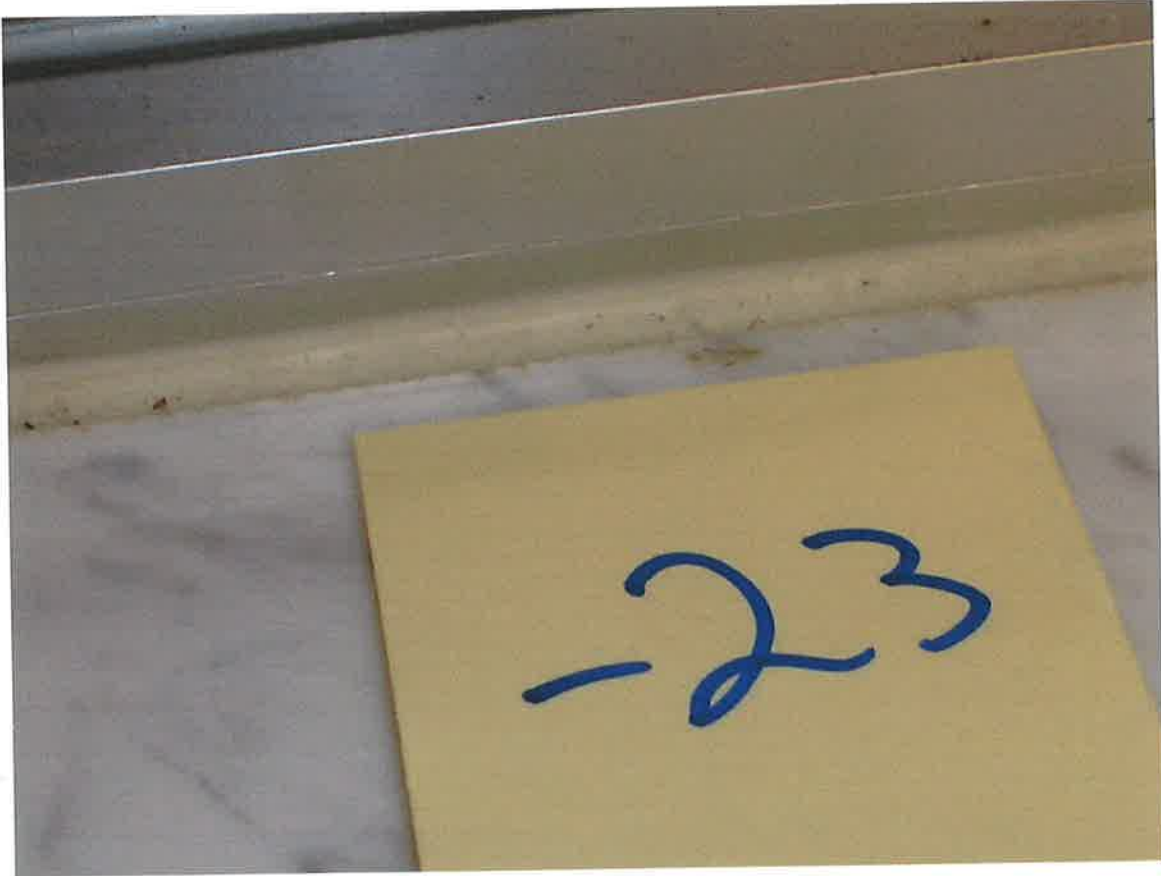
HA #23 – Non asbestos containing window and door frame caulk compound (interior)

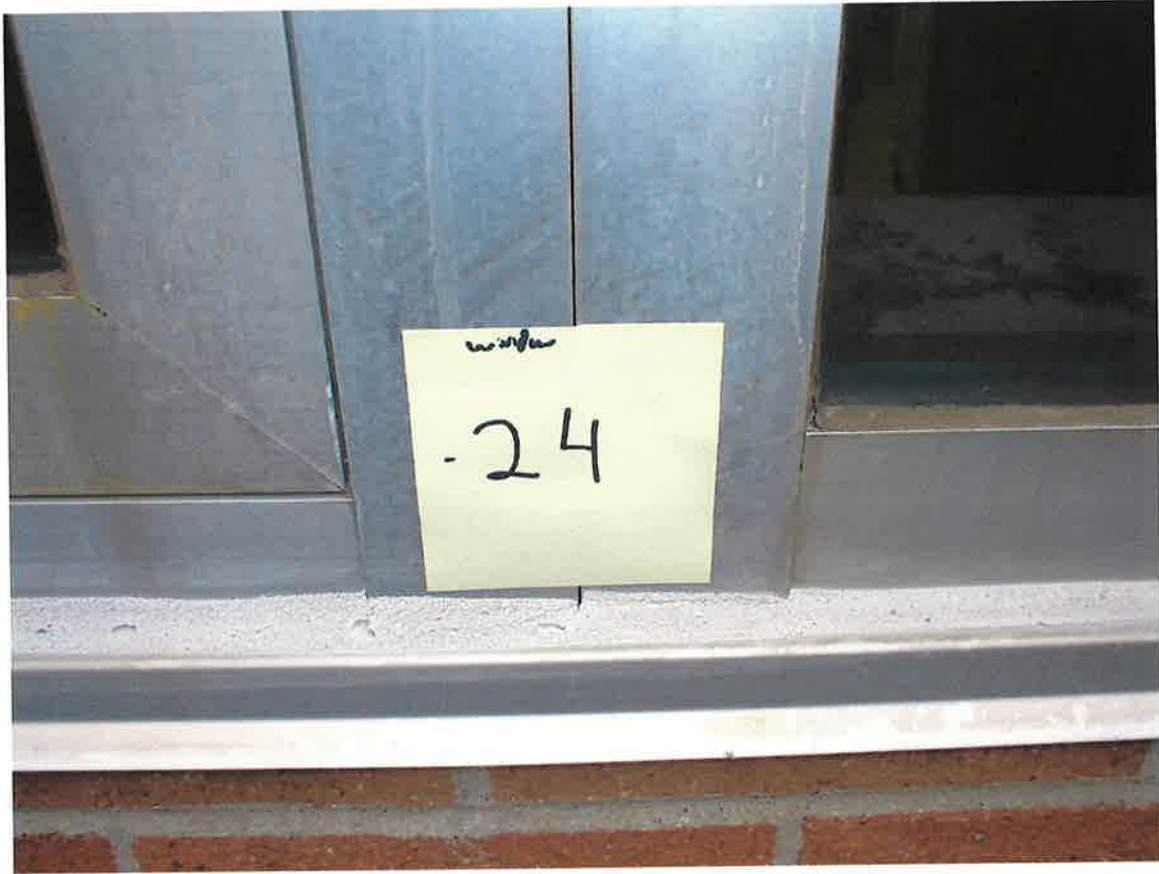
HA #24 – Non asbestos containing window and door frame
caulk compound (exterior)

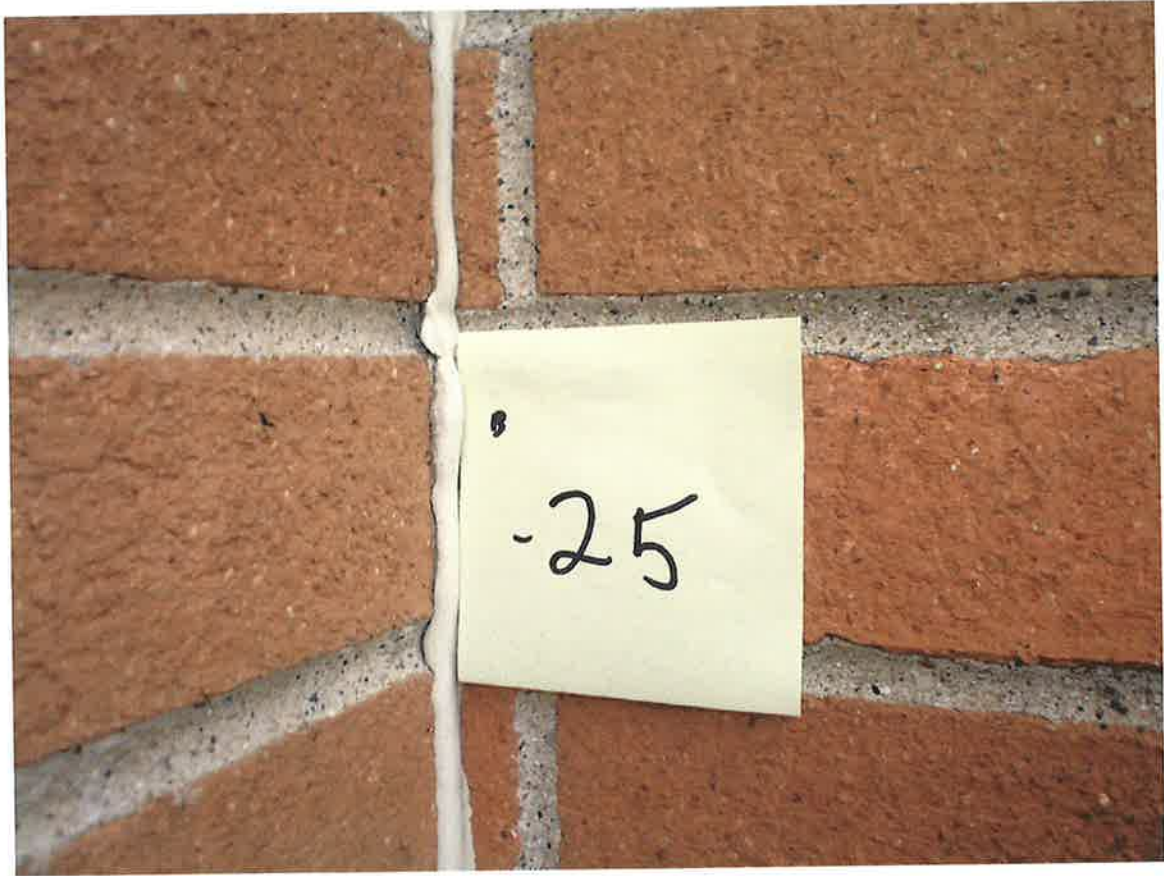
HA #25 – Non asbestos containing building caulk compound

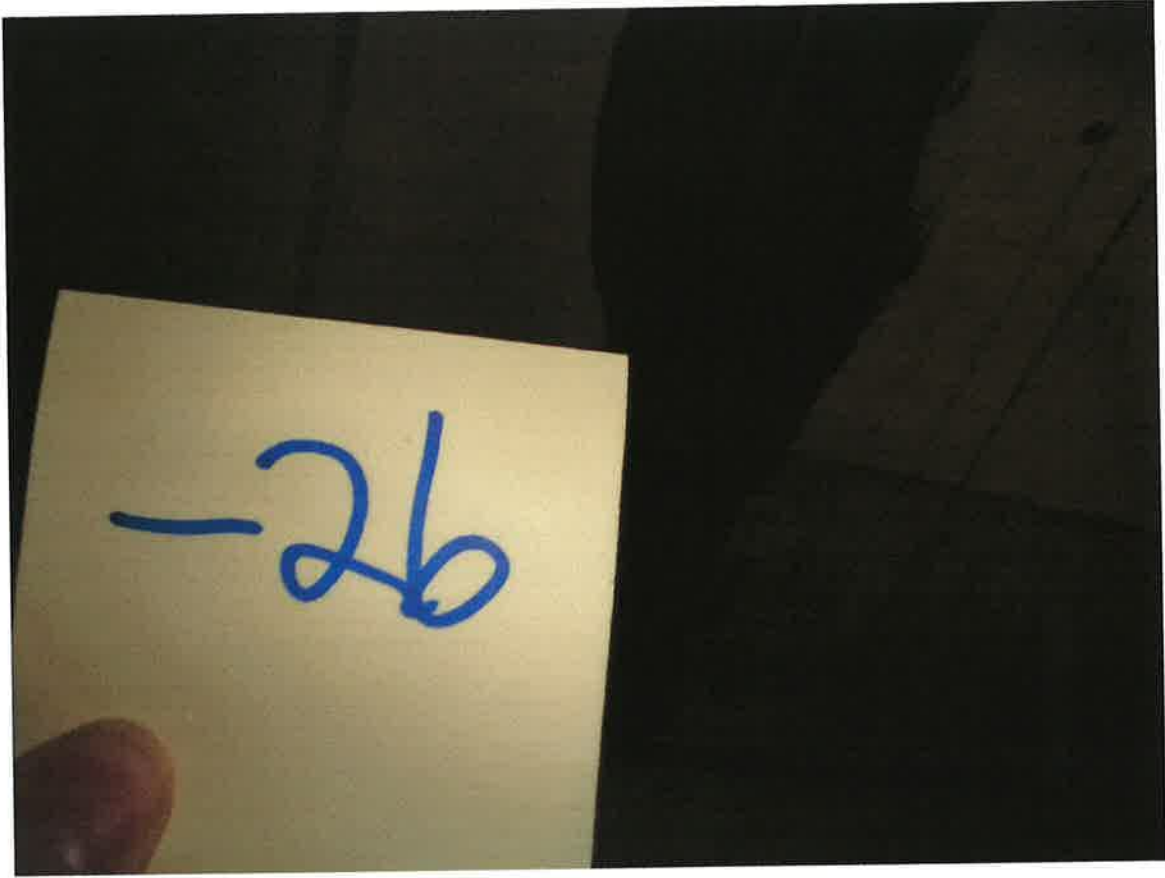
HA #26 – Non asbestos containing gray ventilation duct mastic

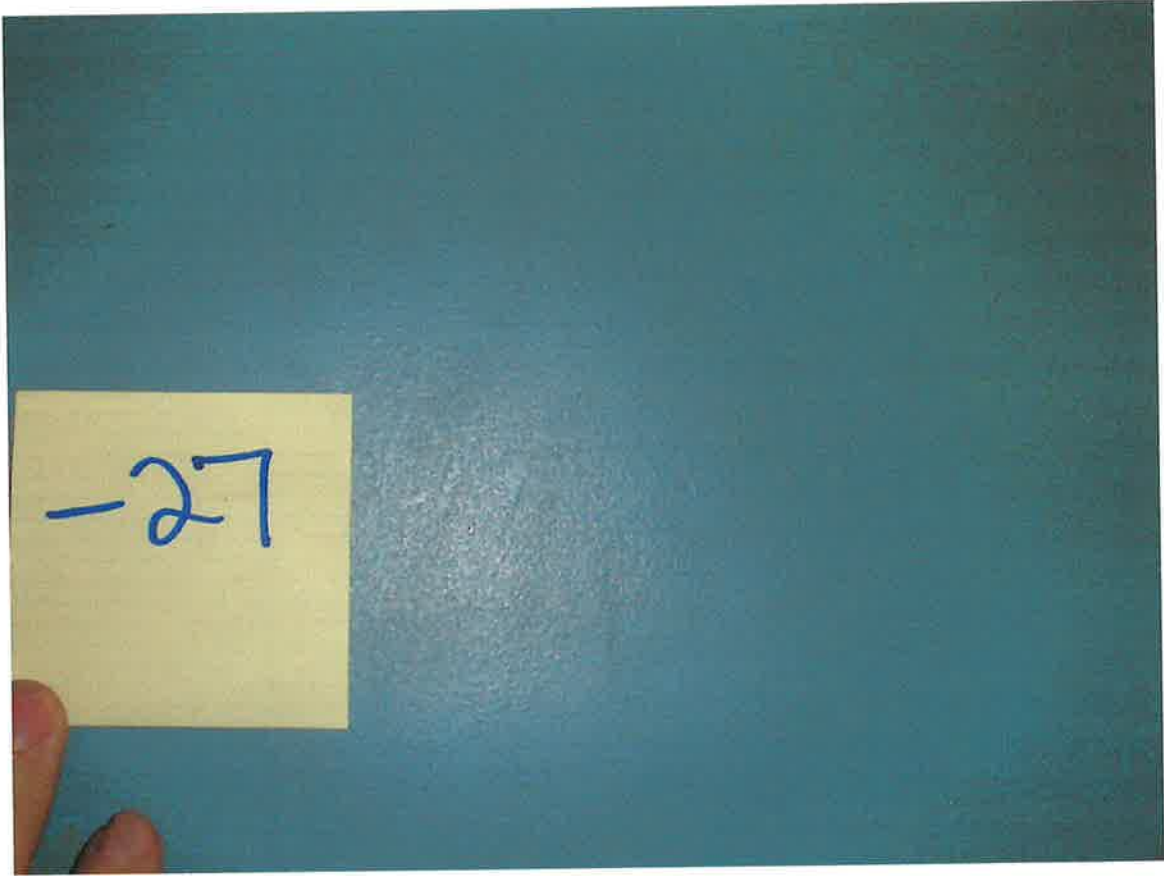
HA #27 – Assumed asbestos containing fire door and frame

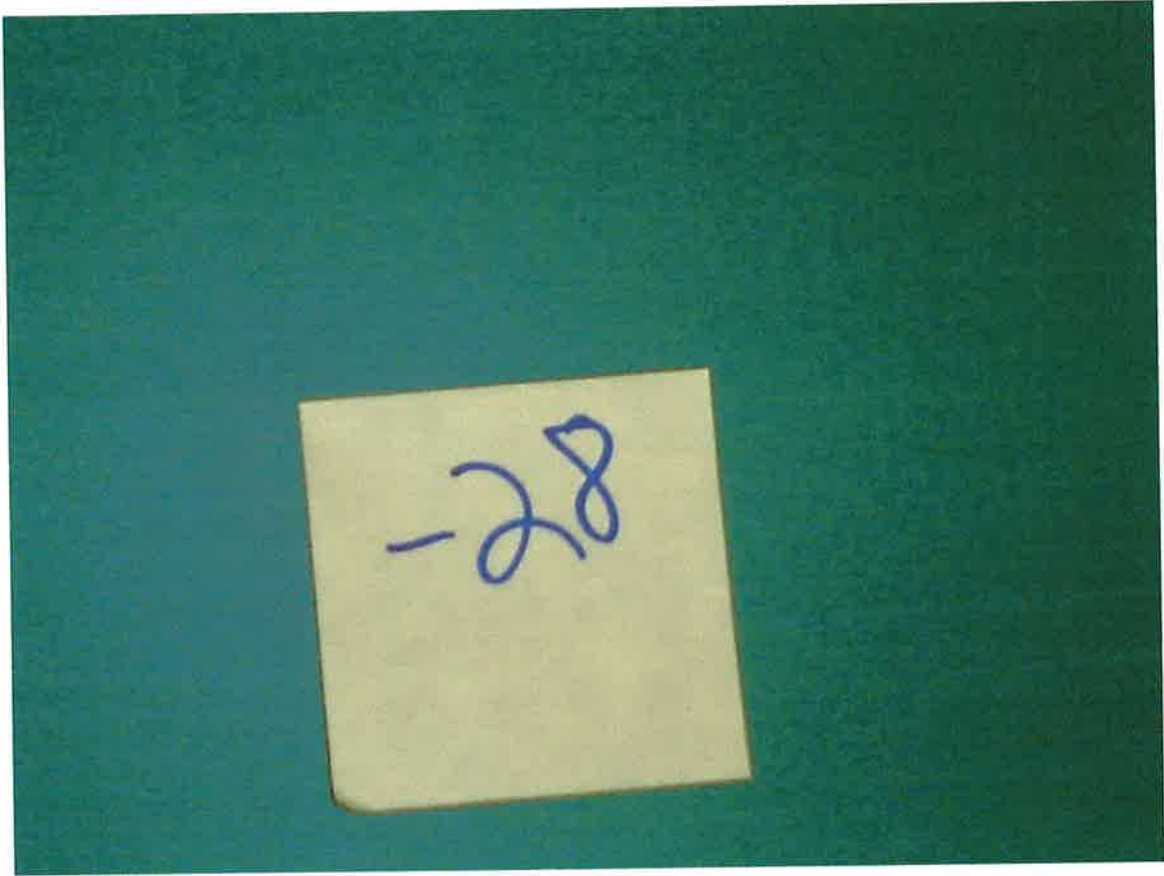
HA #28 – Assumed asbestos containing chalkboards and associated glue pods

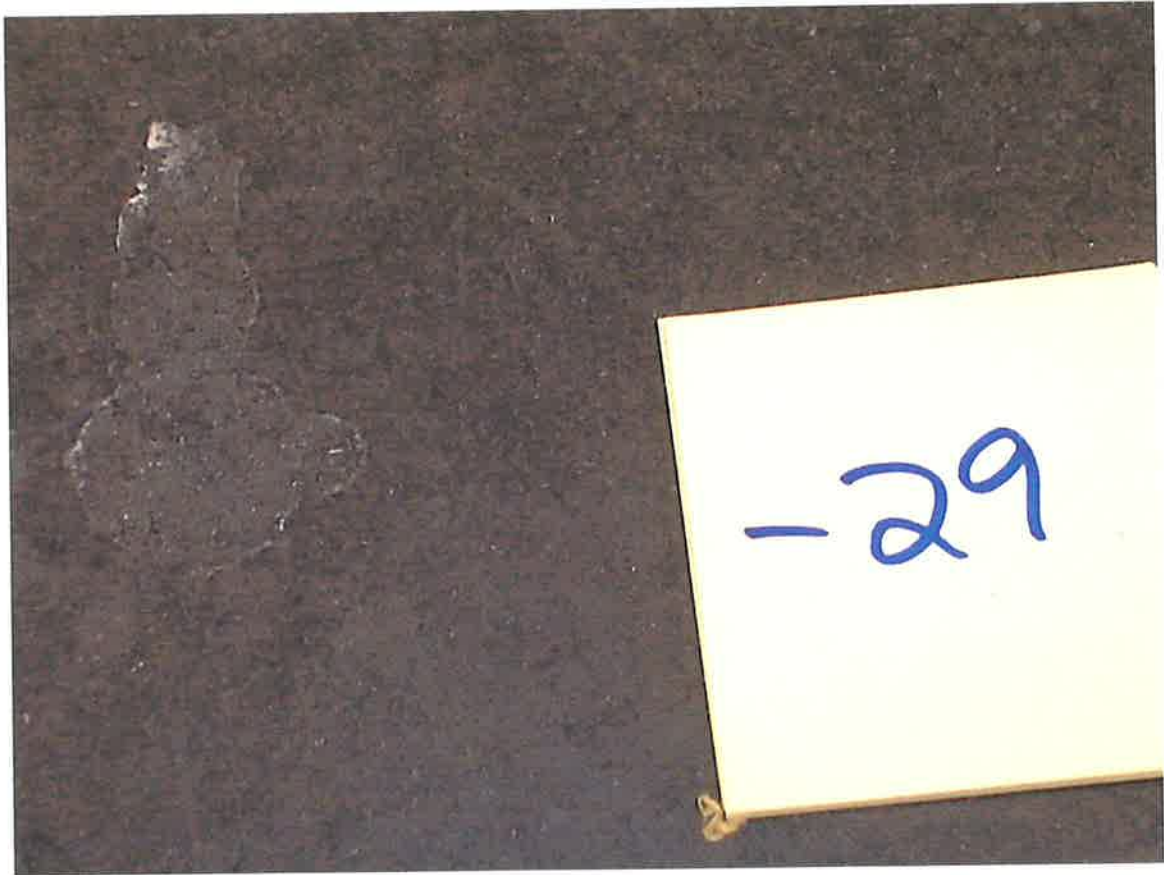
HA #29 – Assumed asbestos containing black laboratory
sinks, countertops and tables

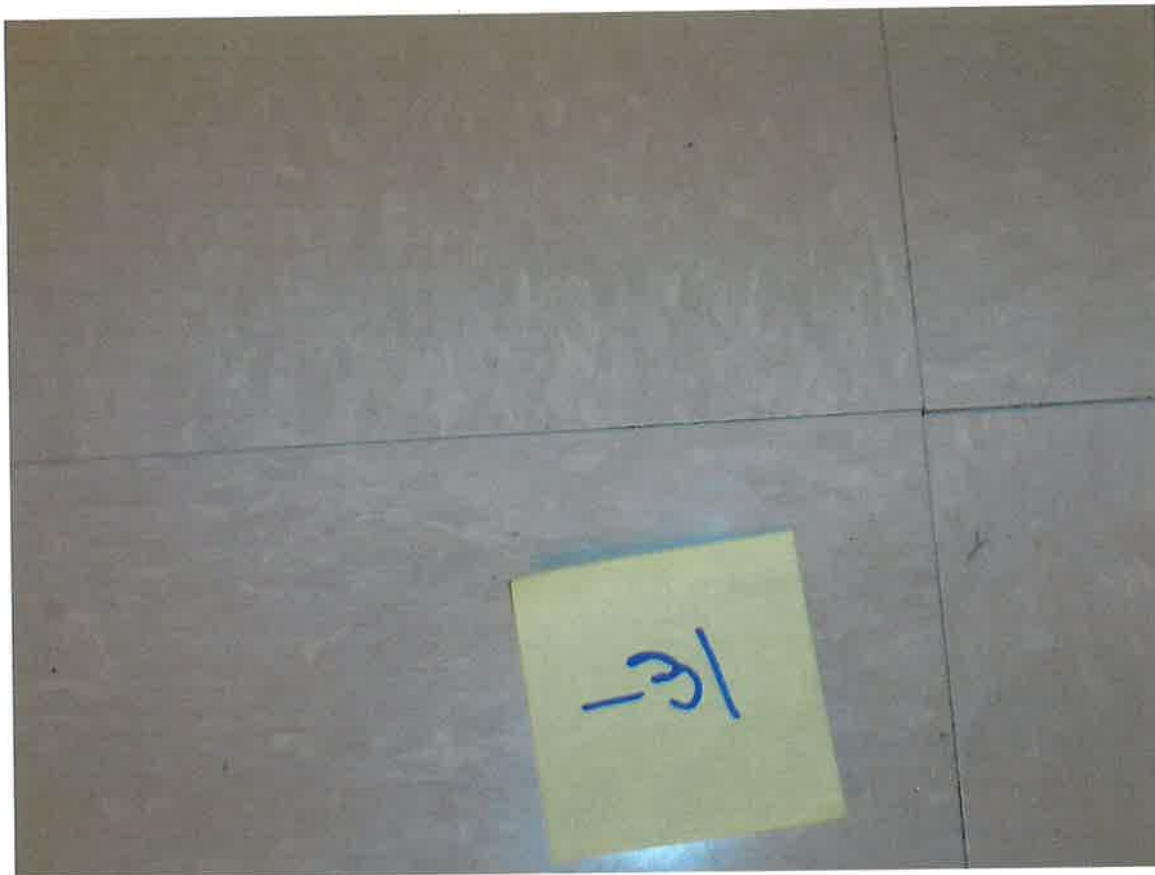
**HA #31 – Non asbestos containing 12” x 12” cream floor tile
with marble pattern and asbestos containing associated mastic**

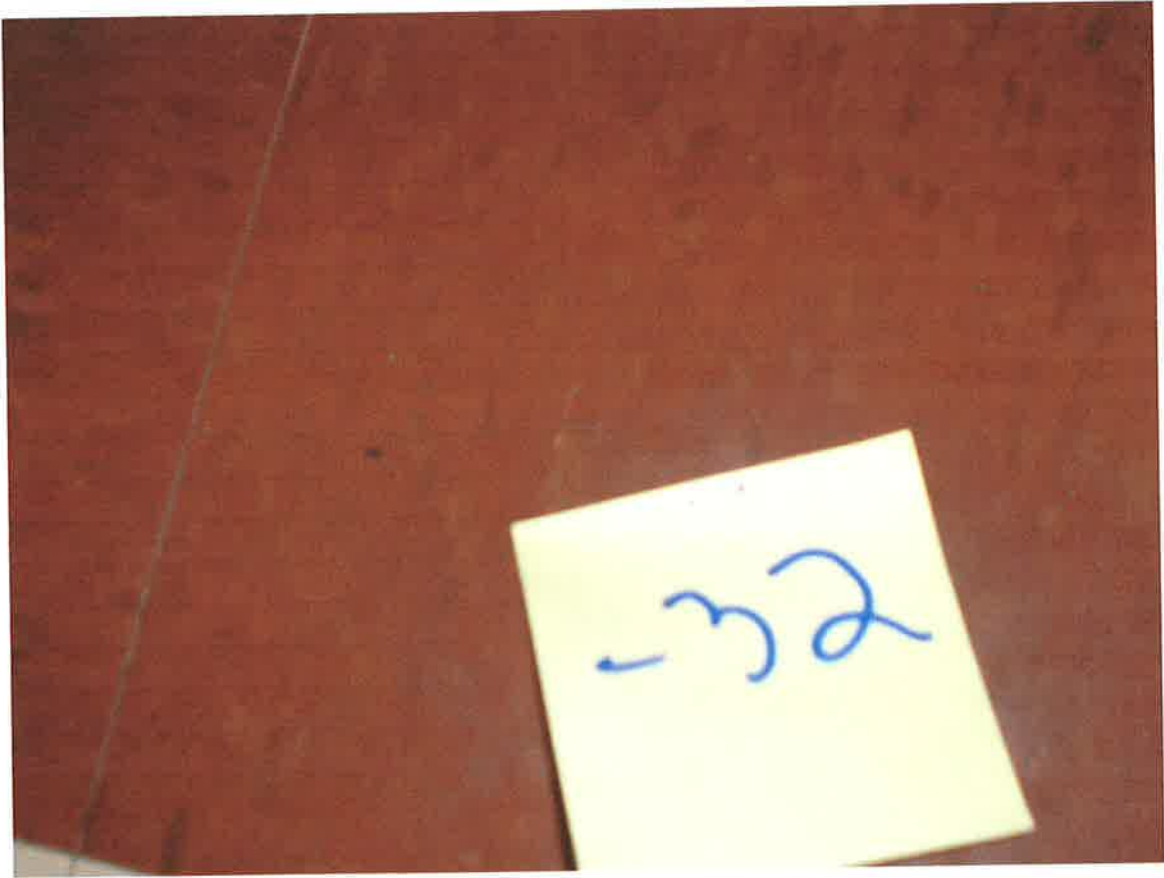
HA #32 – Non asbestos containing 12" x 12" rust floor tile with
marble pattern and asbestos containing associated mastic

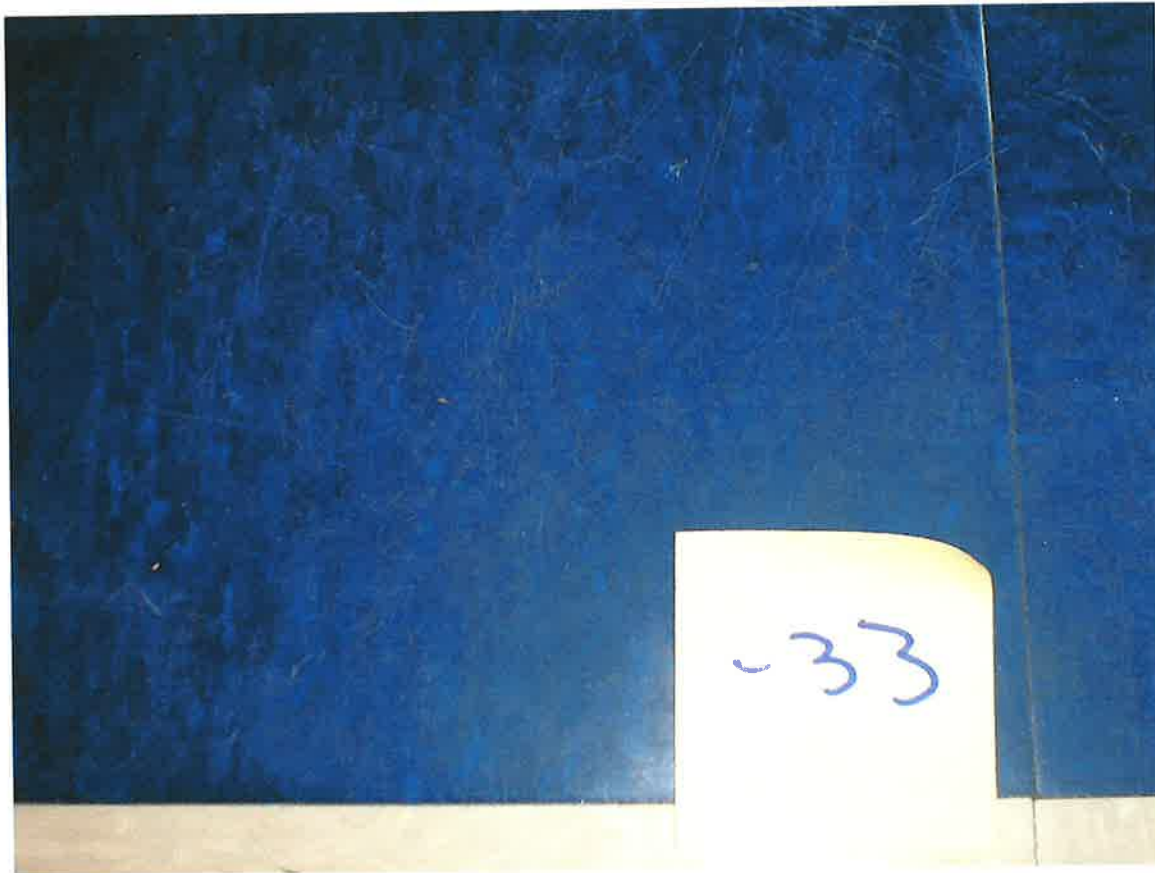
HA #33 – Non asbestos containing 12" x 12" blue floor tile with
marble pattern and asbestos containing associated mastic

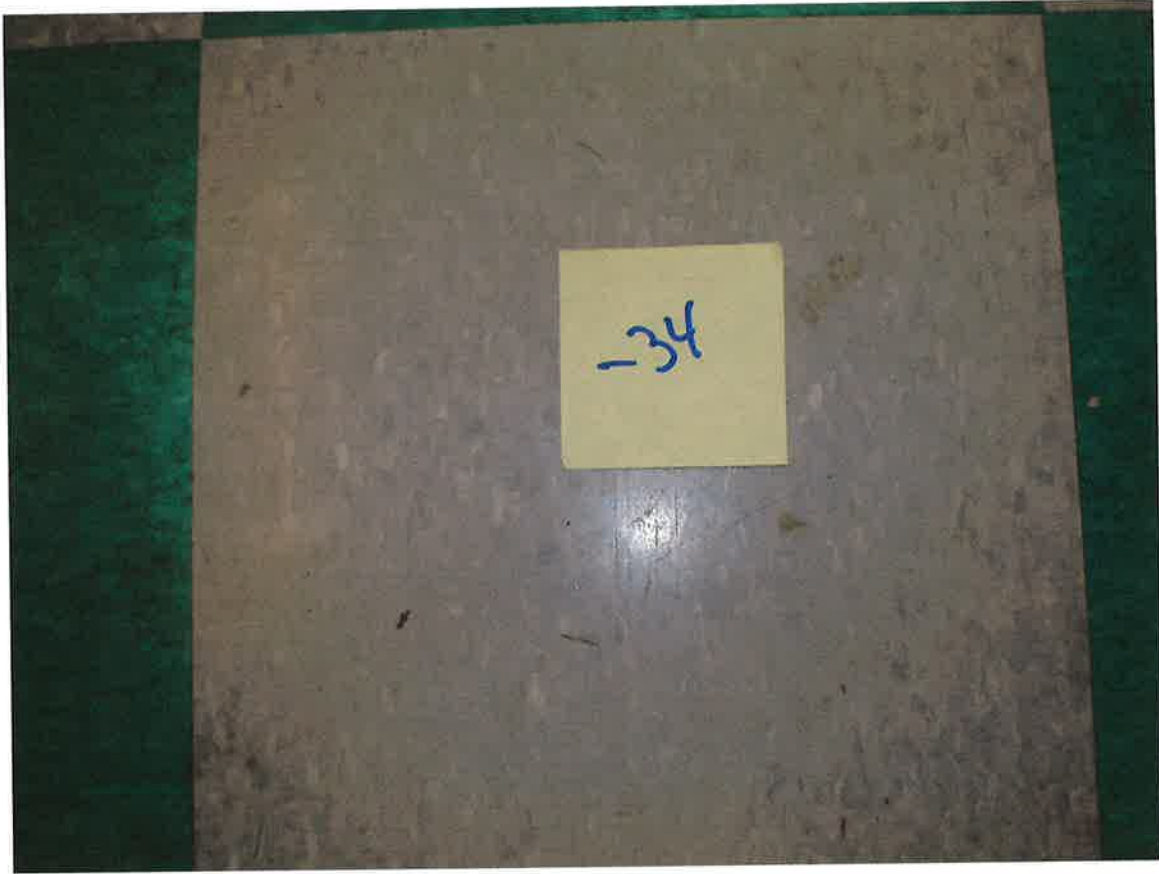
HA #34 – Non asbestos containing 12” x 12” gray floor tile with
marble pattern and associated mastic

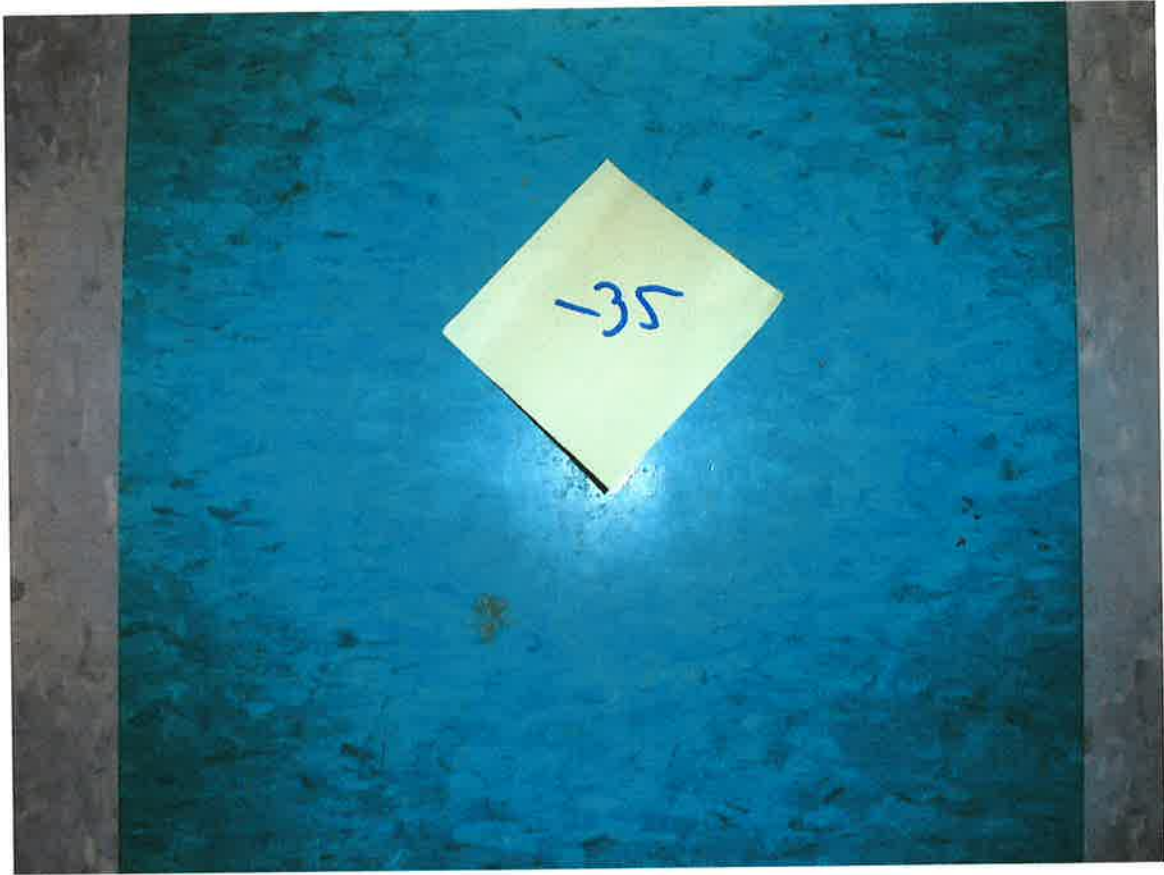
HA #35 – Non asbestos containing 12” x 12” green floor tile
with marble pattern and associated mastic

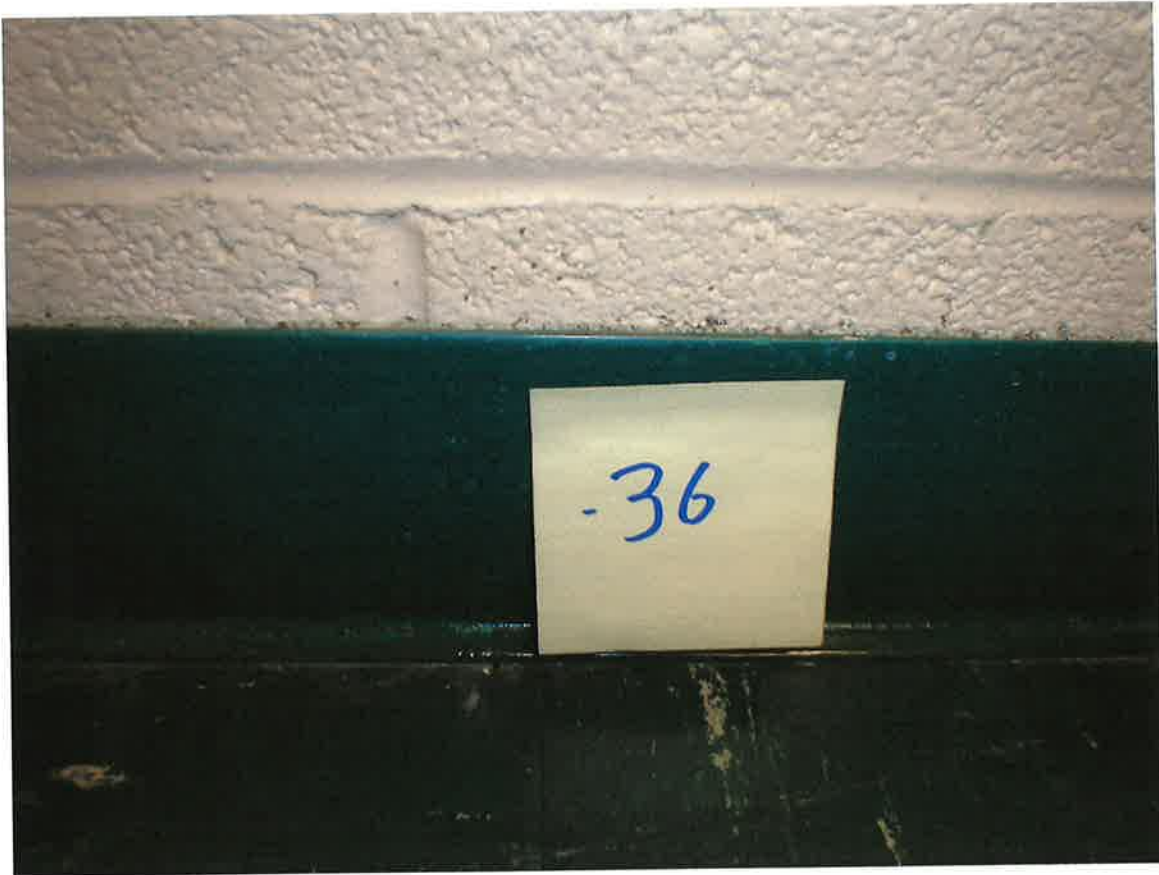
HA #36 – Non asbestos containing 4" green cove molding
and associated mastic

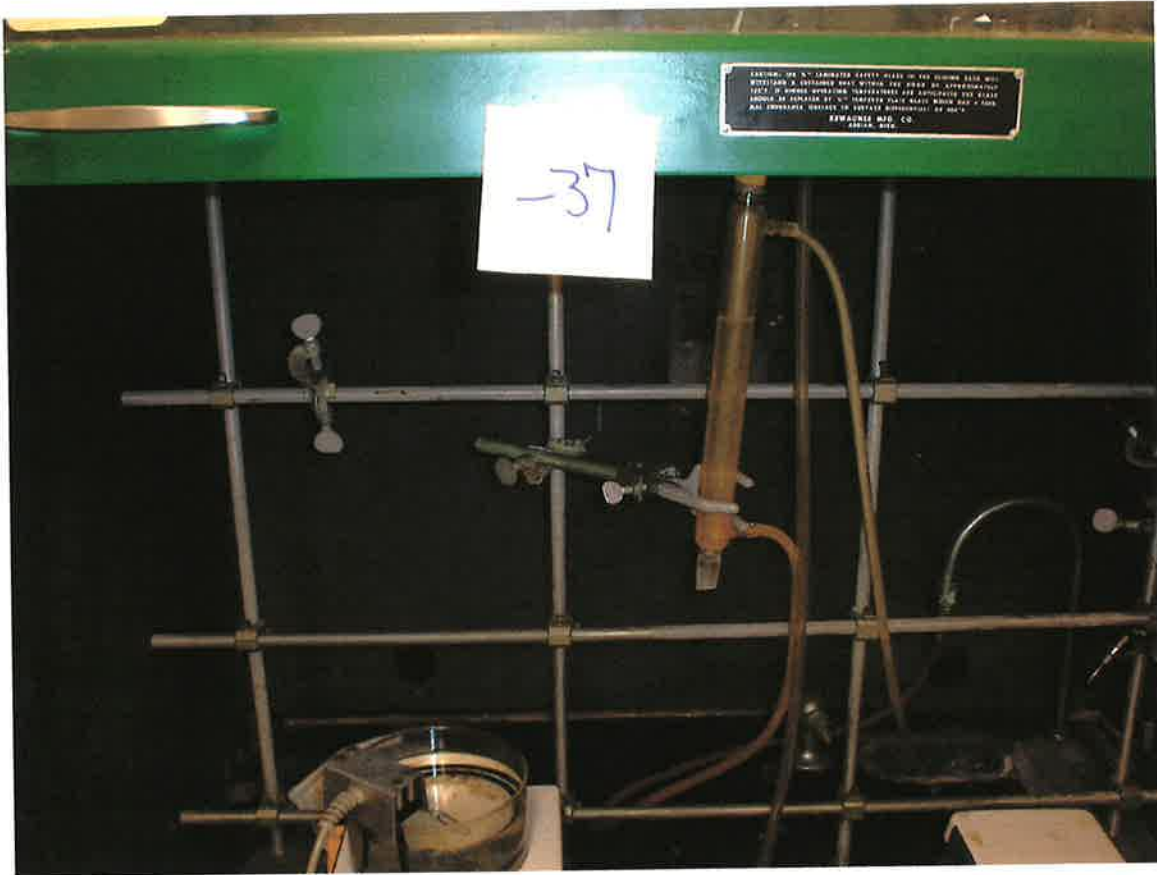
HA #37 – Assumed asbestos containing transite fume hood

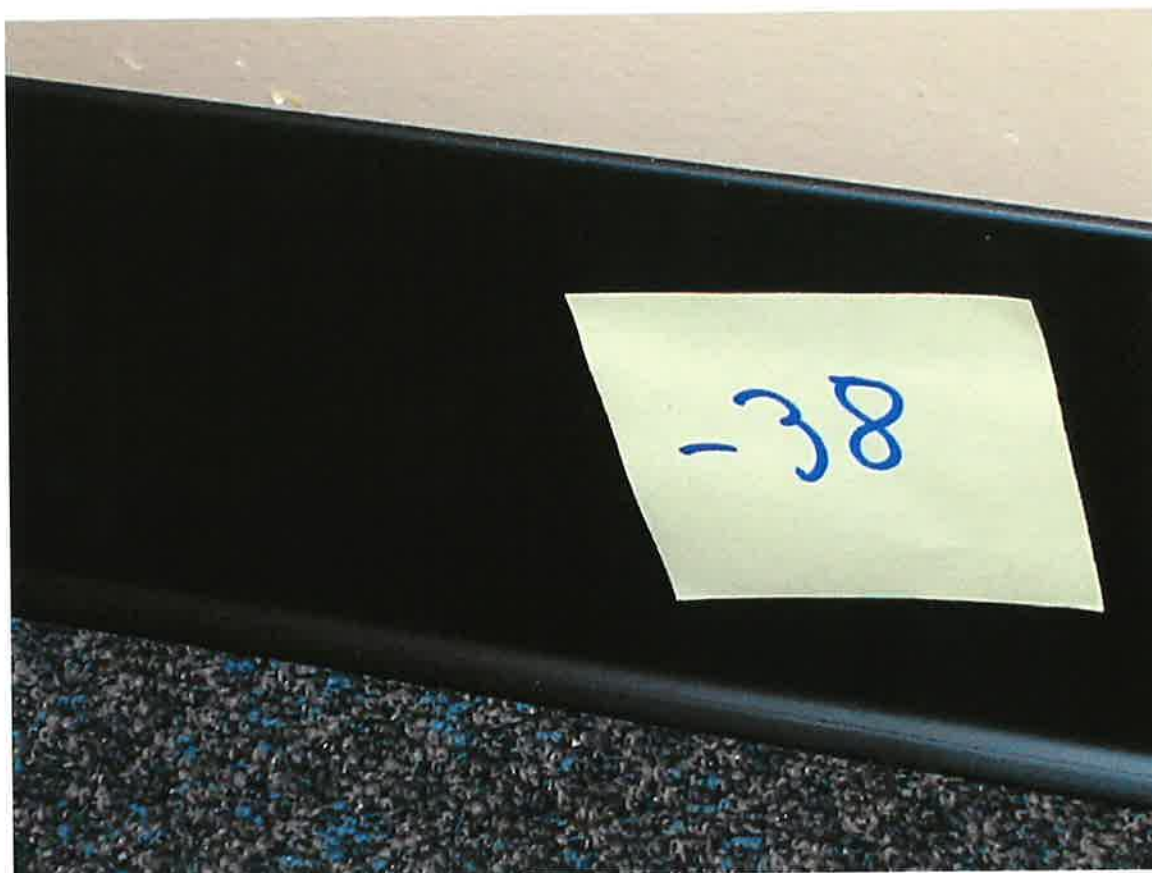
HA #38 – Non asbestos containing 6" black cove
molding and associated mastic

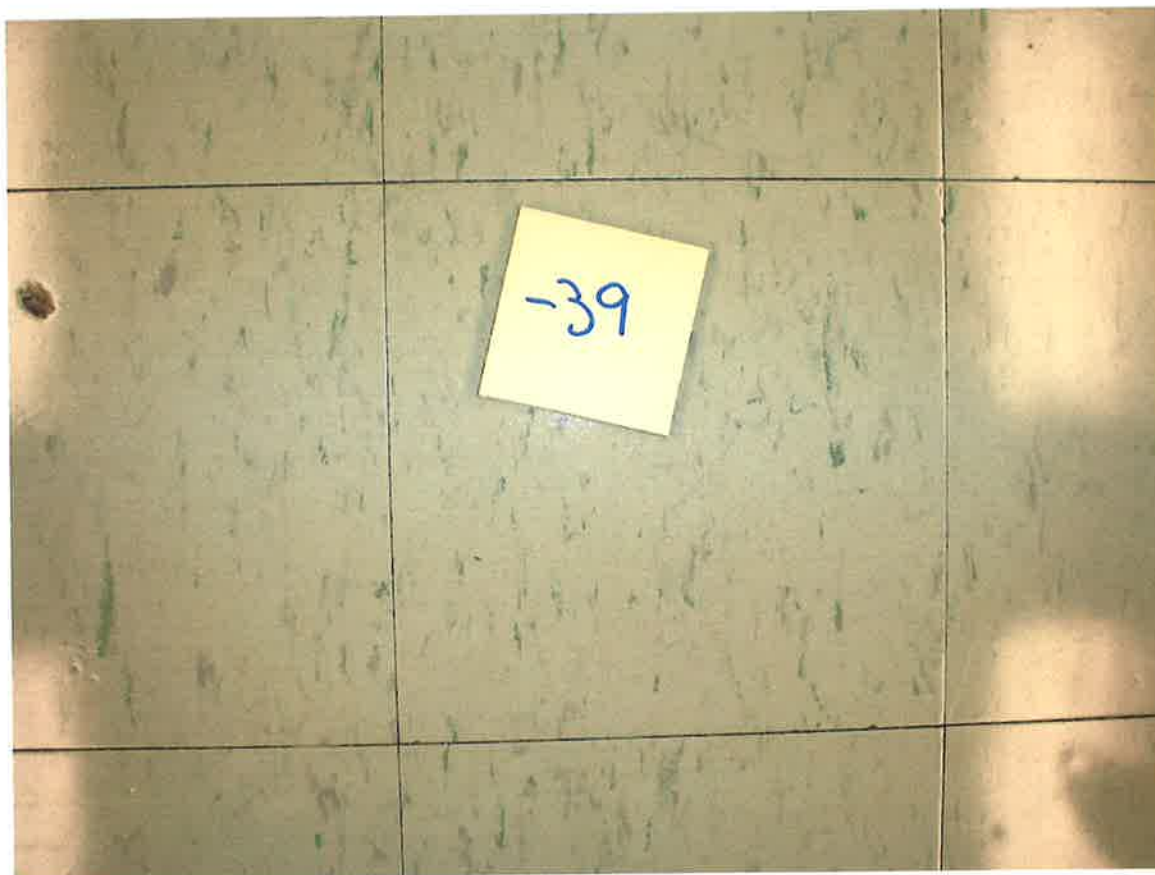
**HA #39 – Asbestos containing 9” x 9” light green floor tile
with green and gray streaks and non asbestos containing associated mastic**

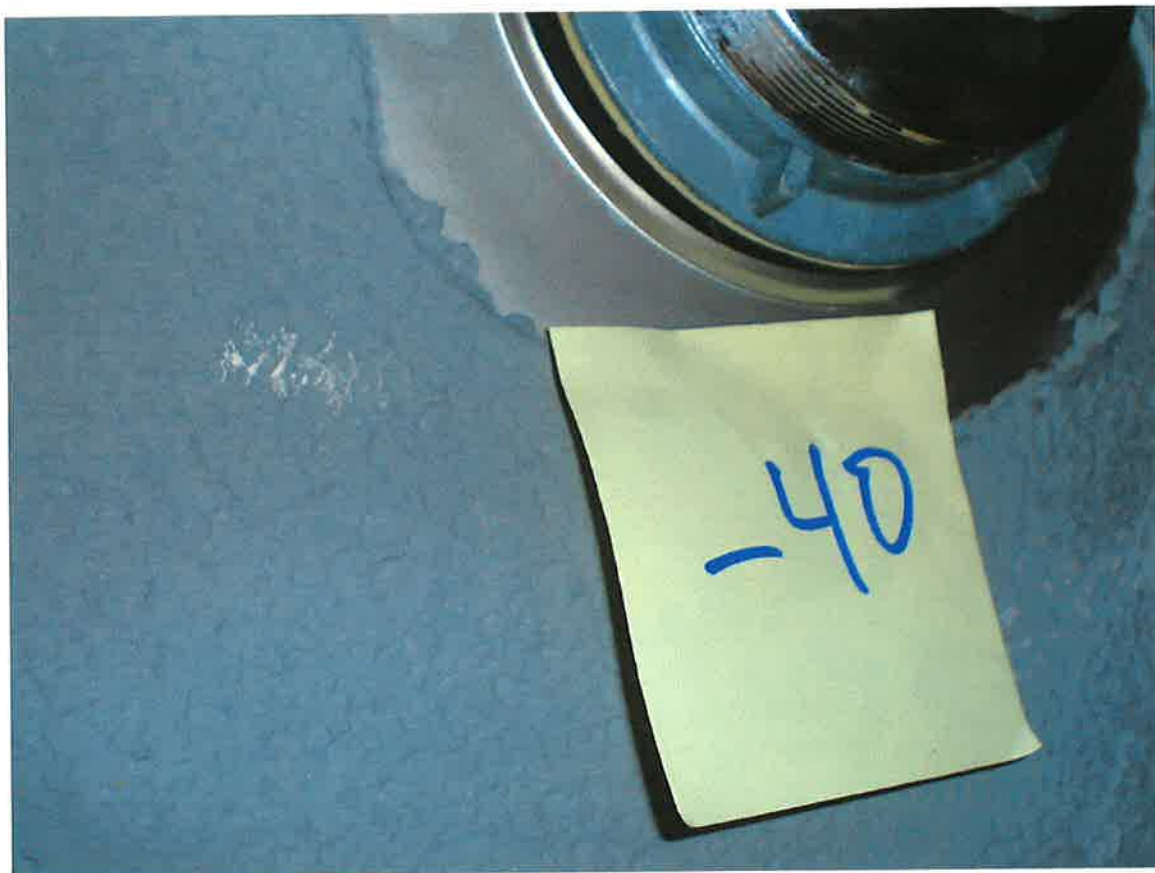
HA #40 – Non asbestos containing gray sink undercoating

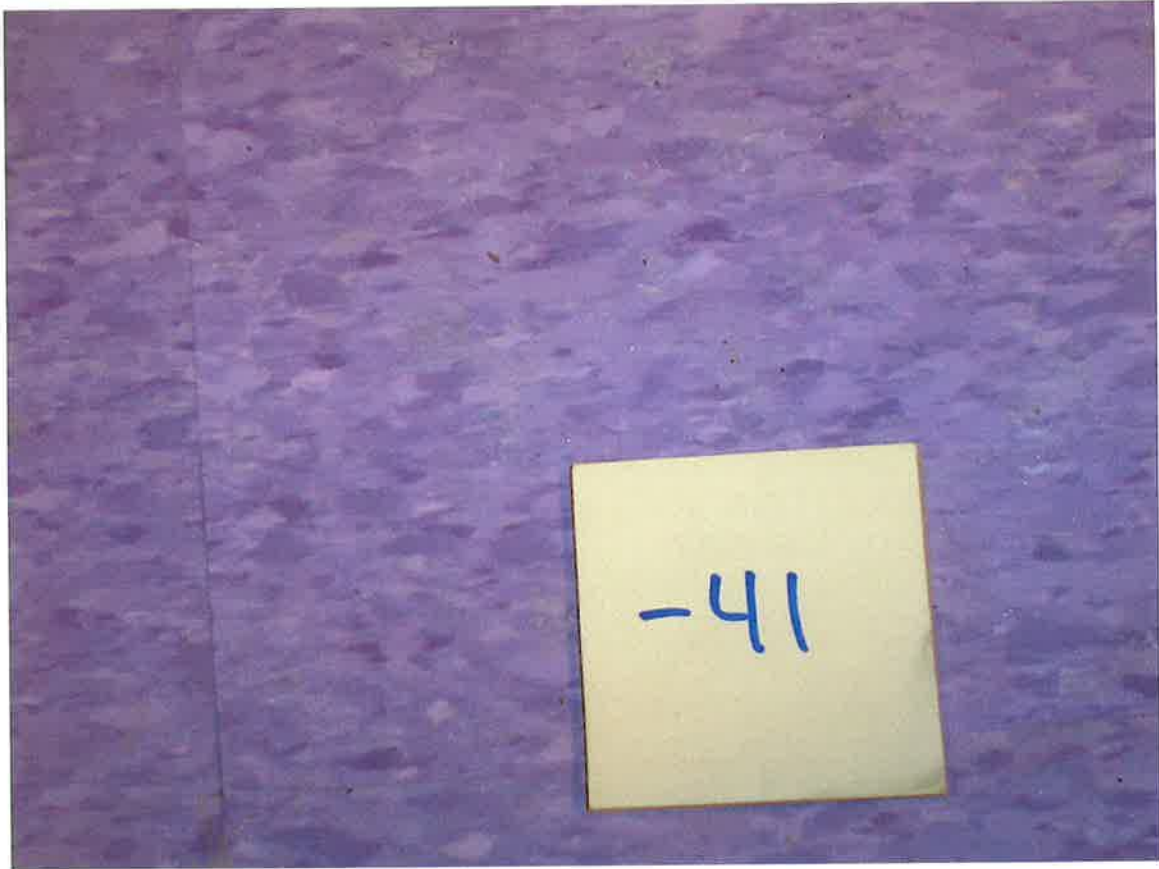
HA #41 – Non asbestos containing peach linoleum flooring
and associated mastic
