Michigan State University  
Asbestos Inspection Photo Log

MSU Water Reservoir (#96)

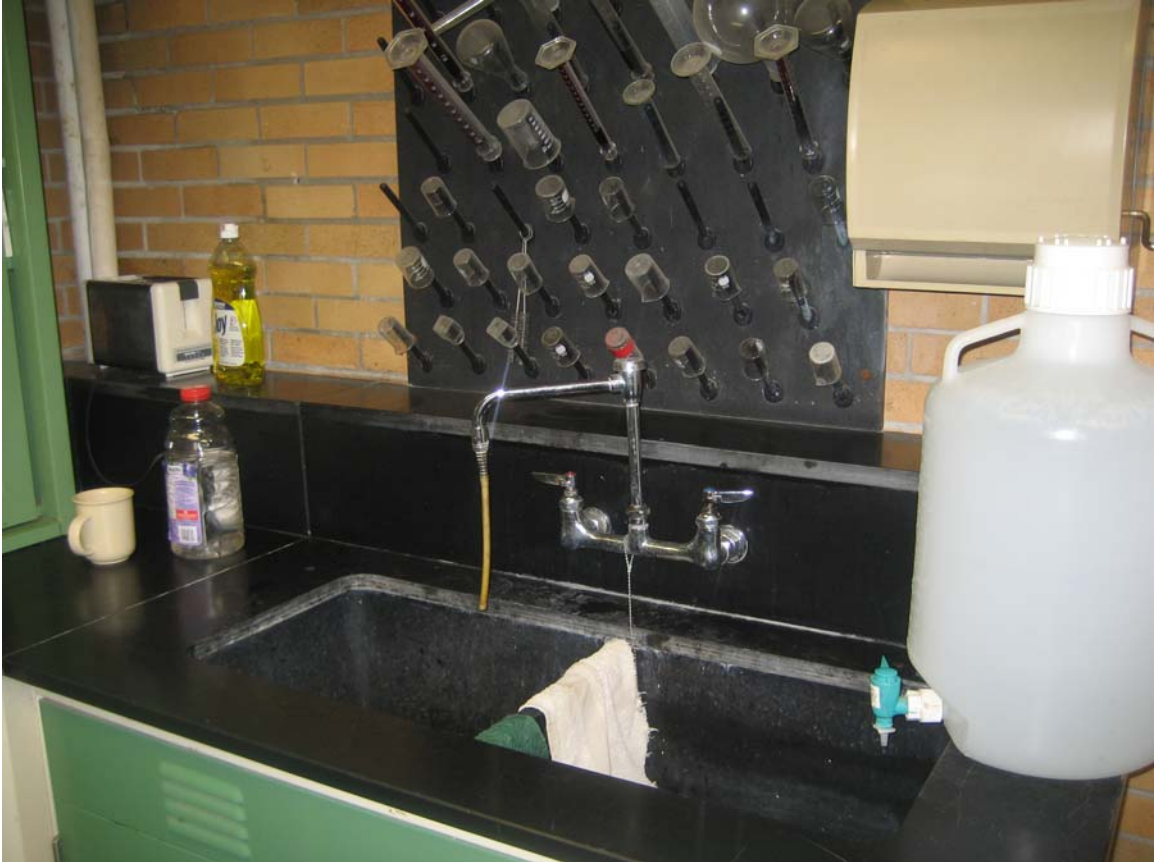
HA #1 – Assumed asbestos containing lab bench, sink, and drying rack

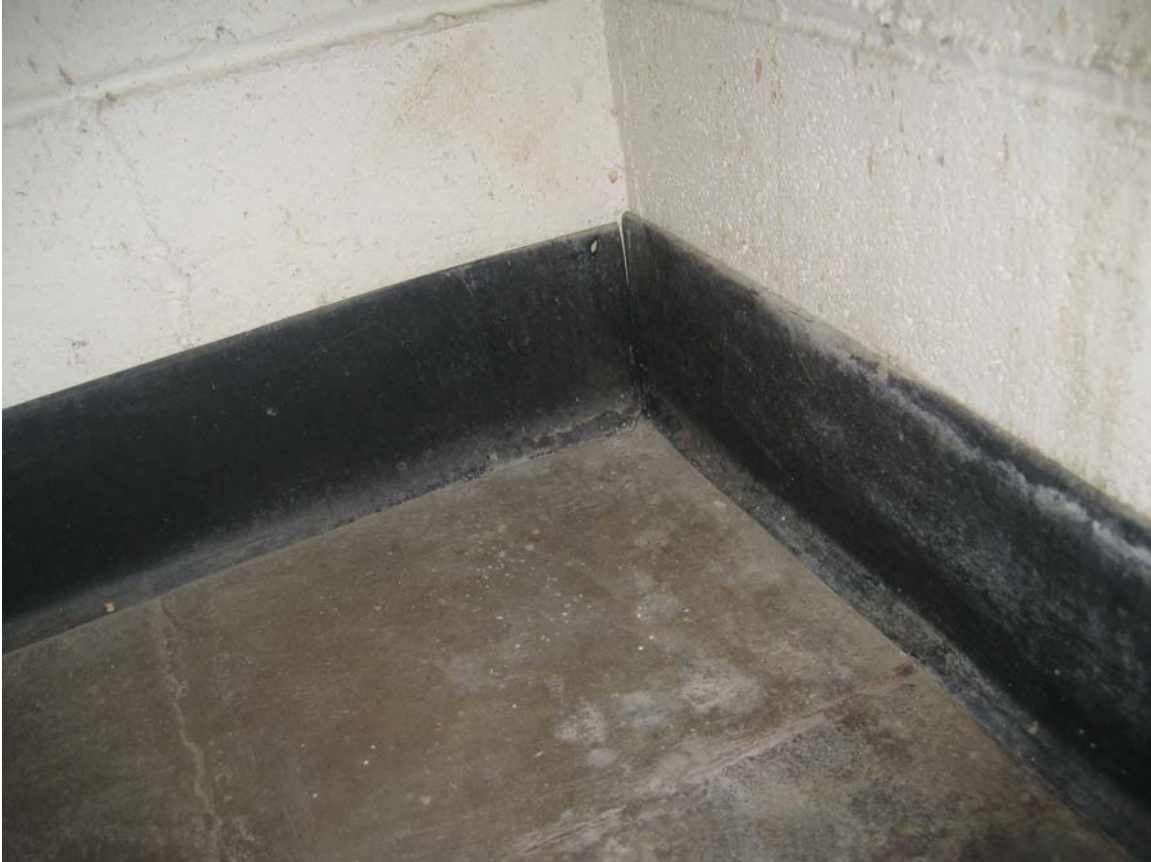
HA #2 – Non asbestos containing 4” black cove molding and associated mastic

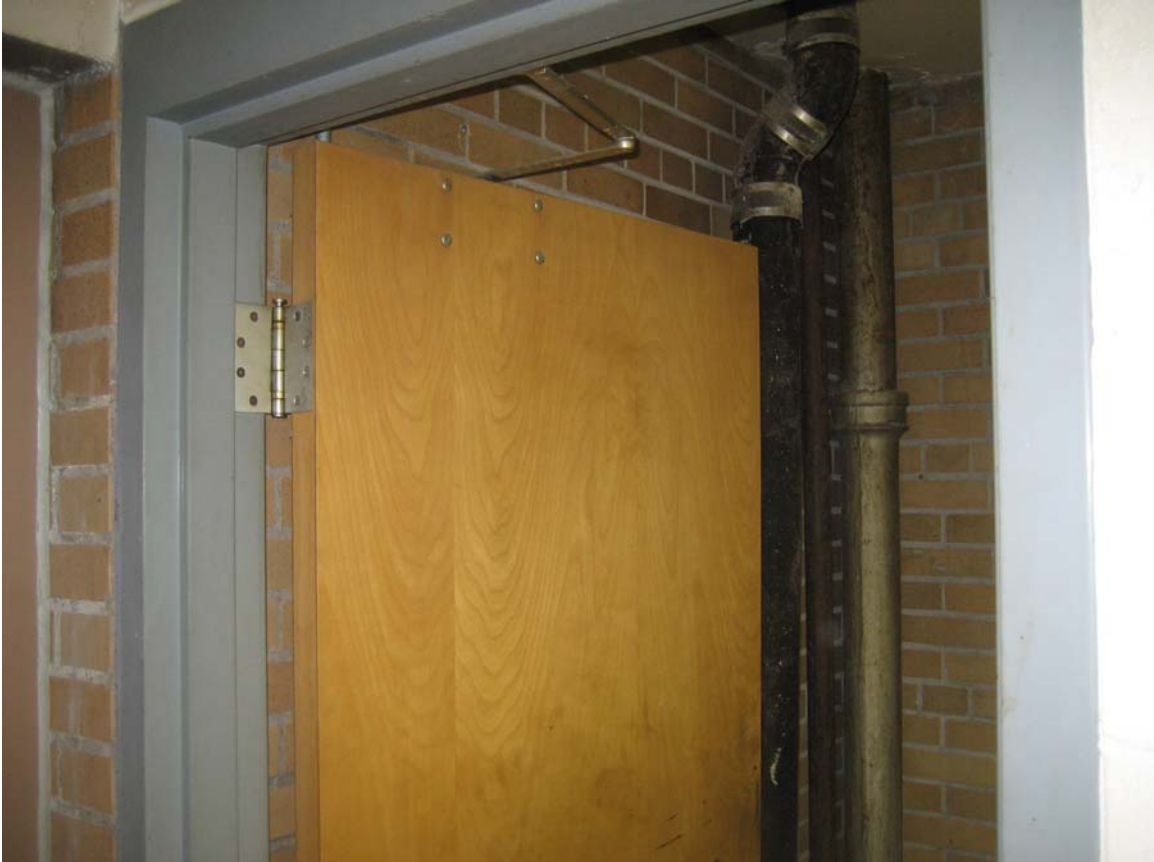
HA #3 – Assumed asbestos containing fire door and frame

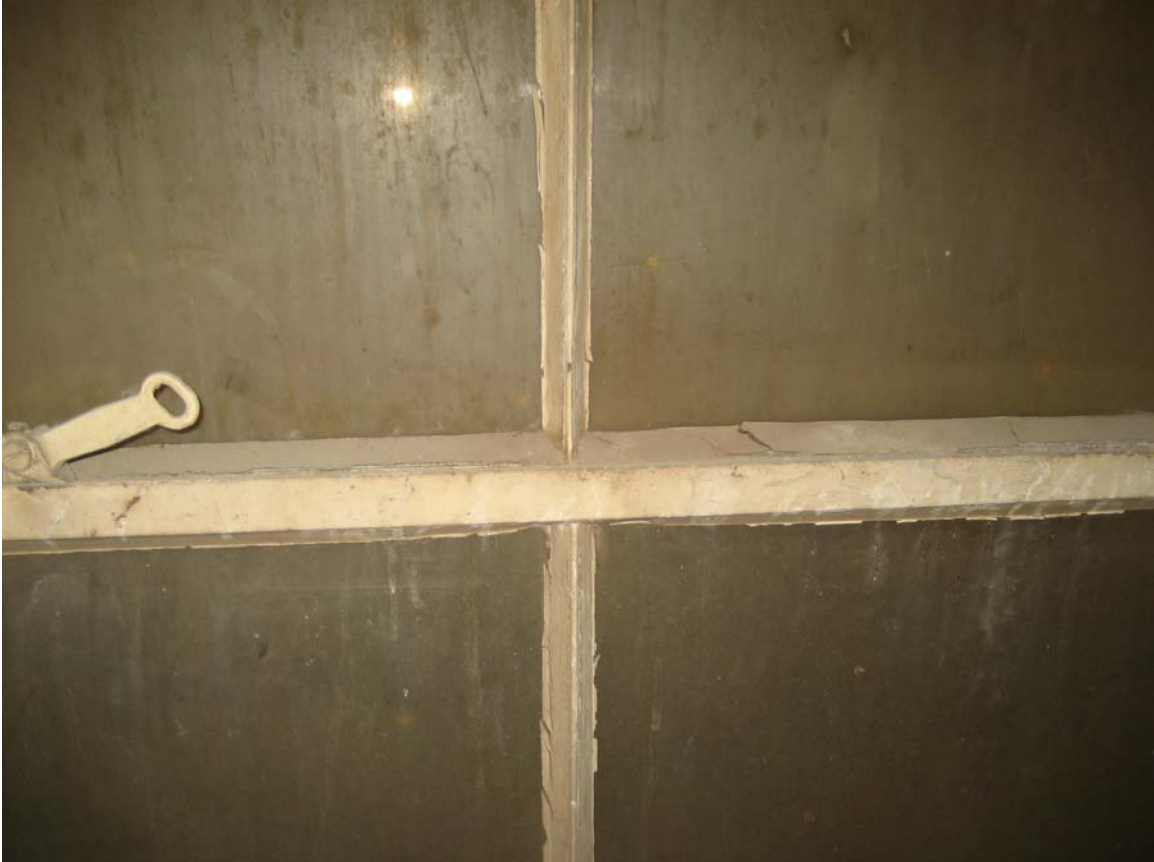
HA #4 – Asbestos containing brown window glazing

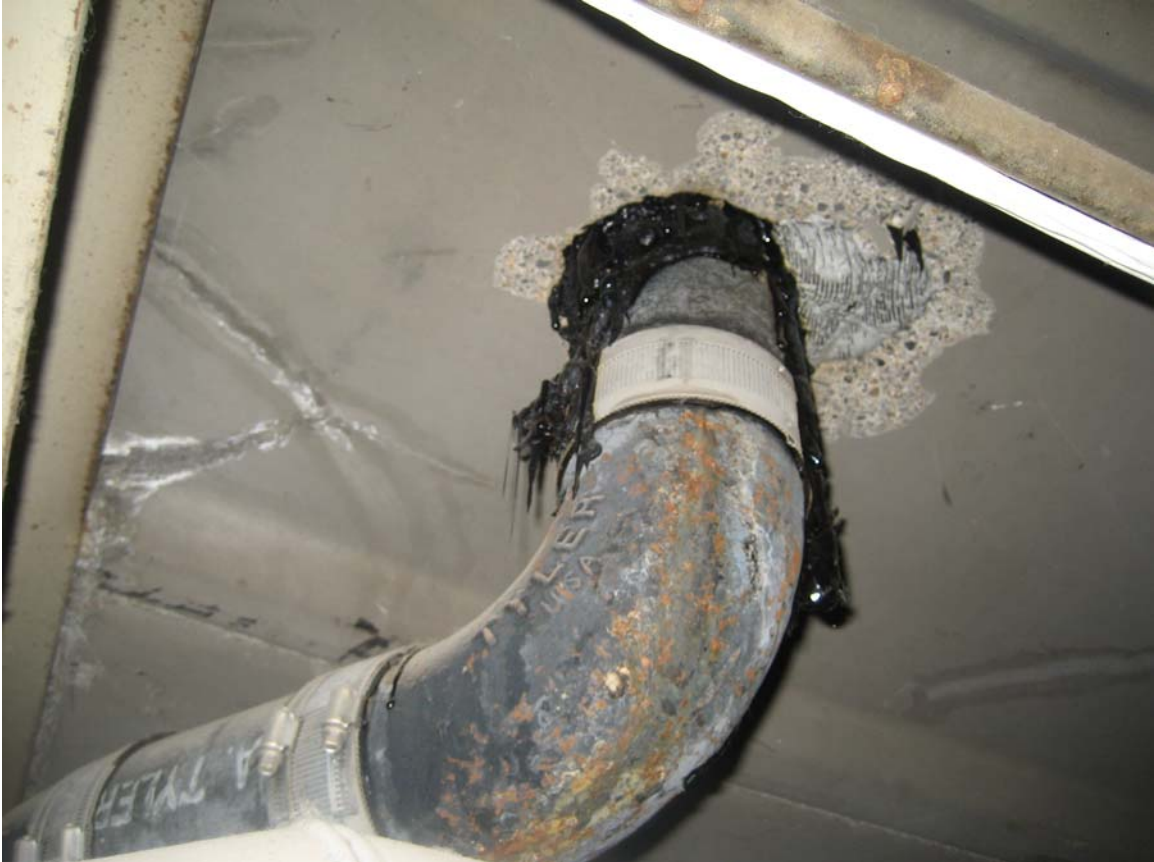
HA #5 – Asbestos containing black roof tar

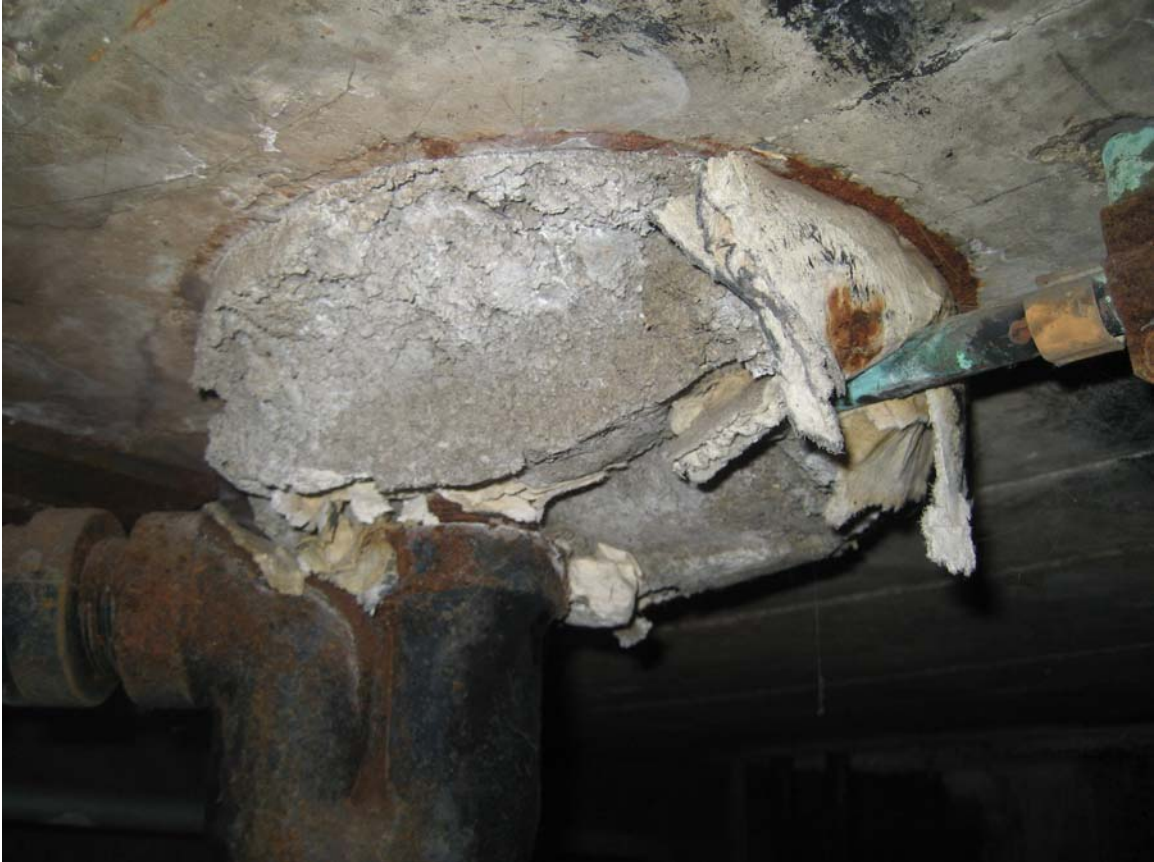
HA #6 – Non-asbestos containing corrugated material

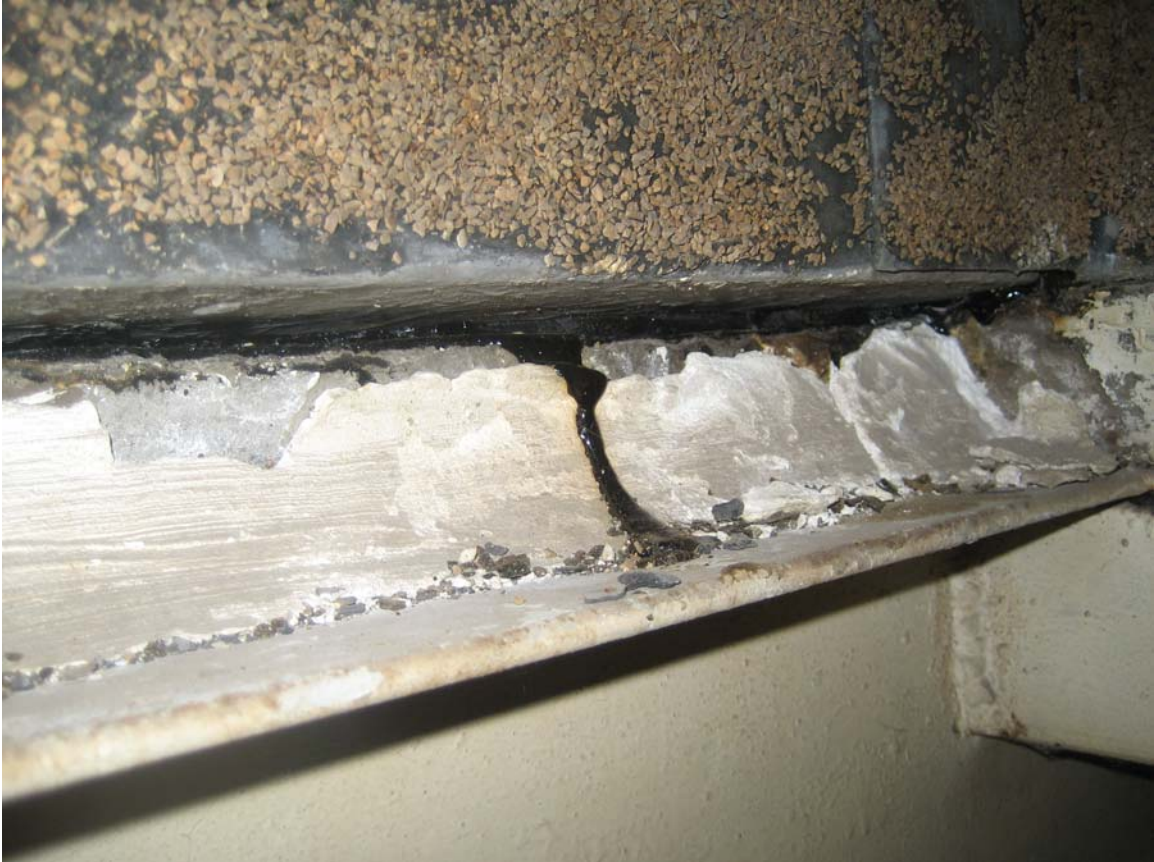
HA #8 – Non-asbestos containing white decking patch

(Associated black roof tar is positive)
