Student Services Photo Log

Exterior of Student Services Building

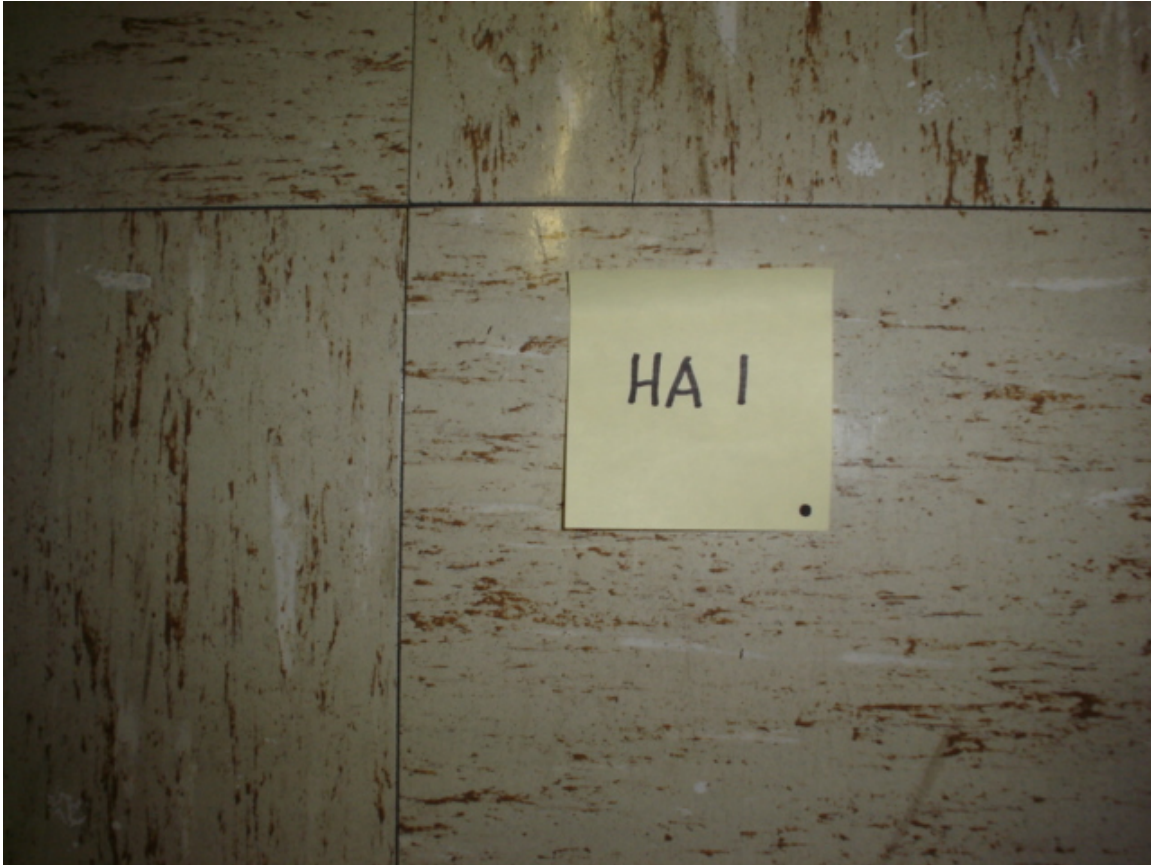
HA #4 – Non asbestos-containing 12" x 12" cream floor tile
with rust and white streaks and associated mastic

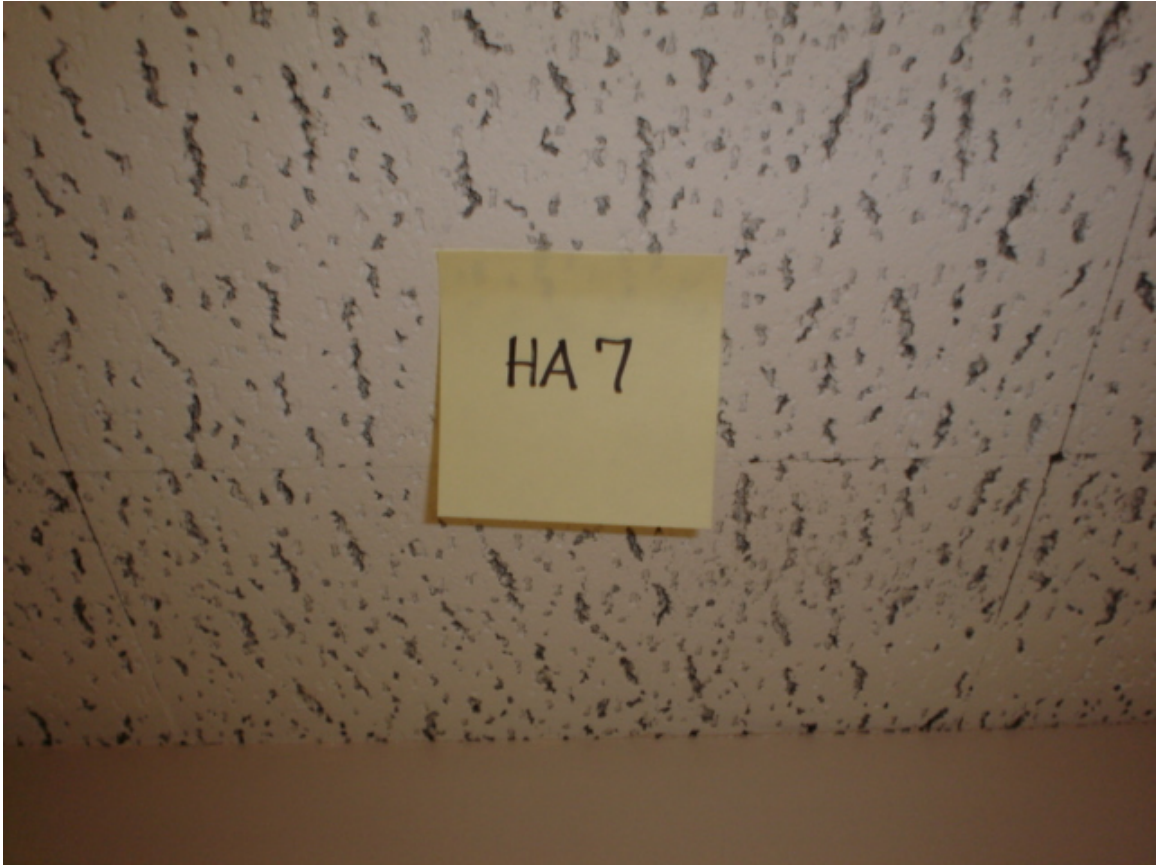
HA #7 – Non asbestos-containing 12" x 12" white ceiling tile with pin holes and fissures and associated non asbestos-containing glue pods

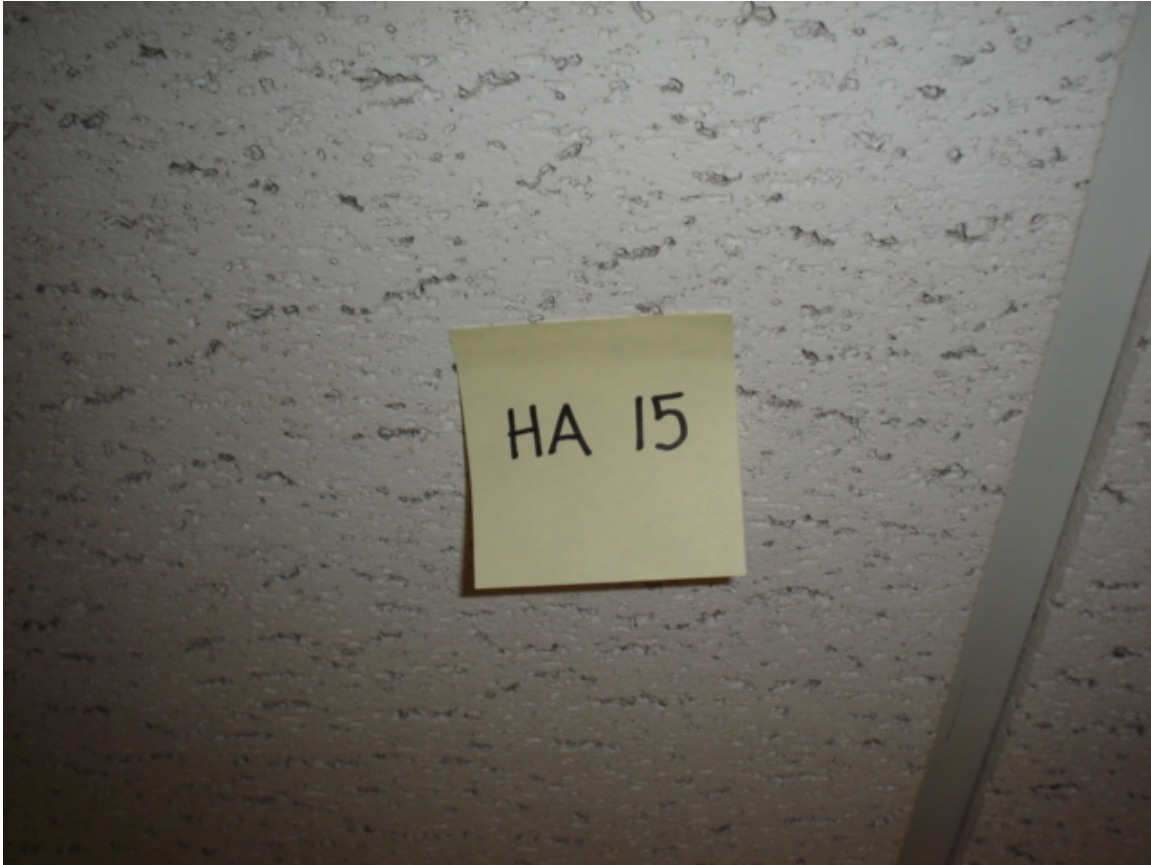
HA #15 – Non asbestos-containing 2' x 2' white drop-in ceiling tile
with pin holes and fissures

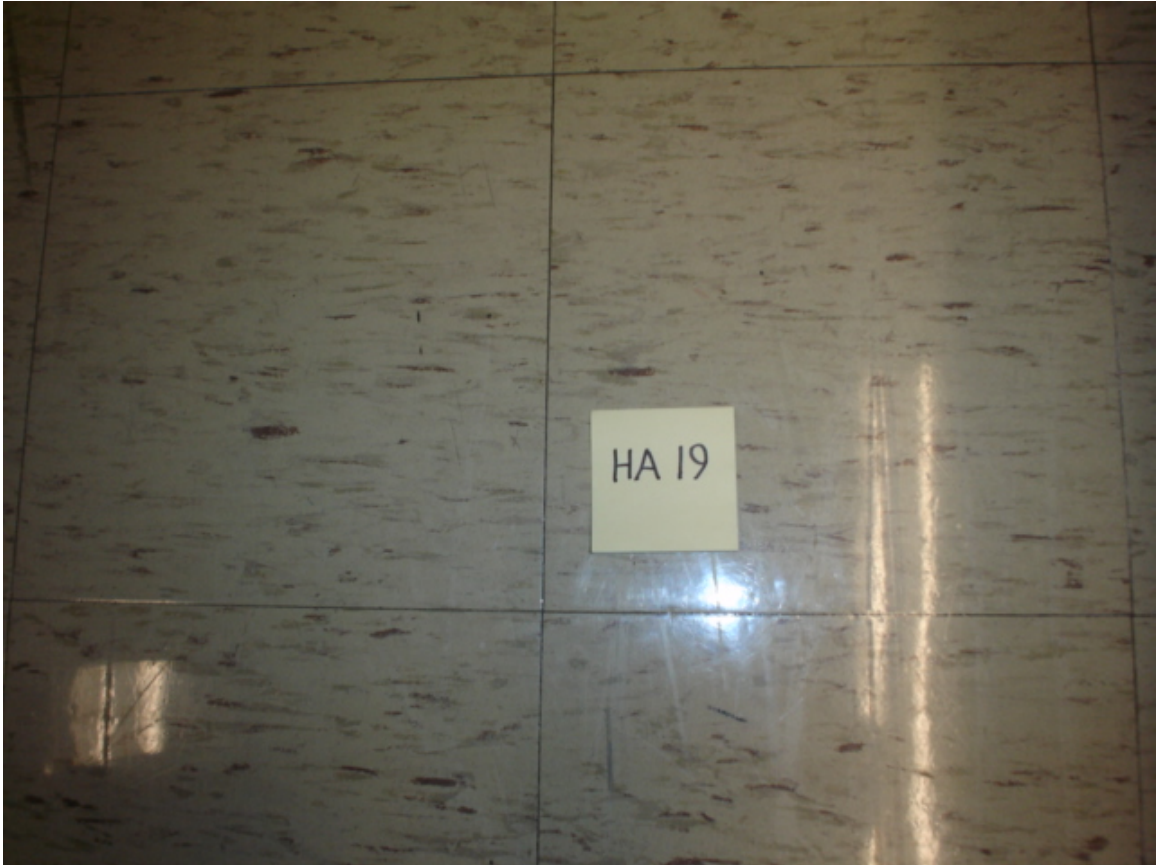
HA #19 – Asbestos-containing 12" x 12" beige floor tile with green and rust streaks and associated non asbestos-containing mastic

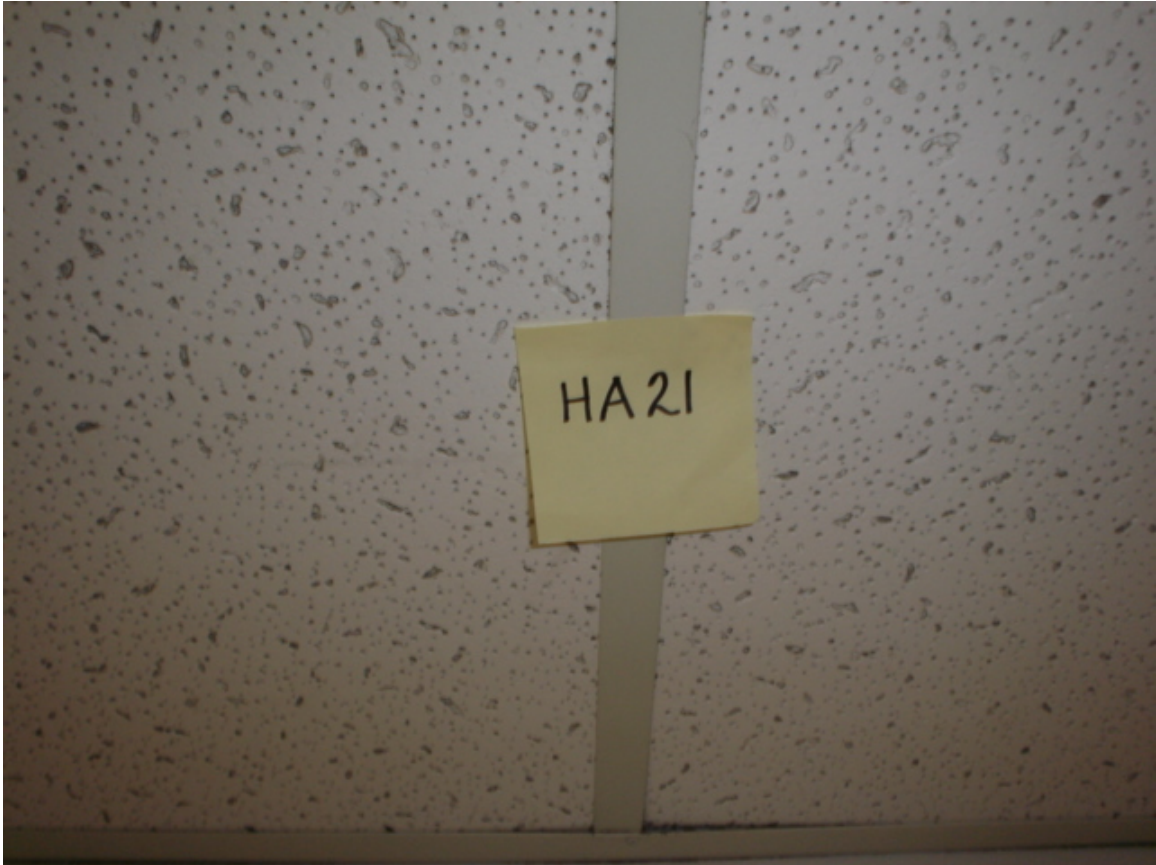
HA #21 – Non asbestos-containing 2' x 2' white lay-in ceiling tile
with pin holes and fissures

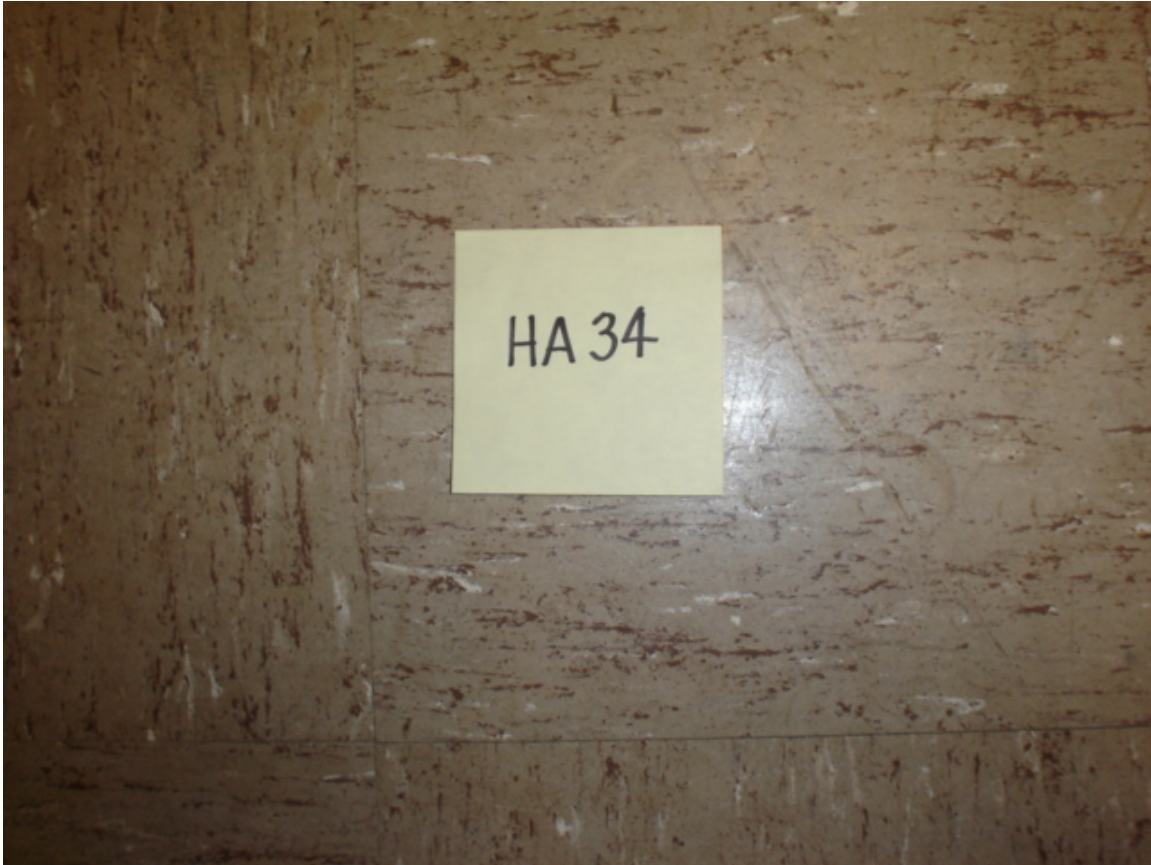
HA #34 – Asbestos-containing 9" x 9" tan floor tile
with cream and rust streaks and associated mastic

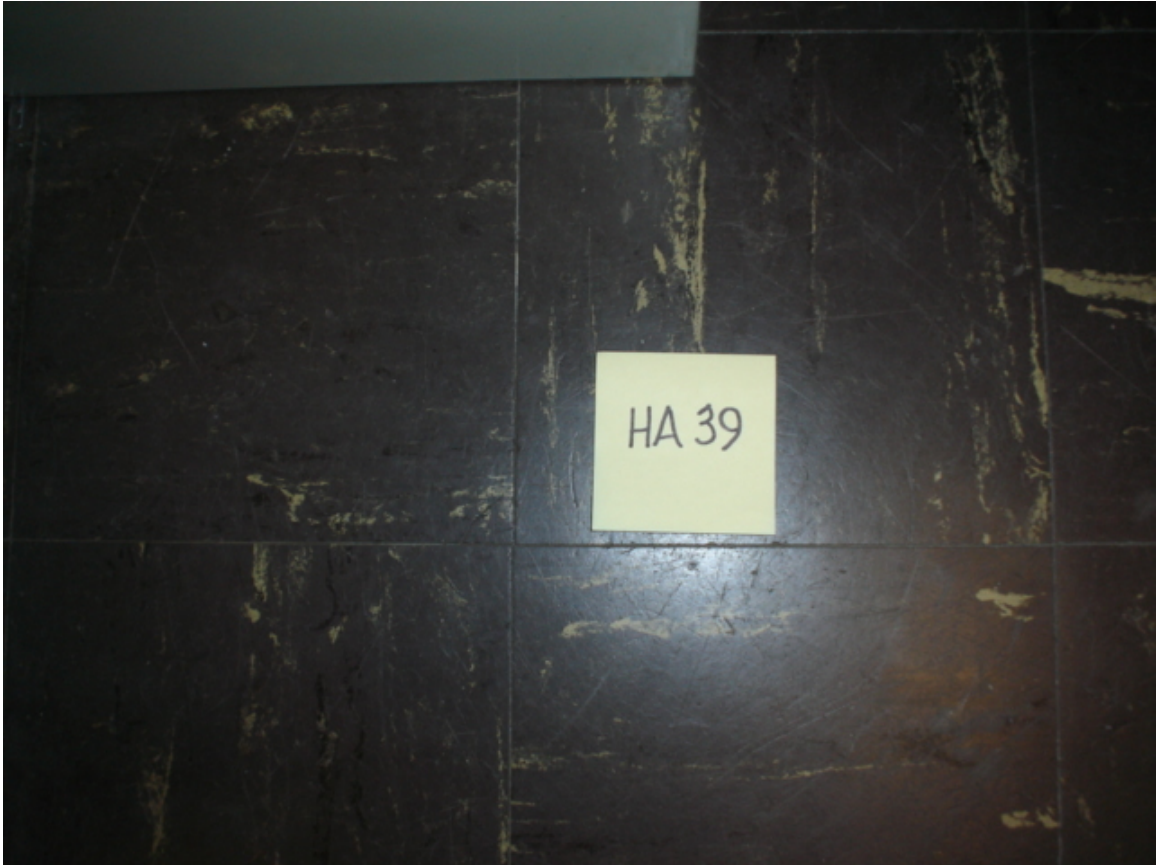
HA #39 – Asbestos-containing 9" x 9" brown floor tile with cream and rust streaks and associated non asbestos-containing mastic

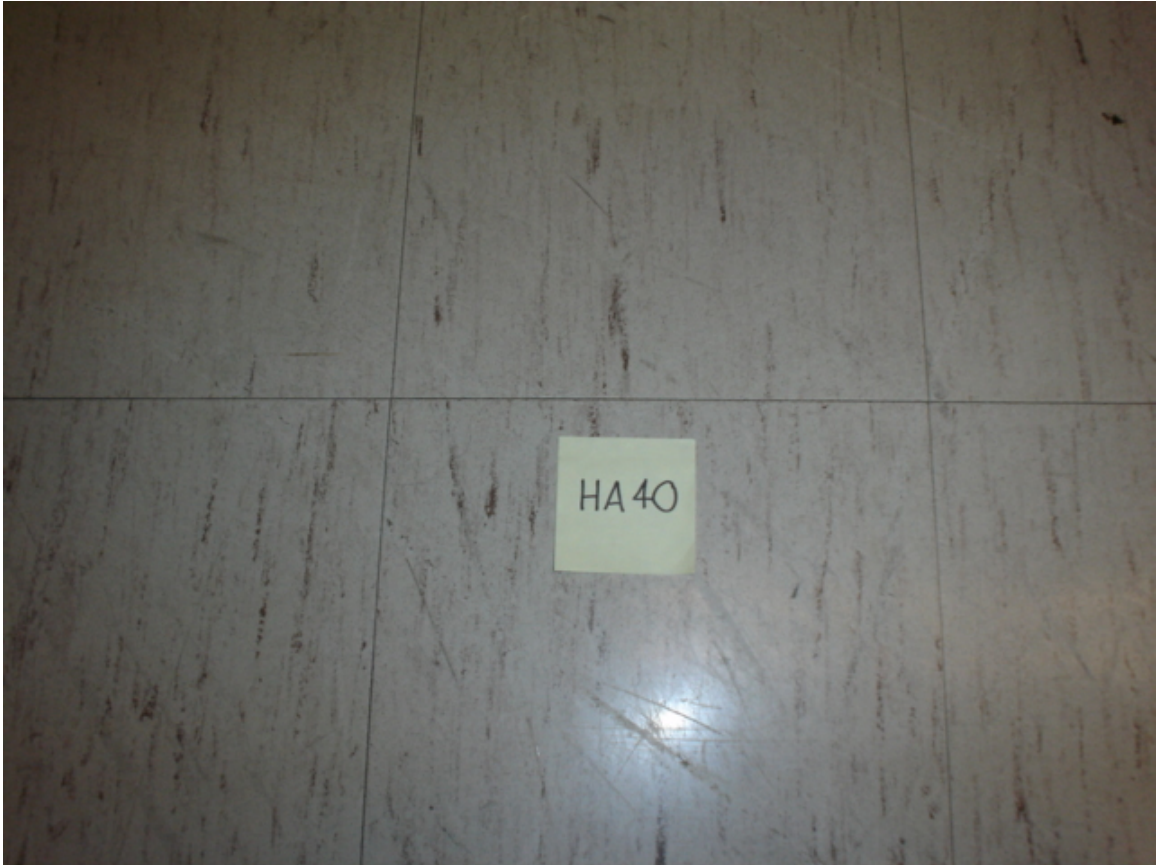
HA #40 – Asbestos-containing 12" x 12" white floor tile with green and rust streaks and associated non asbestos-containing mastic
