Psychology Research (now Geography) Photo Log

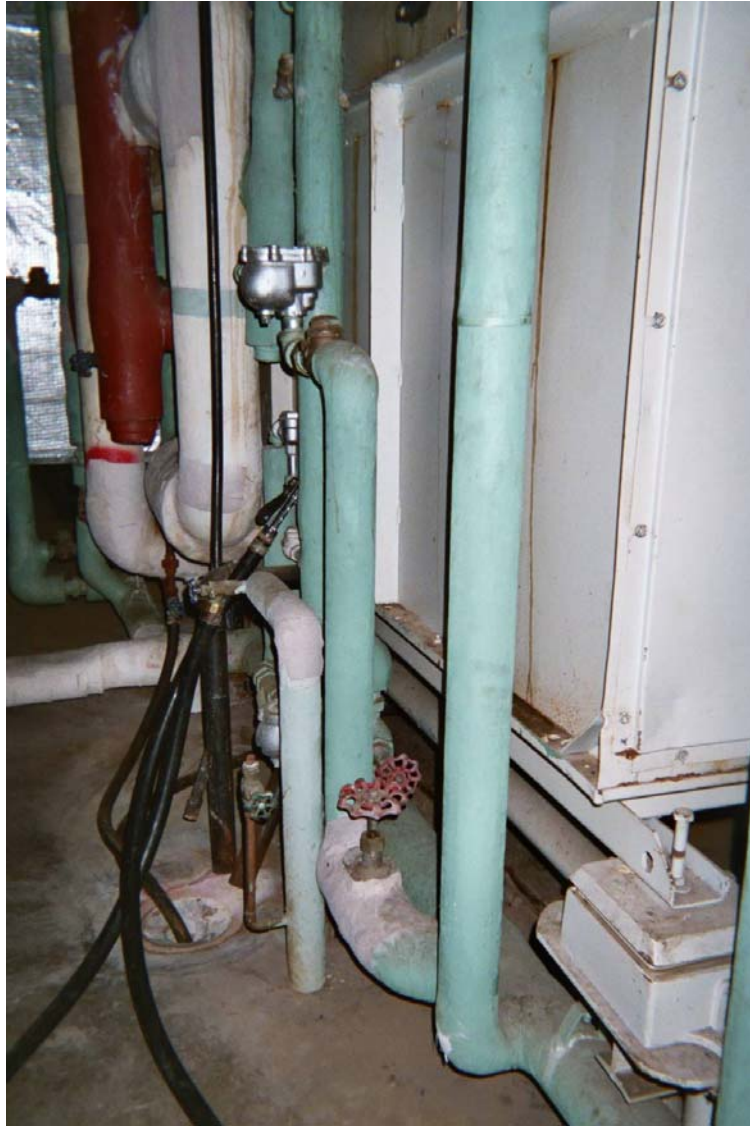
Photo 1 – Non asbestos-containing domestic water pipe straight insulation

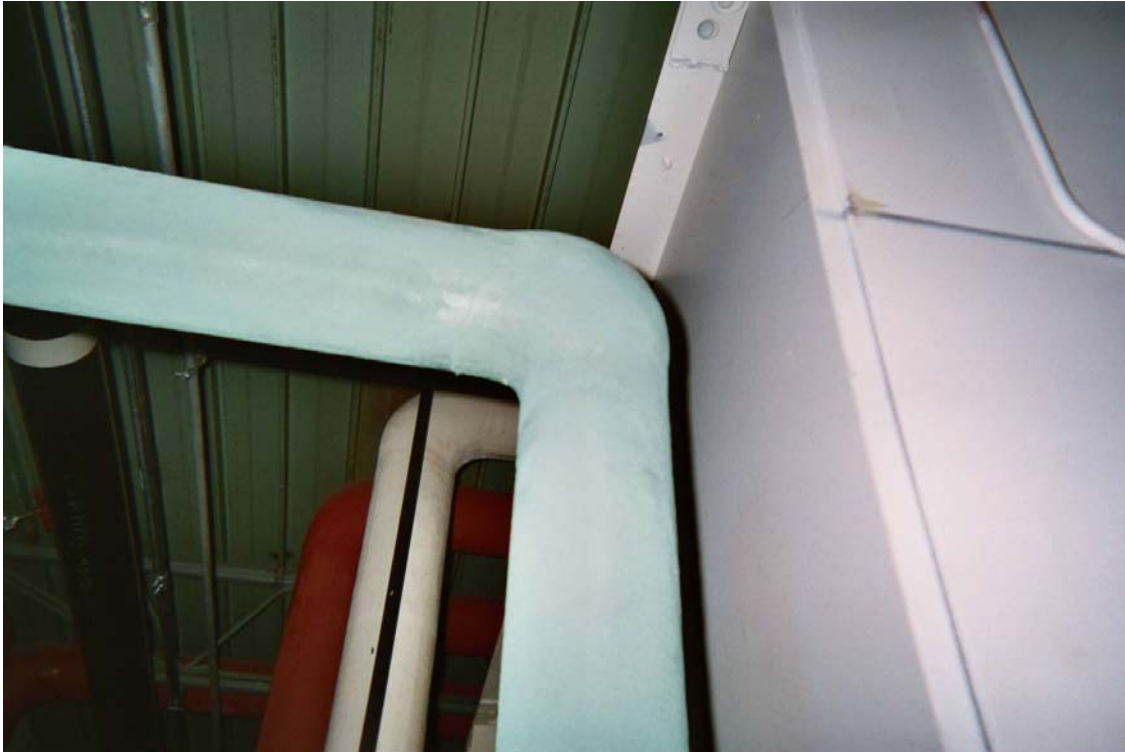
Photo 2 – Asbestos-containing domestic water pipe joint insulation

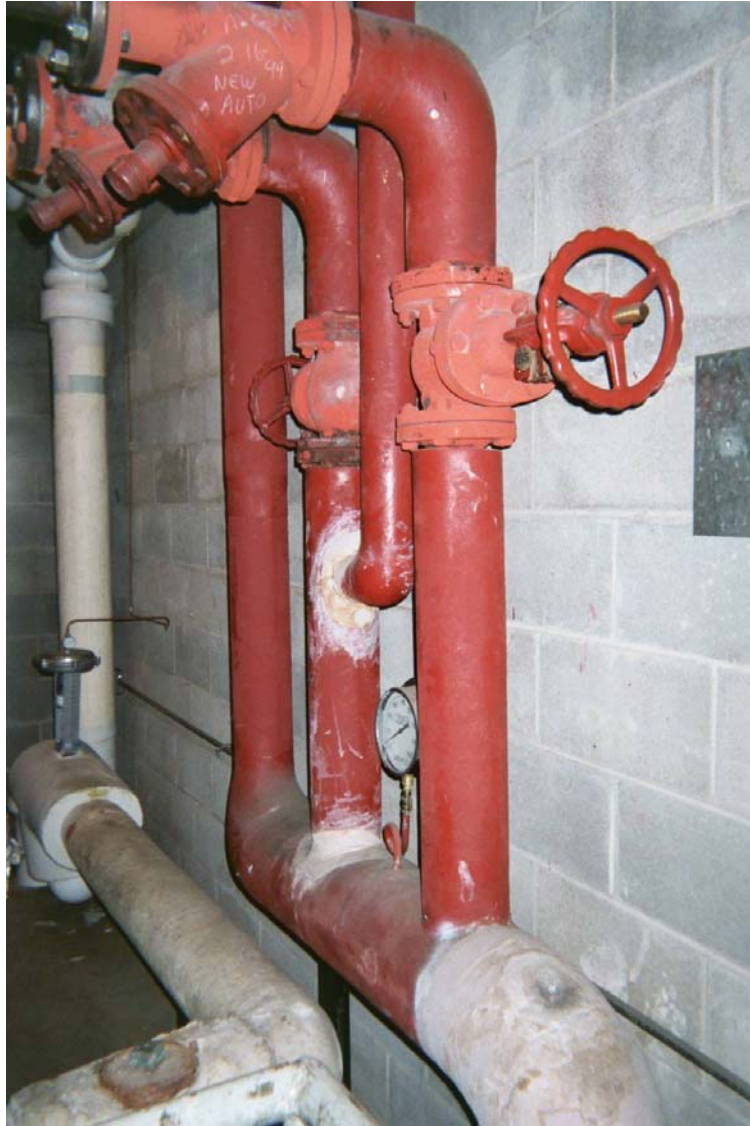
Photo 3 – Asbestos-containing steam/condensate pipe straight insulation

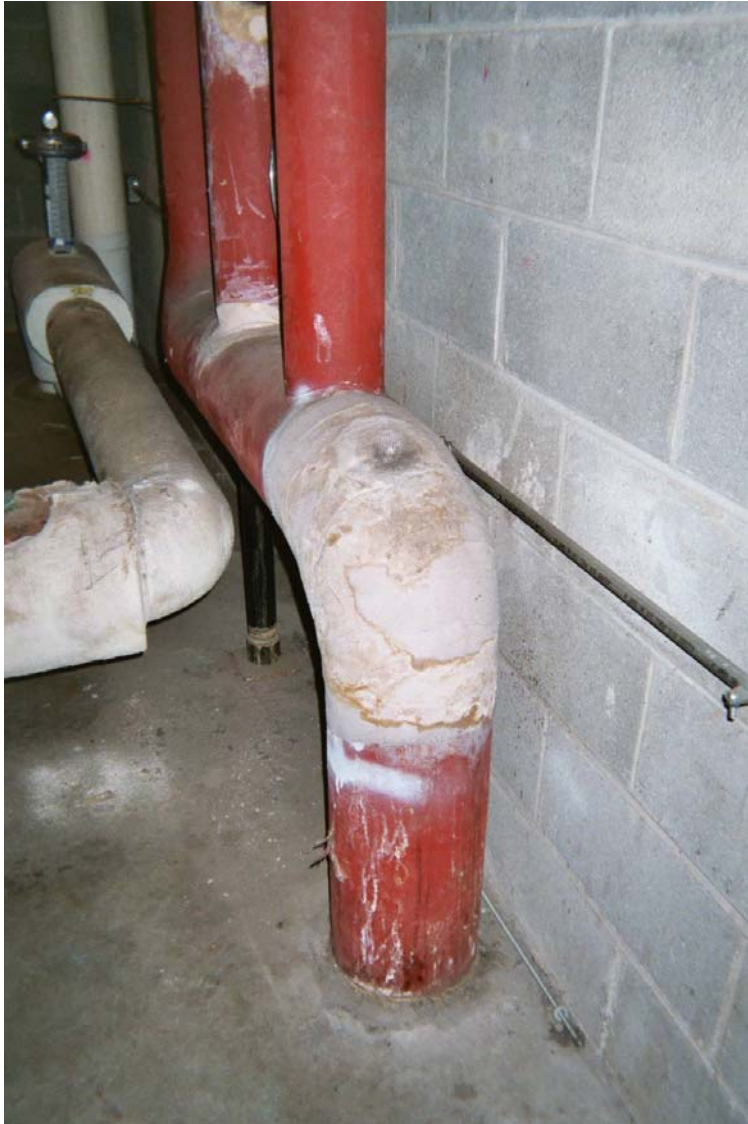
Photo 4 – Asbestos-containing steam/condensate pipe joint insulation

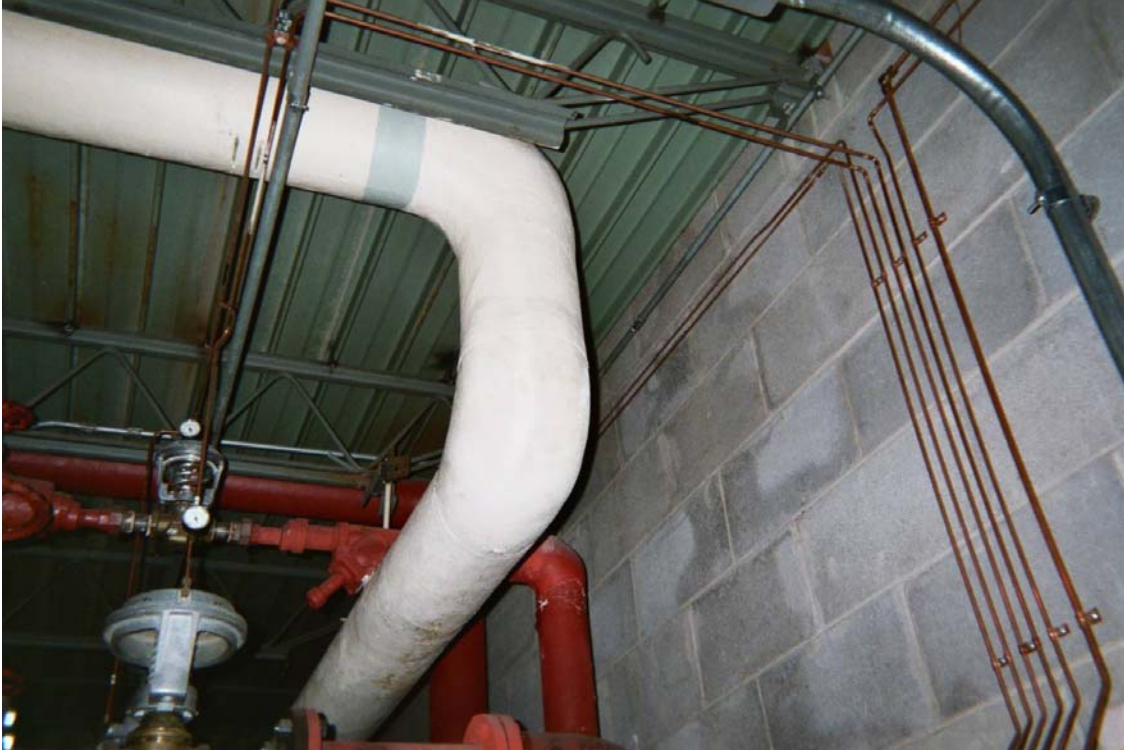
Photo 5 – Asbestos-containing chilled water pipe joint insulation

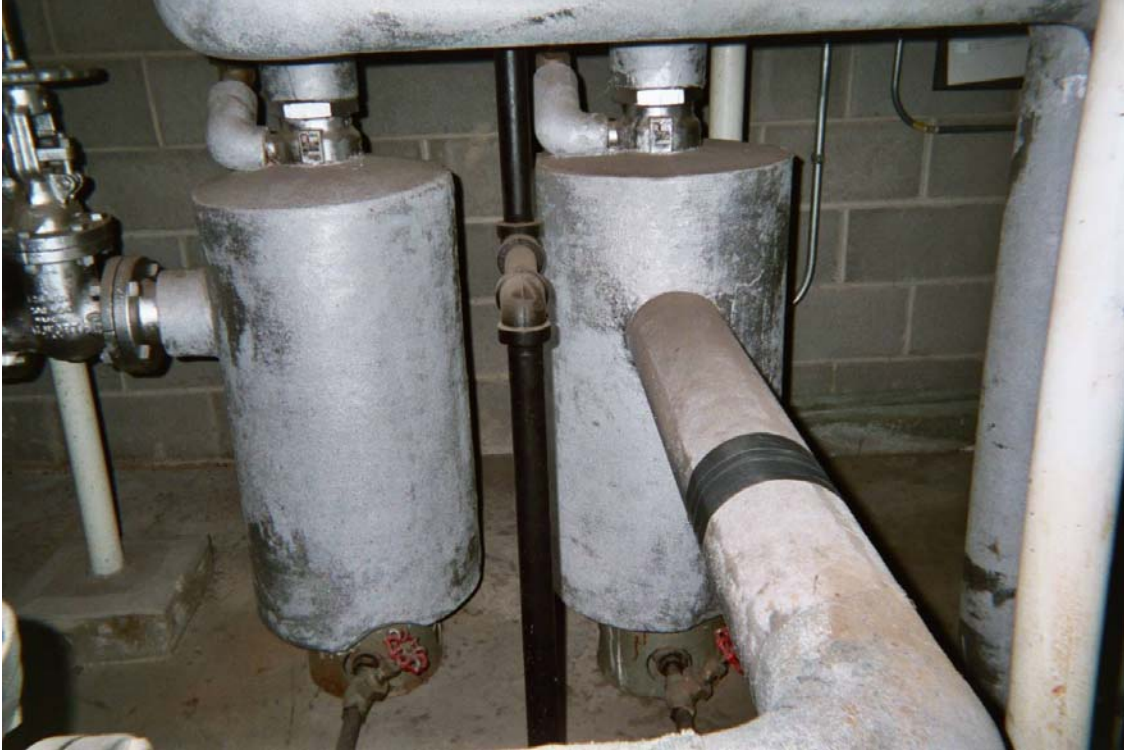
Photo 6 – Asbestos-containing radiation heat tank insulation

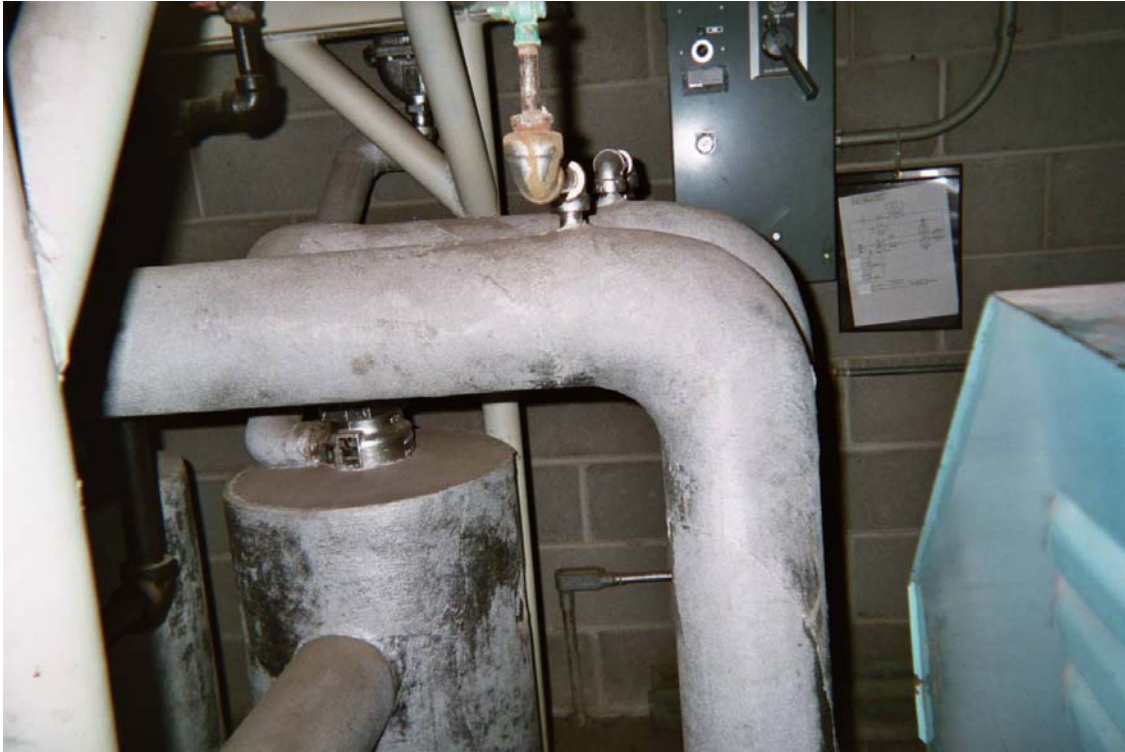
Photo 7 – Asbestos-containing radiation heat pipe joint insulation

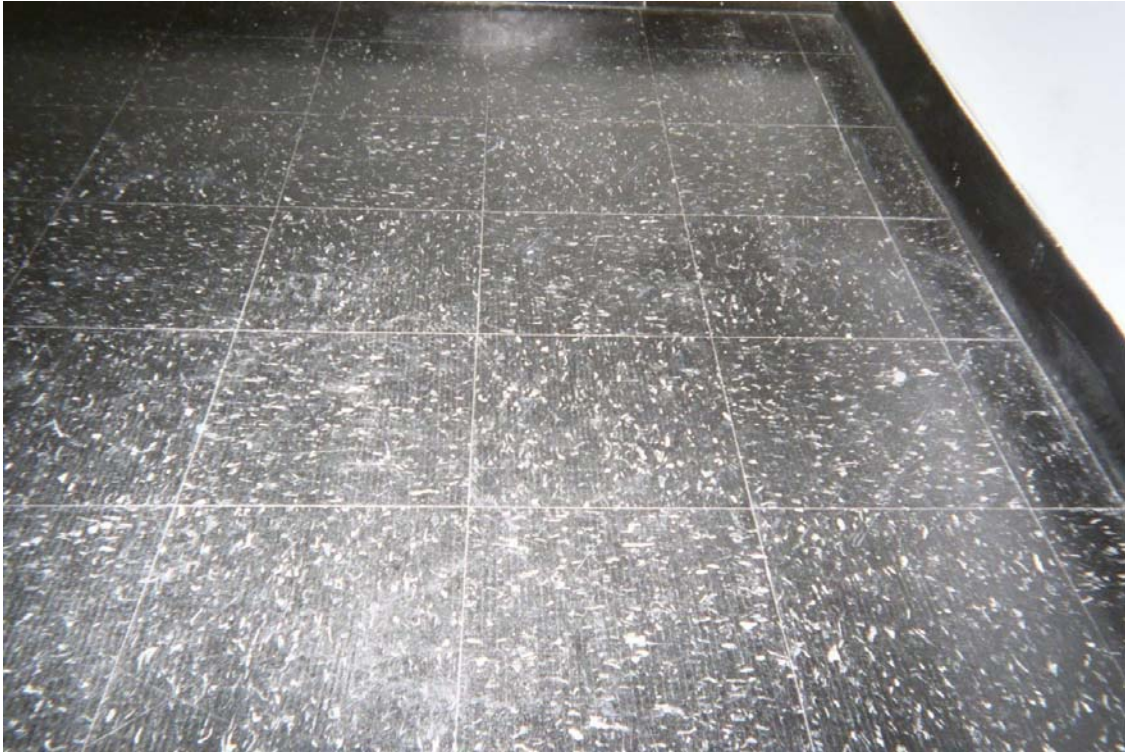
Photo 8 – Asbestos-containing 9” x 9” black floor tile with white specks and associated mastic

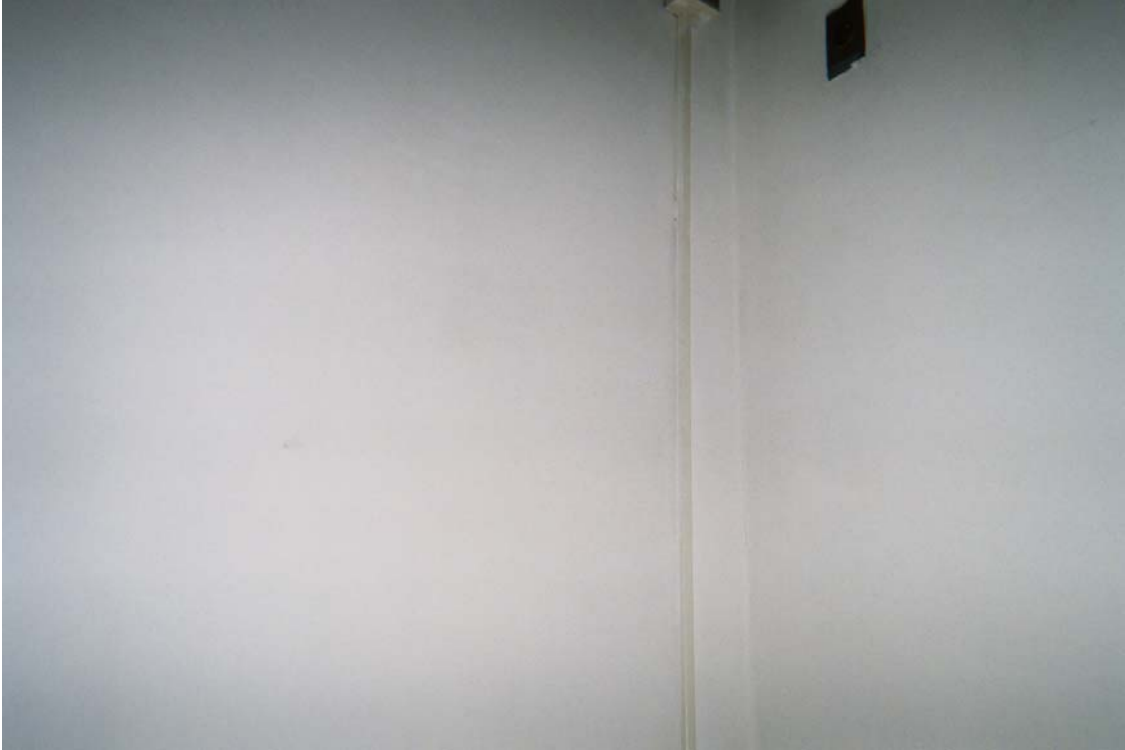
Photo 9 – Non asbestos-containing plaster

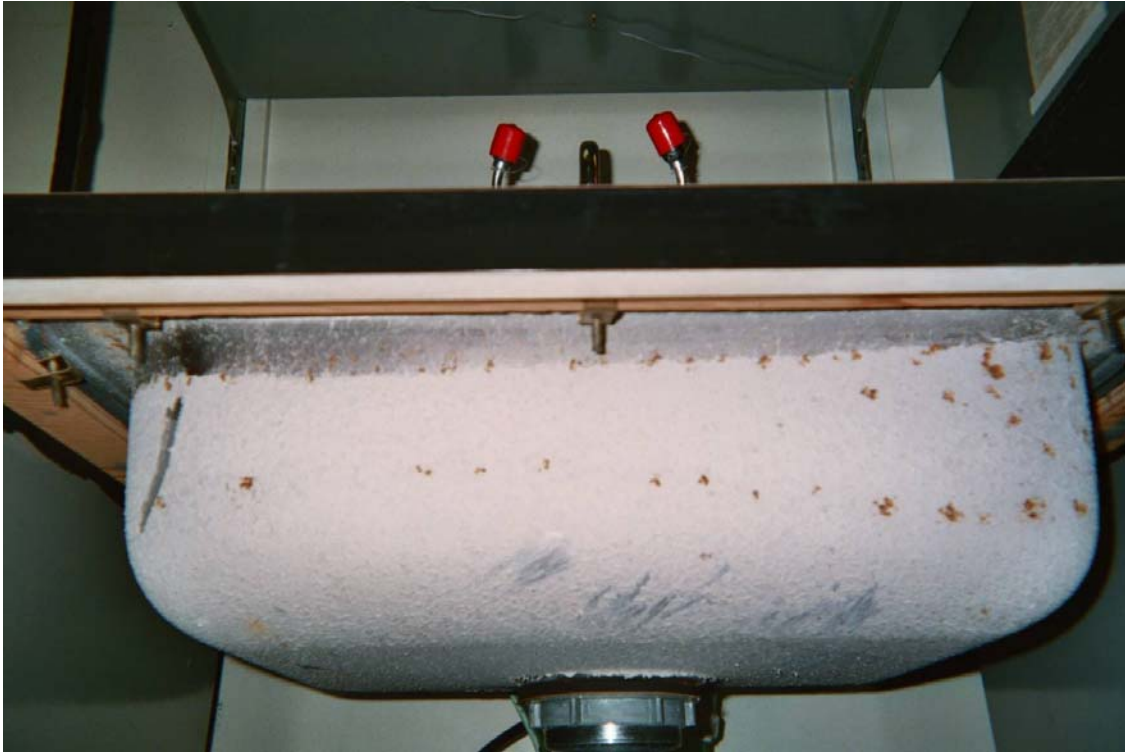
Photo 10 – Non asbestos-containing pink sink undercoating

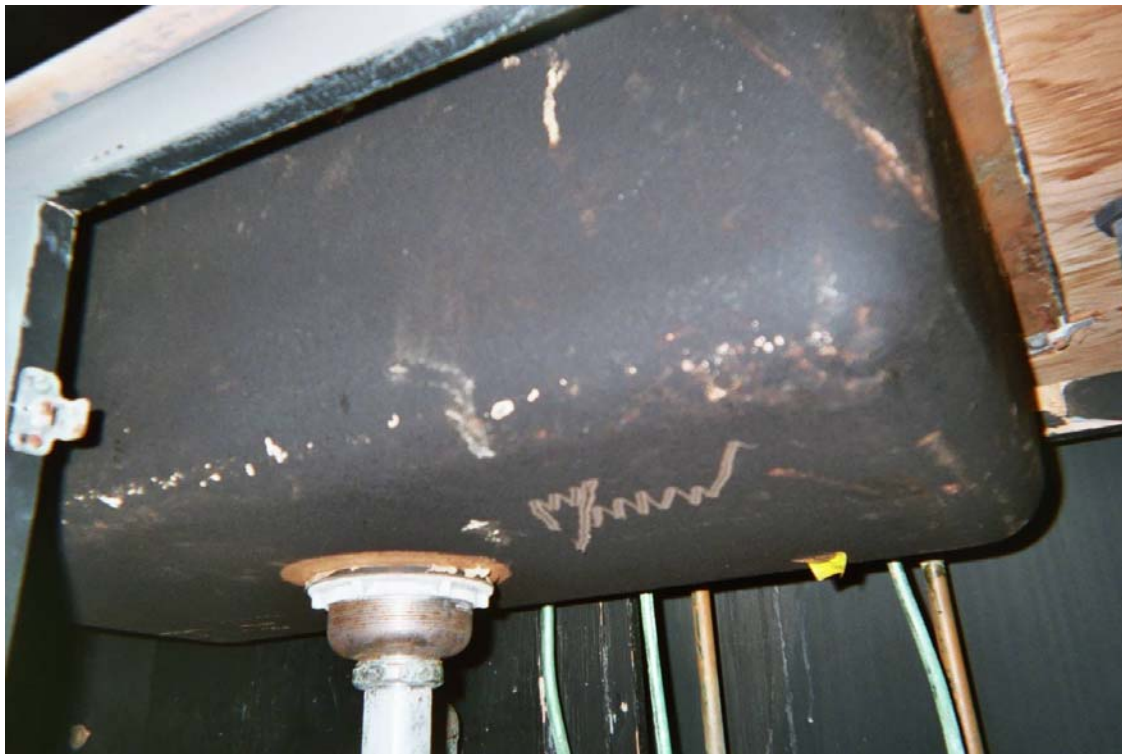
Photo 11 – Asbestos-containing black sink undercoating

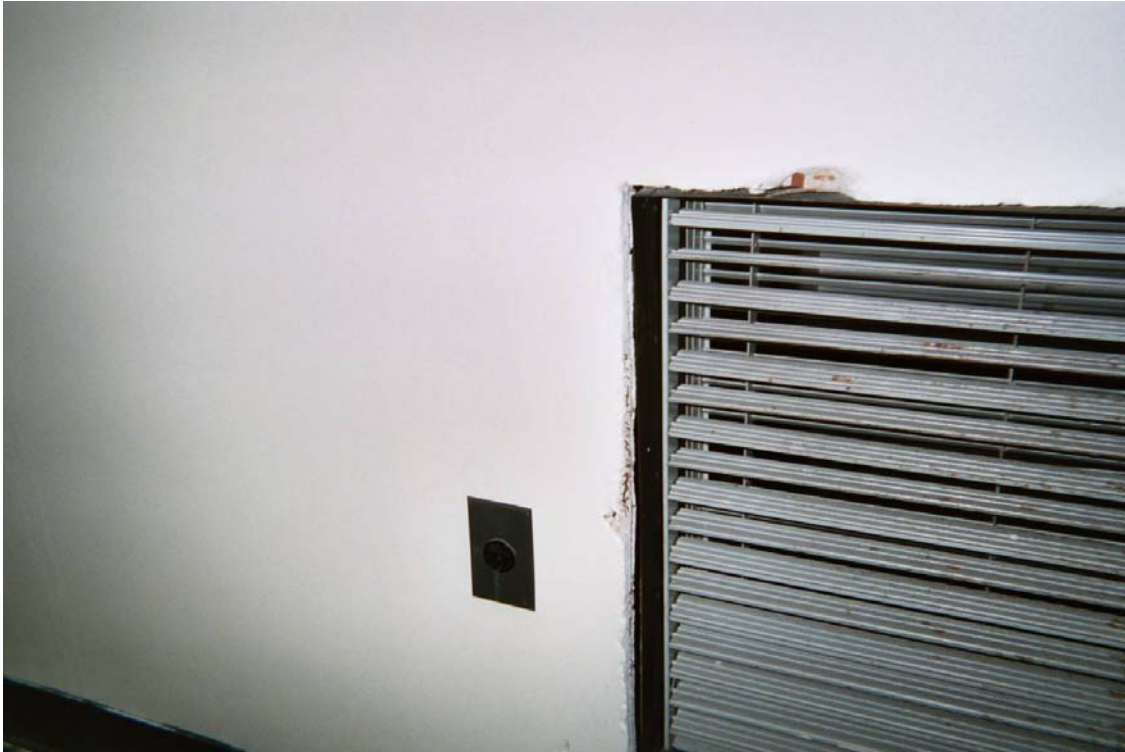
Photo 12 – Non asbestos-containing plaster

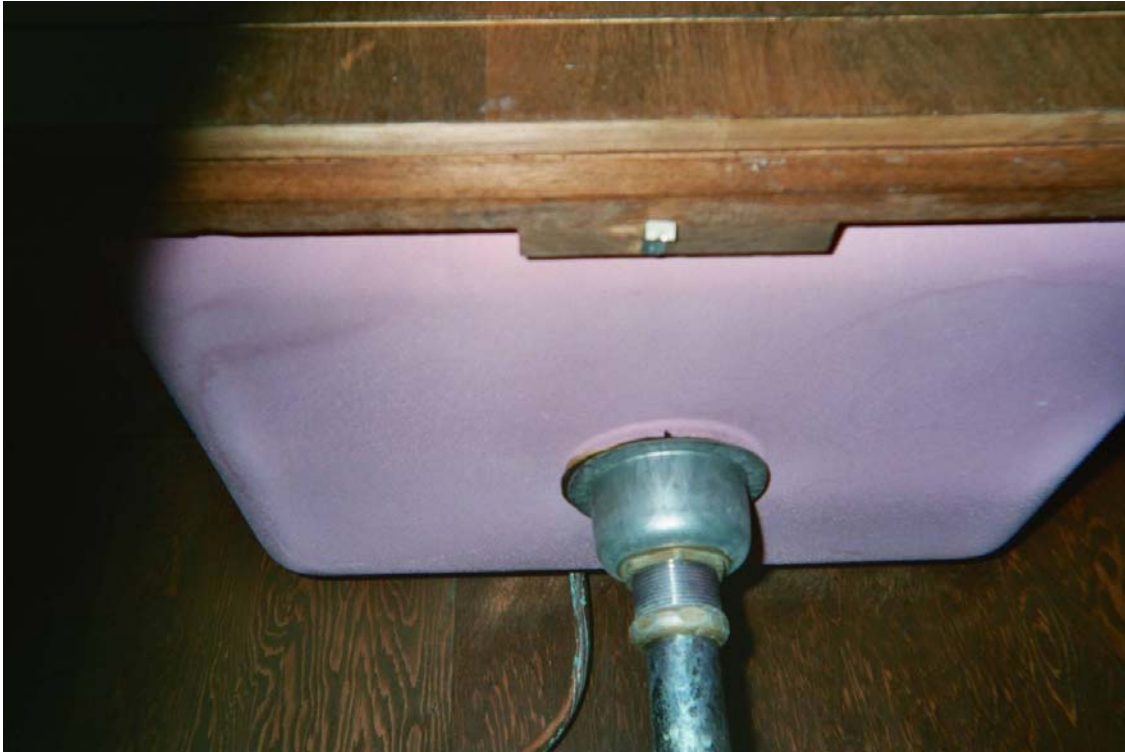
Photo 13 – Non asbestos-containing pink sink undercoating

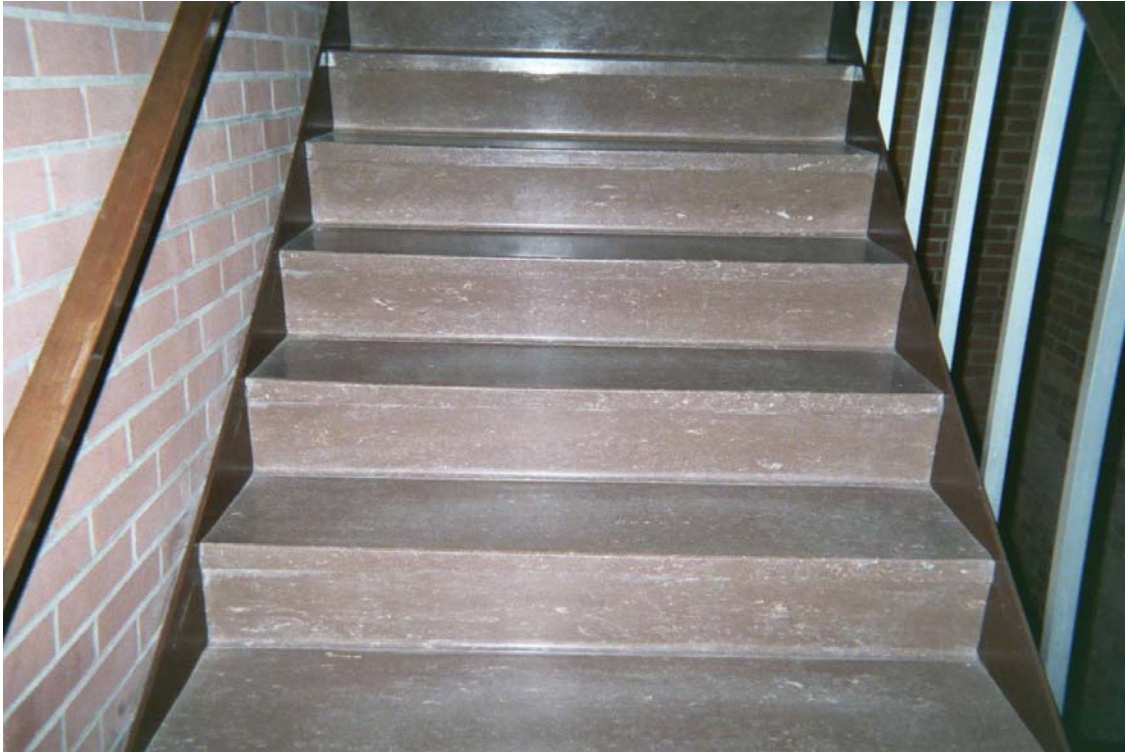
Photo 14 – Asbestos-containing brown vinyl stair tread

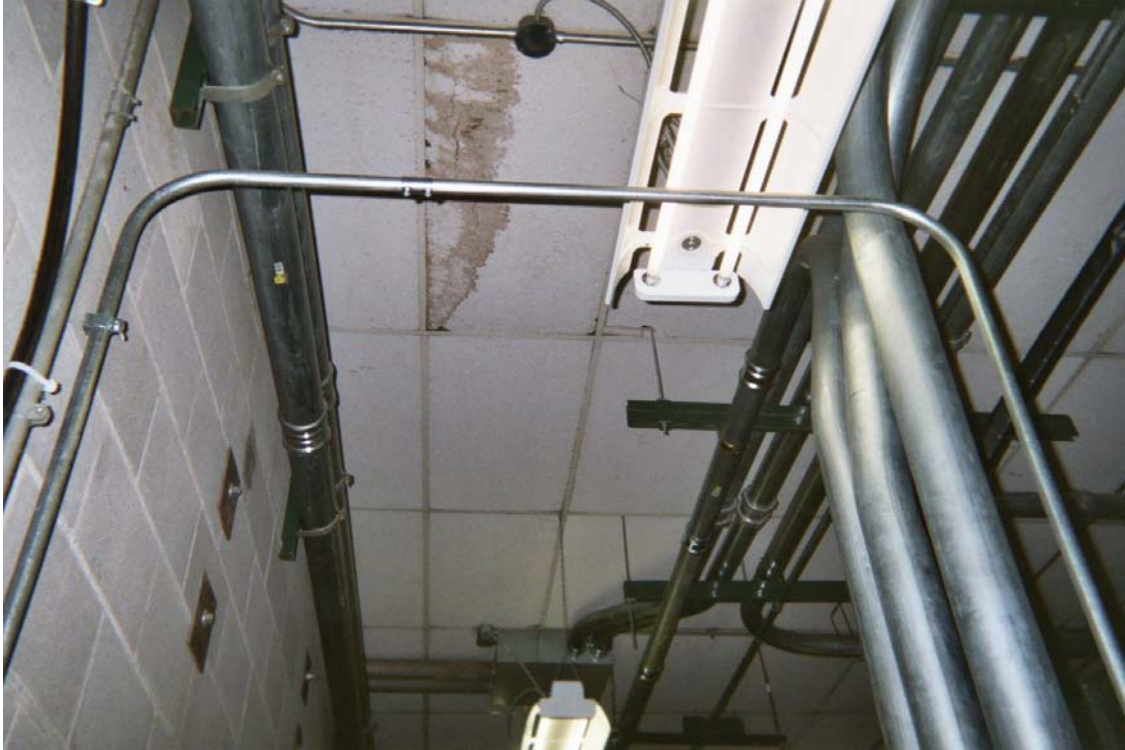
Photo 15 – Non asbestos-containing 2' x 4' white lay-in ceiling tile with pin holes and fissures

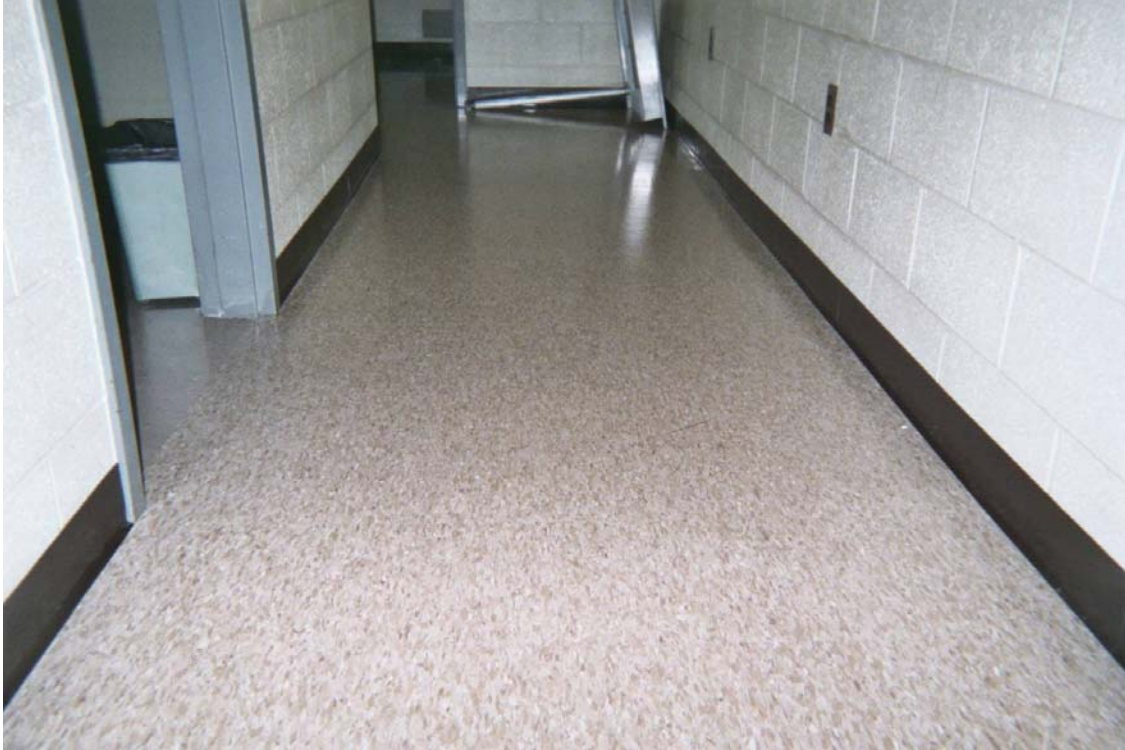
Photo 16 – Asbestos-containing 12” x 12” tan marble floor tile

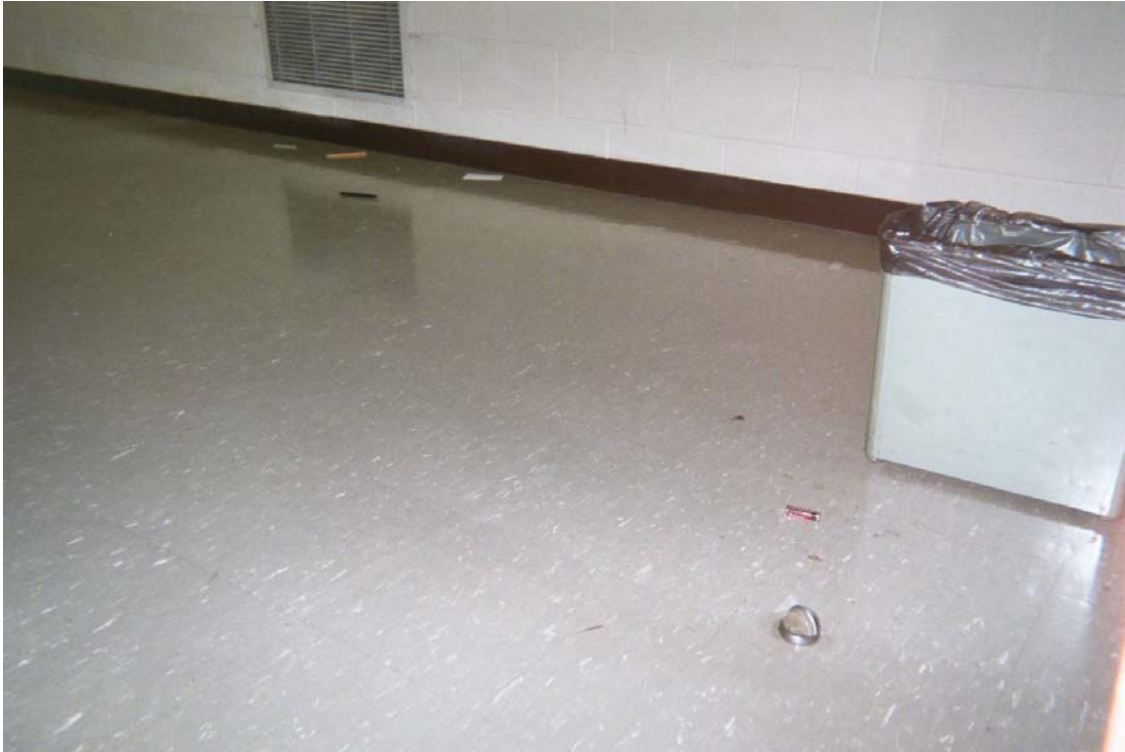
Photo 17 – Asbestos-containing 12” x 12” gray floor tile with white streaks and associated mastic

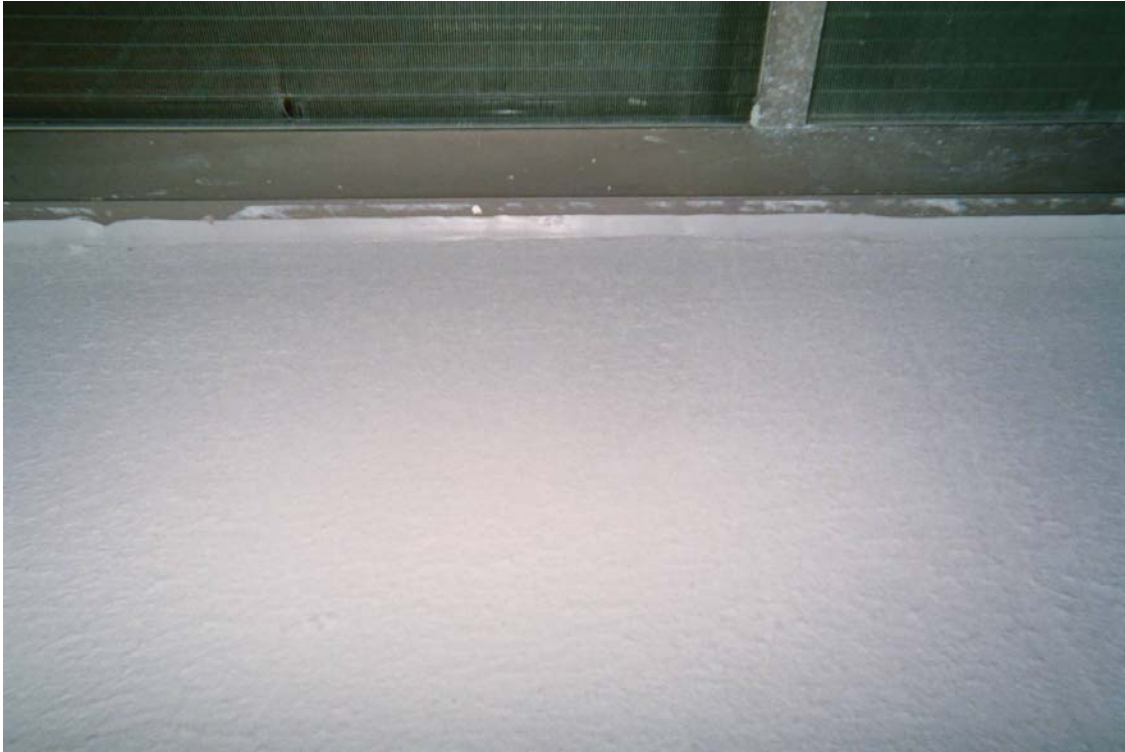
Photo 19 – Assumed asbestos-containing caulk compound

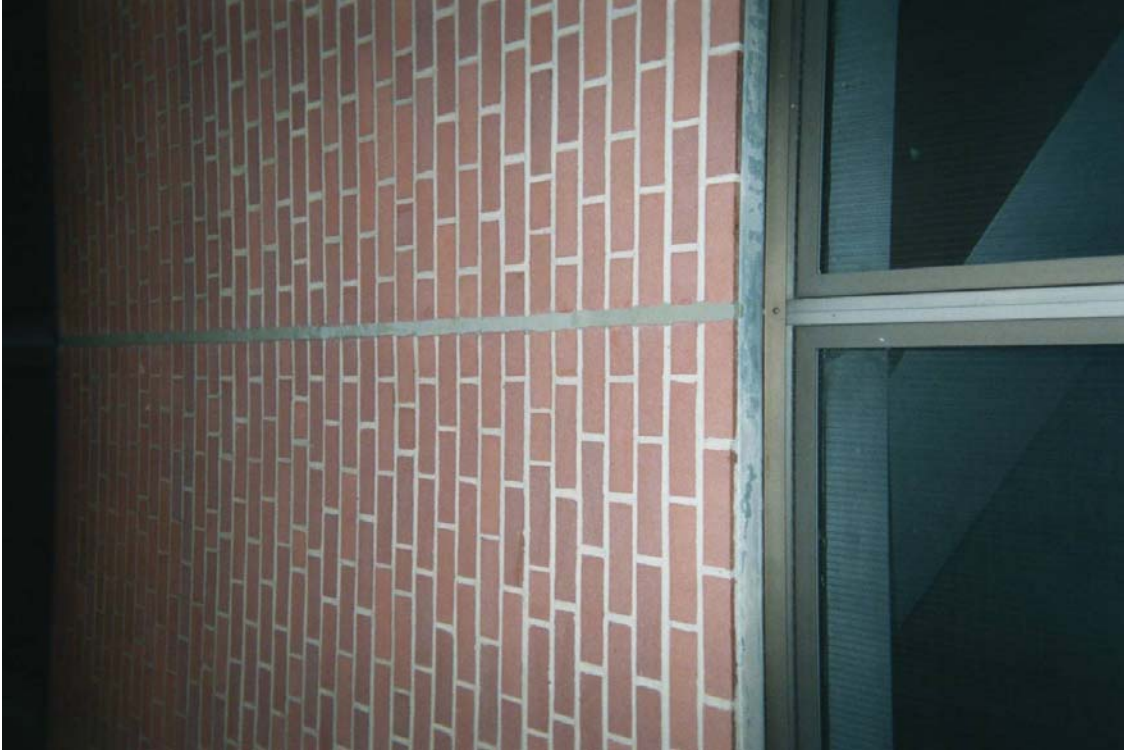
Photo 20 – Assumed asbestos-containing caulk compound
