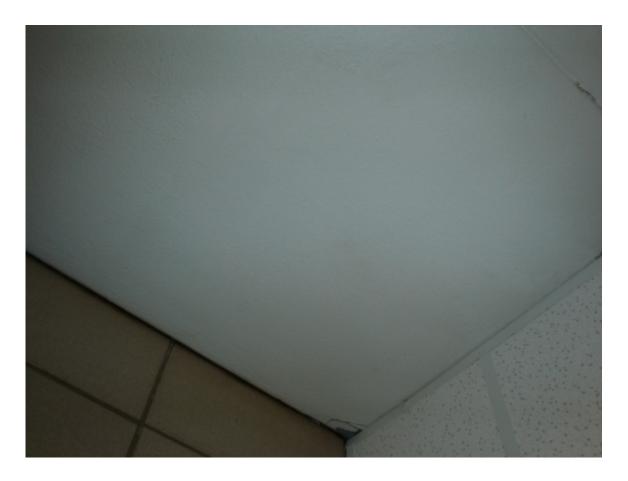
HA #1 – Non asbestos-containing ceiling plaster

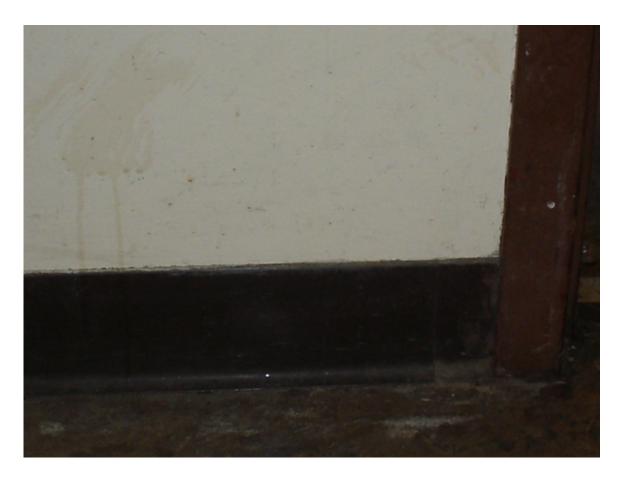
HA #4 – Non asbestos-containing 4" brown cove molding and associated mastic

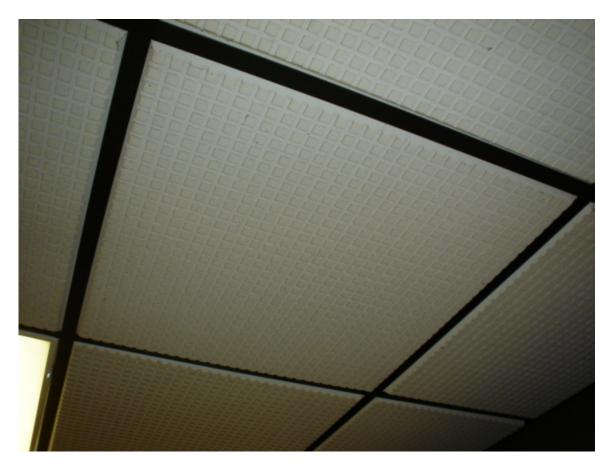
HA #12 – Non asbestos-containing 2' x 2' white drop-in ceiling tile with pin holes and fissures

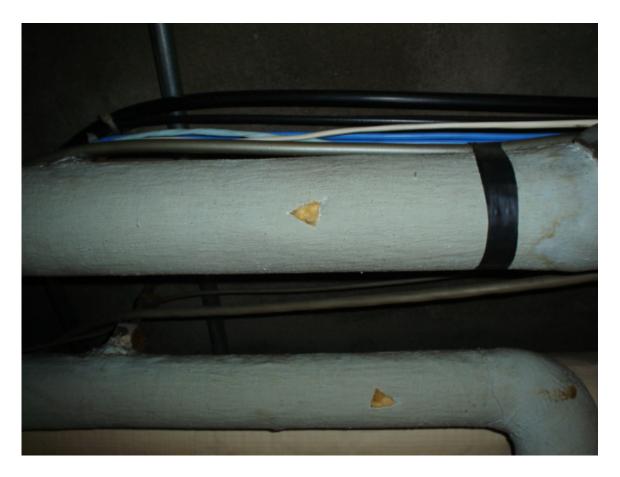
HA #13 – Non asbestos-containing canvas wrap on fiberglass pipe straight insulation

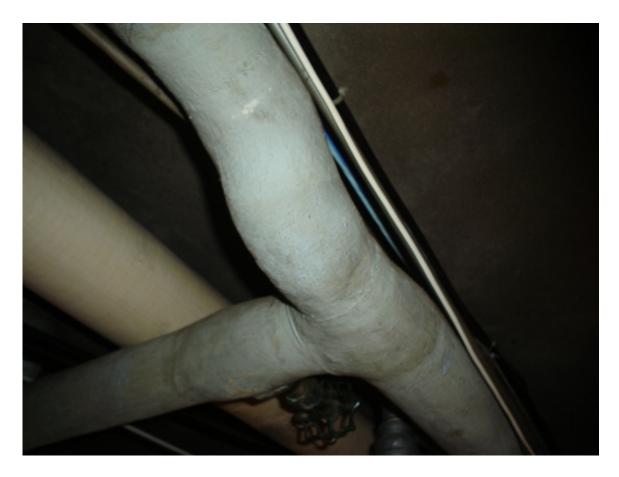
HA #14 – Asbestos-containing domestic water pipe joint and hanger insulation

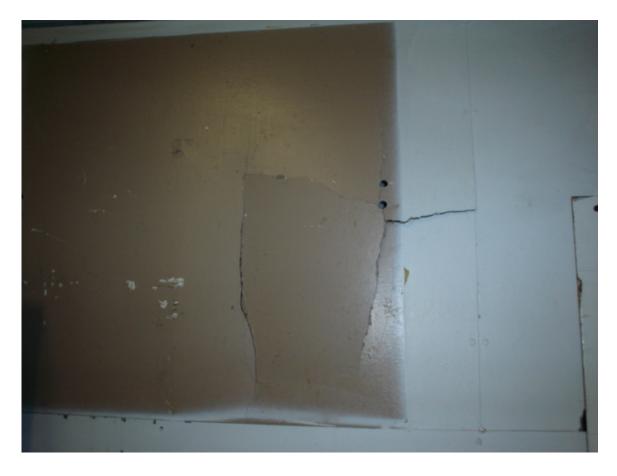
HA #15 – Significantly damaged asbestos-containing transite paneling

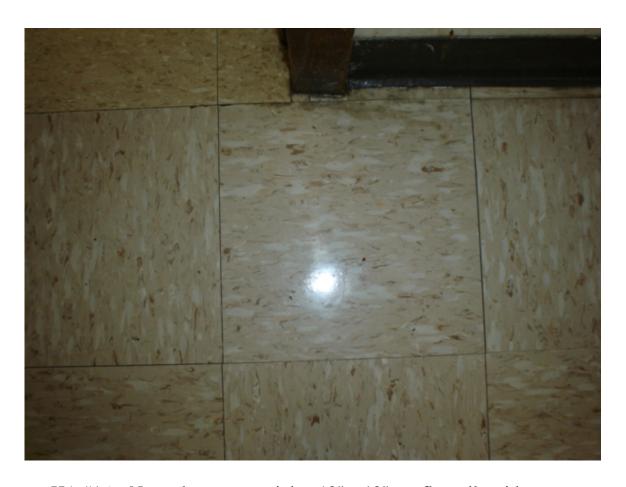
HA #16 – Non asbestos-containing 12" x 12" tan floor tile with cream and brown specks and associated mastic

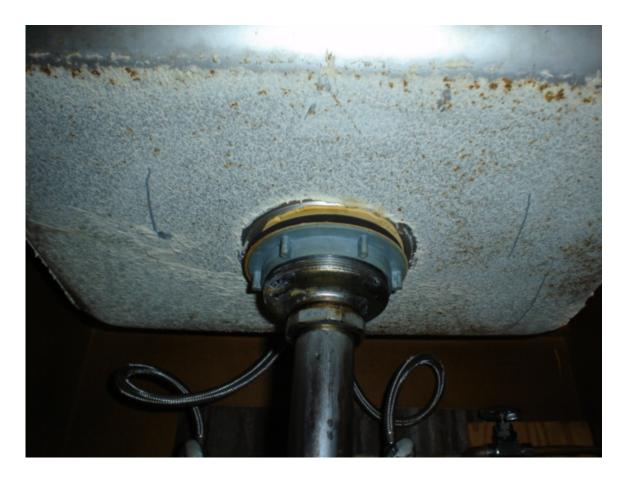
HA #17 – Asbestos-containing white sink undercoating

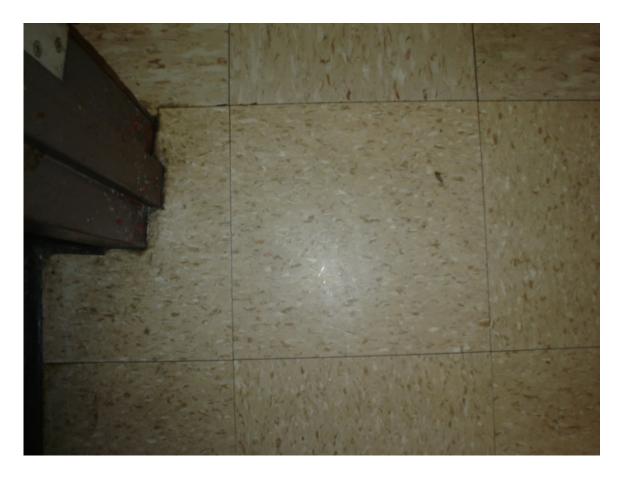
HA #18 – Non asbestos-containing 12" x 12" tan floor tile with marble pattern and associated mastic

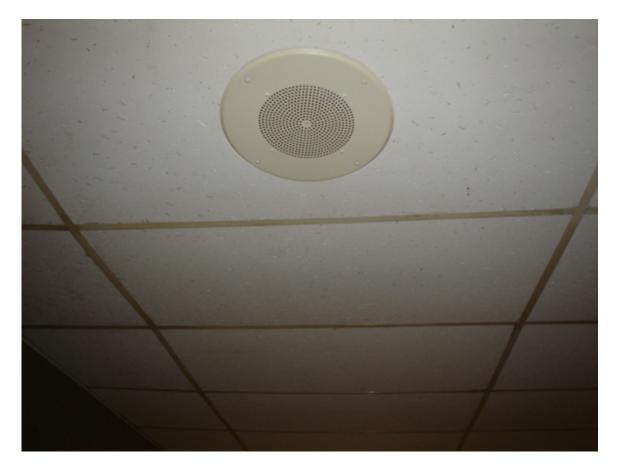
HA #19 – Non asbestos-containing 2' x 4' white lay-in ceiling tile with pin holes and fissures

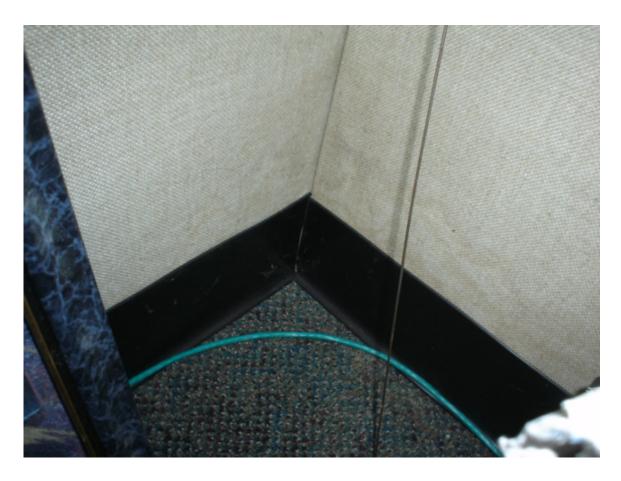
HA #20 – Non asbestos-containing 4" black cove molding and associated mastic
