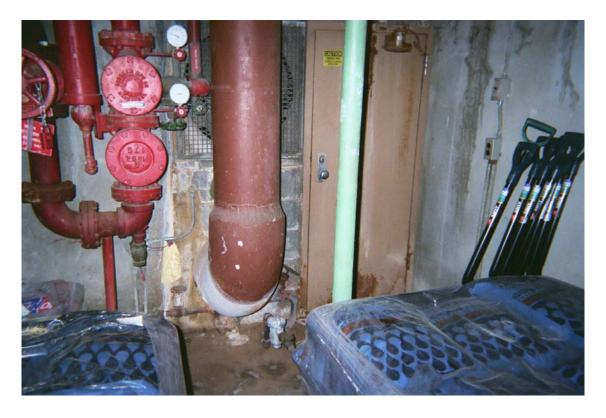
Photo 1 – Asbestos-containing steam/condensate pipe joint insulation

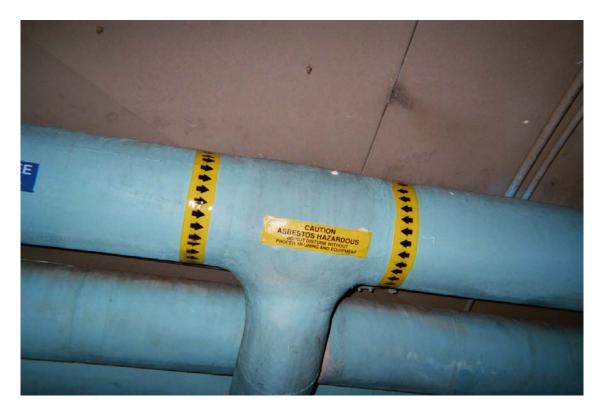
Photo 2 – Asbestos-containing domestic water pipe joint insulation

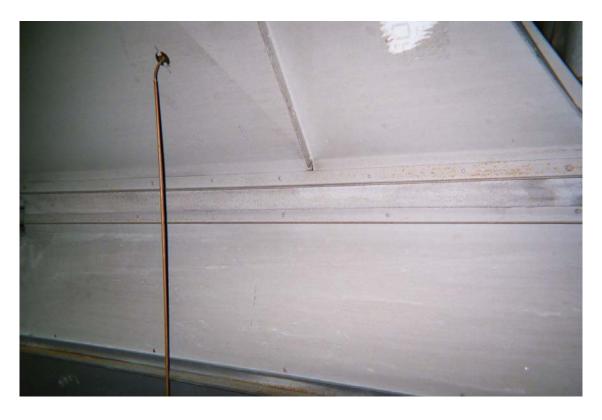
Photo 3 – Asbestos-containing ventilation duct expansion cloth

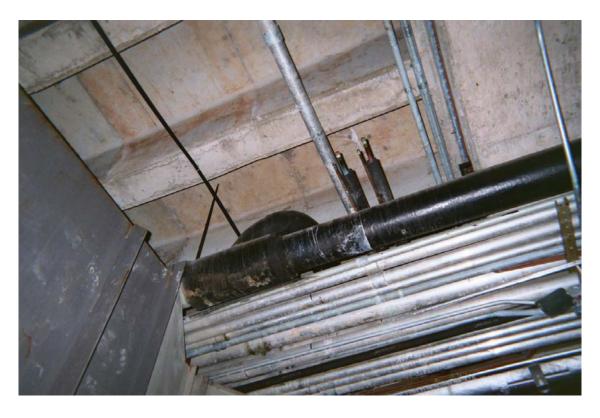
Photo 4 – Asbestos-containing sewer drain pipe joint insulation

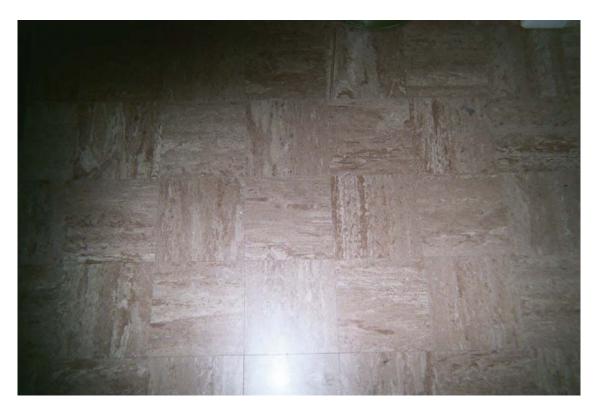
Photo 5 – Asbestos-containing 9" x 9" beige floor tile with swirls and associated mastic

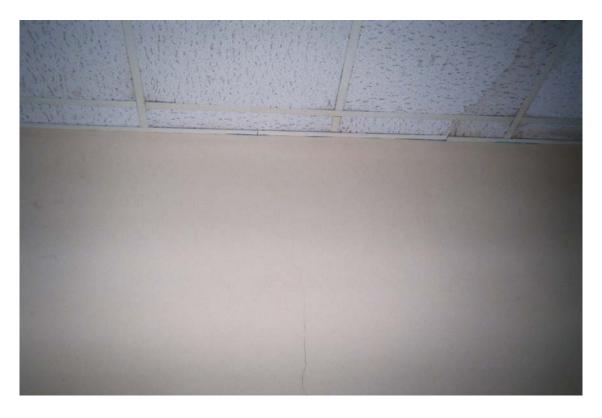
Photo 6 – Non-asbestos containing plaster

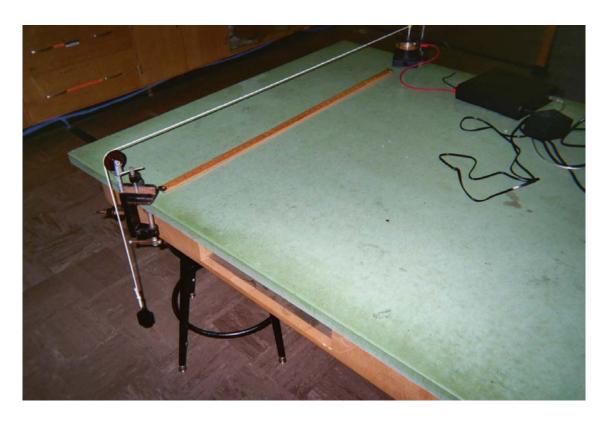
Photo 7 – Asbestos-containing green lab table

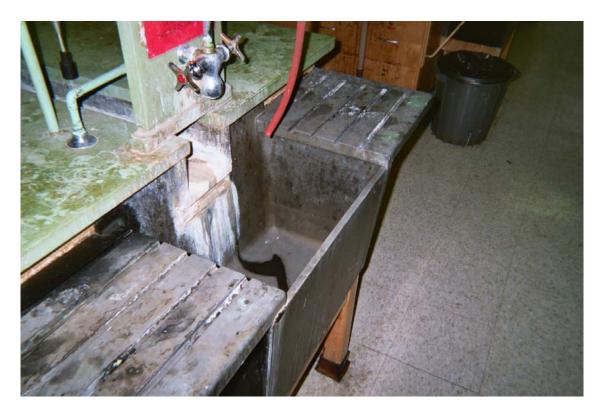
Photo 8 – Non-asbestos containing black lab sink and table tops

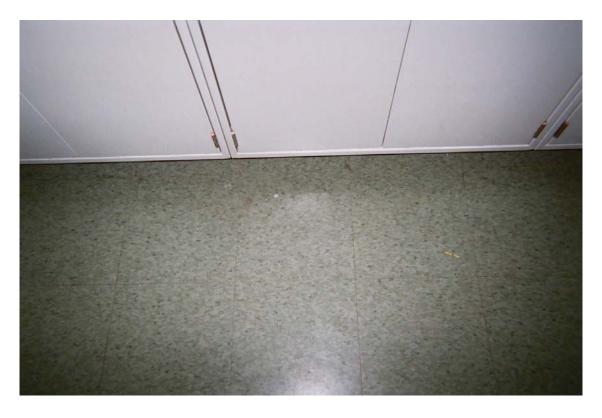
Photo 9 – Non-asbestos containing 12" x 12" green marble pattern floor tile and associated mastic

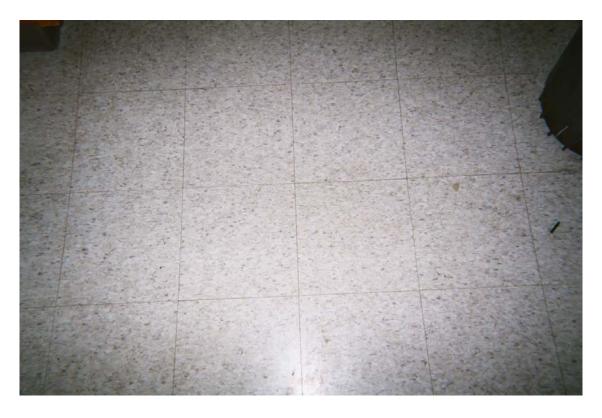
Photo 10 – Non-asbestos containing 12" x 12" cream marble pattern floor tile and associated mastic

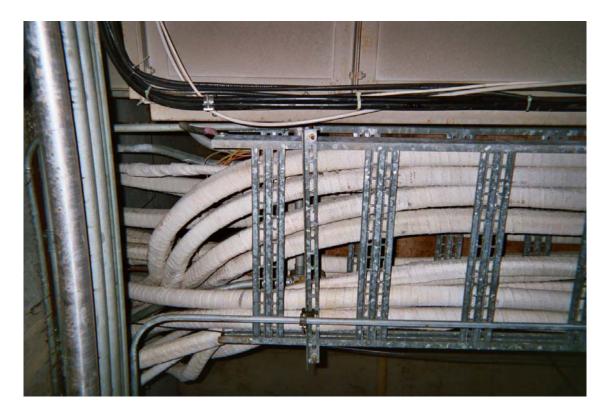
Photo 11 – Asbestos-containing electrical insulation cloth

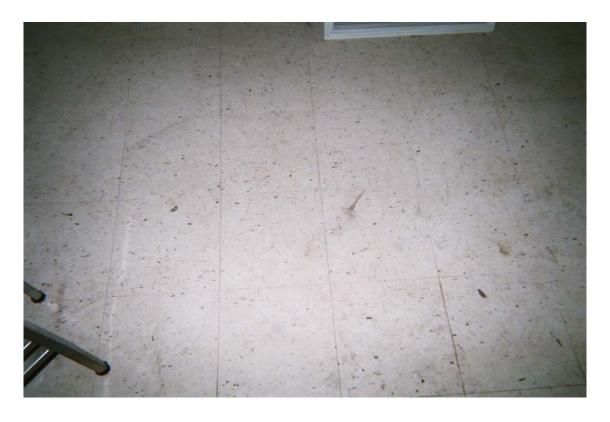
Photo 12 – Non-asbestos containing 12" x 12" light cream floor tile with gray specks and associated mastic

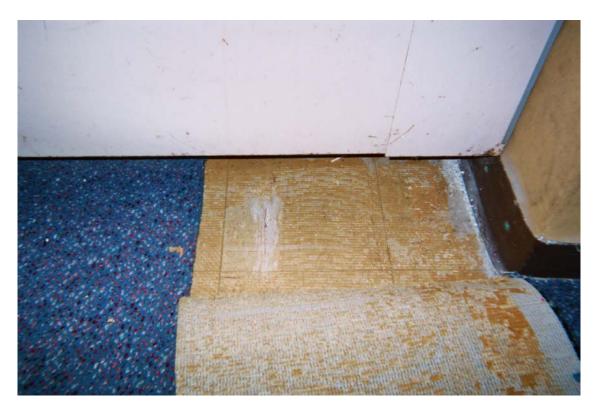
Photo 13 – Asbestos-containing 9" x 9" light brown floor tile with cream and rust streaks and associated mastic

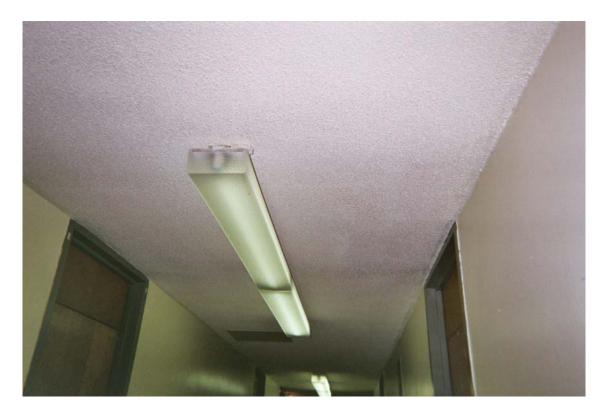
Photo 14 – Non asbestos-containing spray-in acoustical plaster

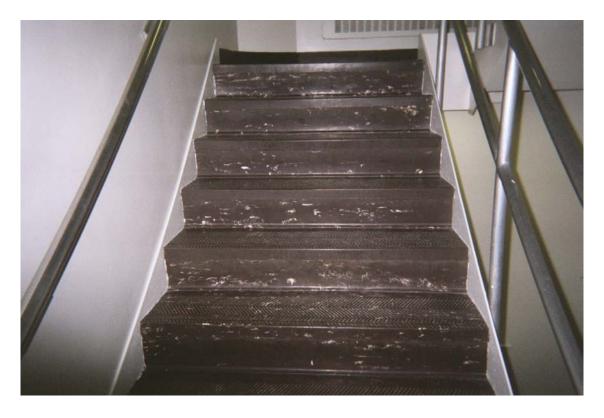
Photo 15 – Non asbestos-containing 2' x 2' brown linoleum and stair tread with cream swirls and associated mastic

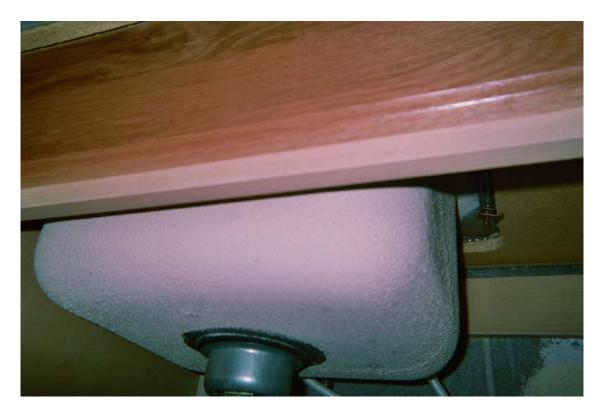
Photo 16 – Non asbestos-containing tan textured sink undercoating

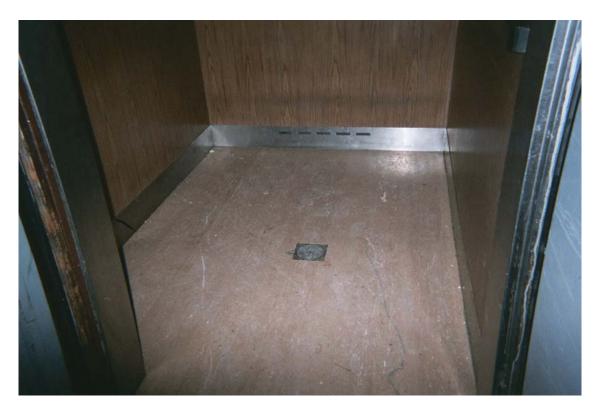
Photo 17 – Non asbestos-containing tan linoleum with cream streaks and associated mastic
