Michigan State University
Asbestos Inspection Photo Log

North Campus Substation (#516)

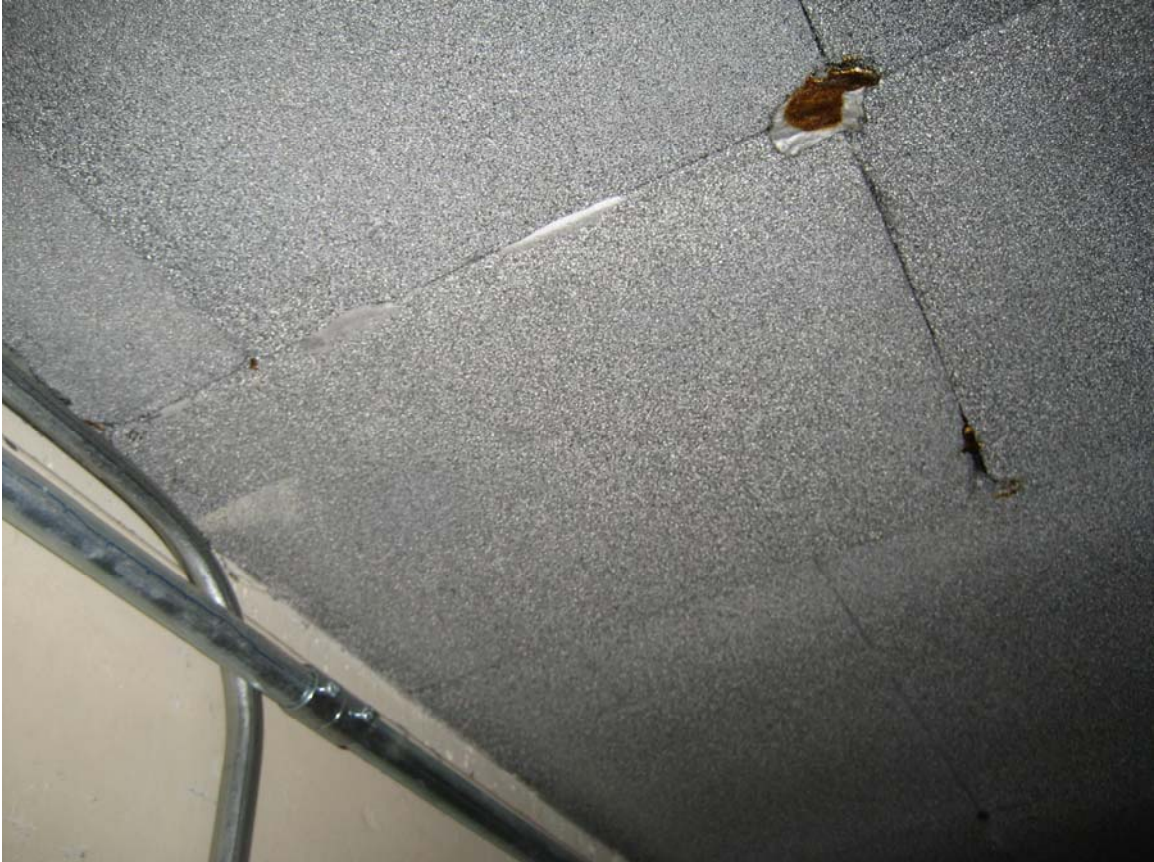
HA #1 – Non asbestos containing Gray Styrofoam insulation and associated brown gluepods

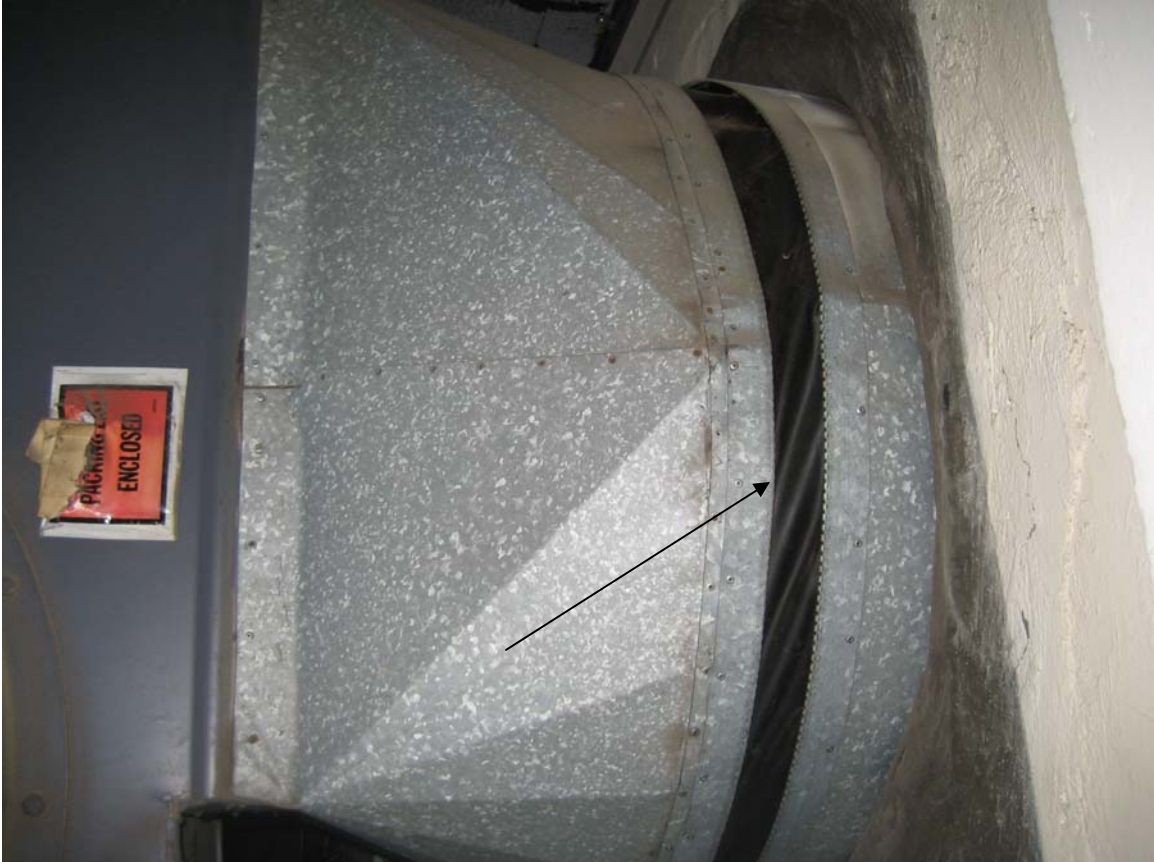
HA #2 – Assumed asbestos containing vibration collar

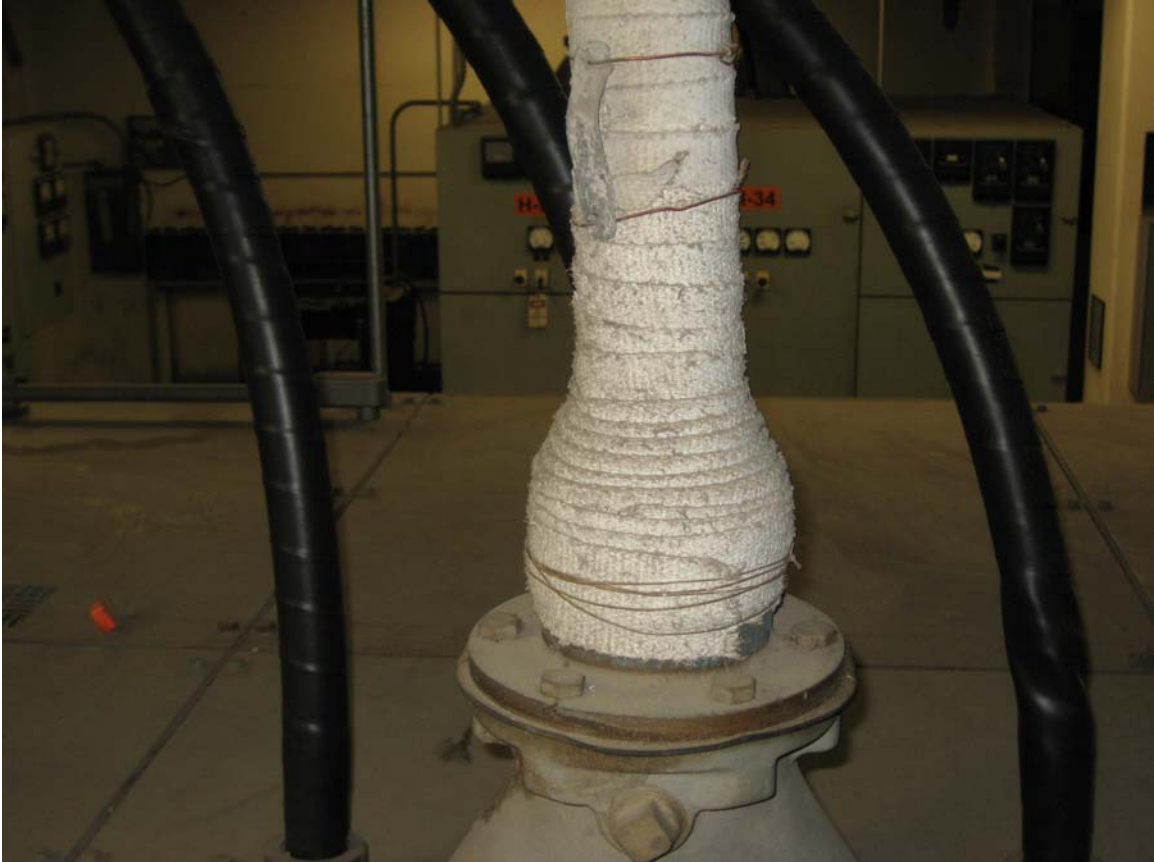
HA #3 – Assumed asbestos containing white electrical line wrap

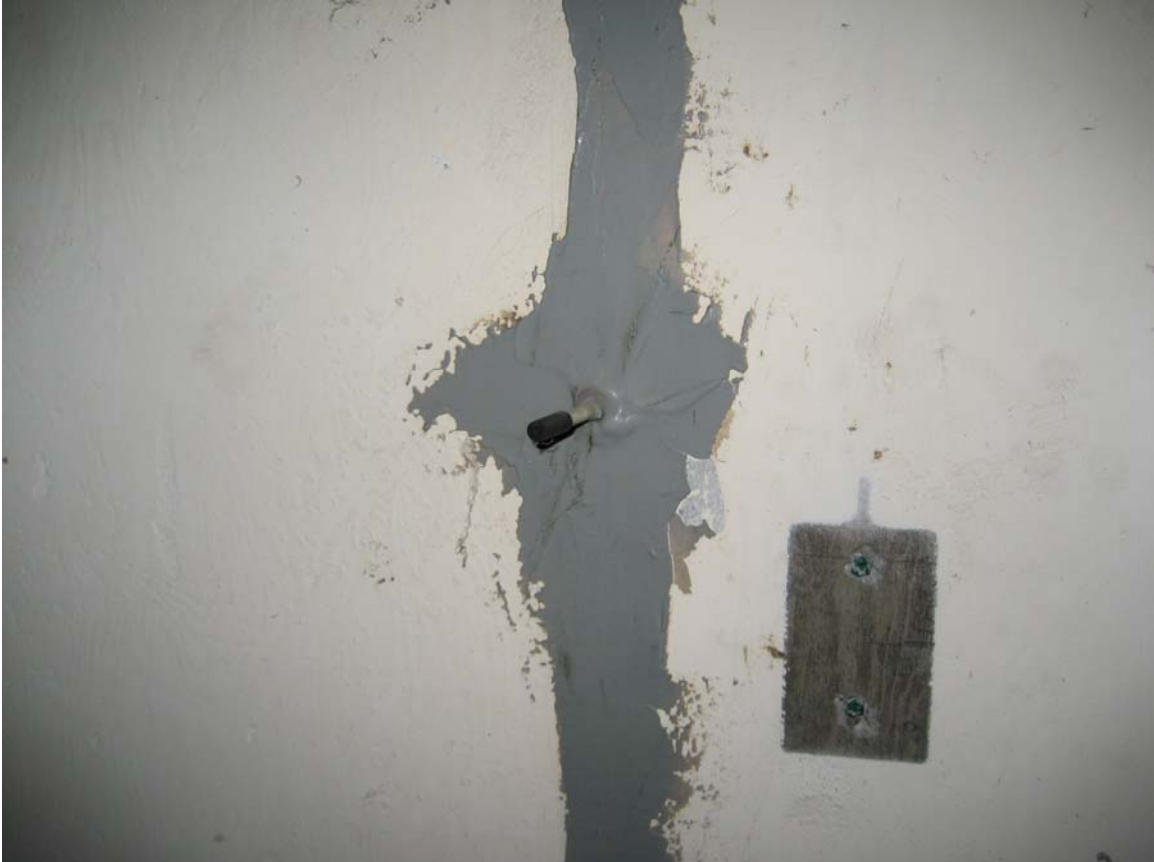
HA #4 – Non asbestos containing Grey wall caulk

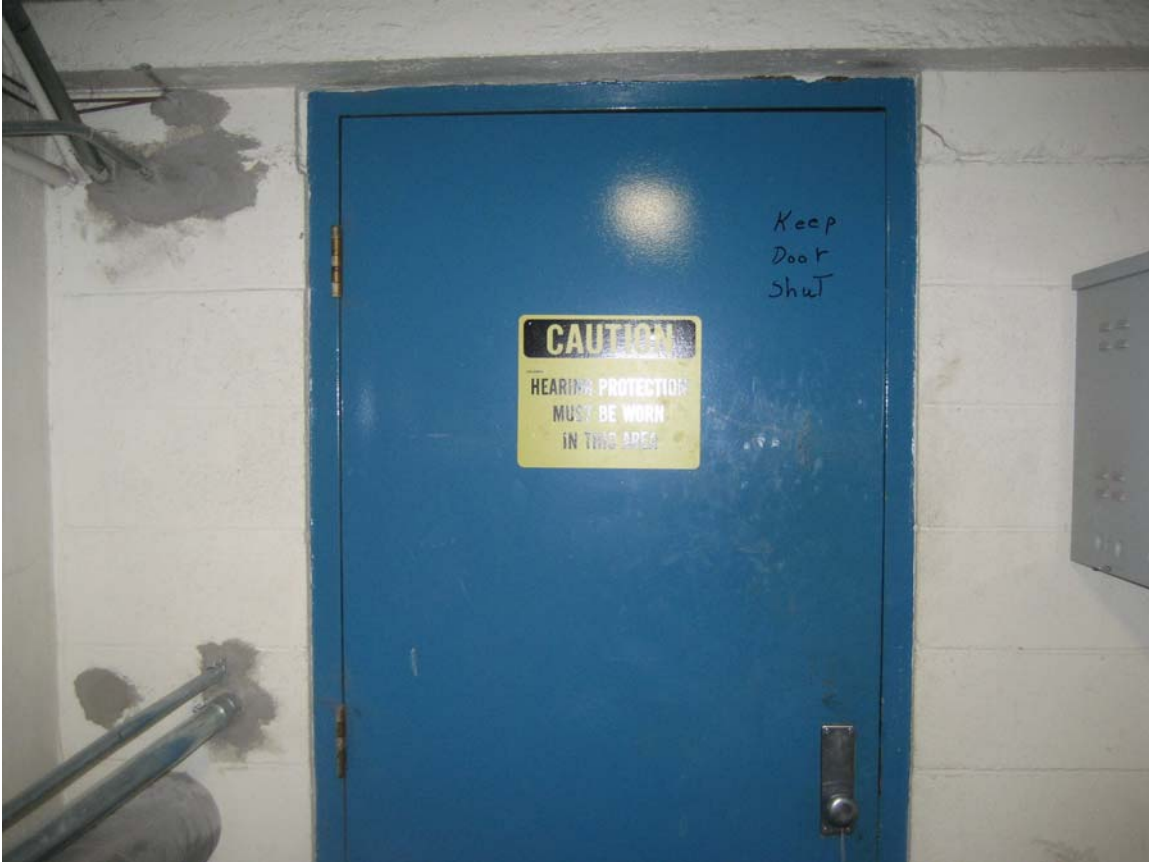
HA #5 – Assumed asbestos containing fire door and frame

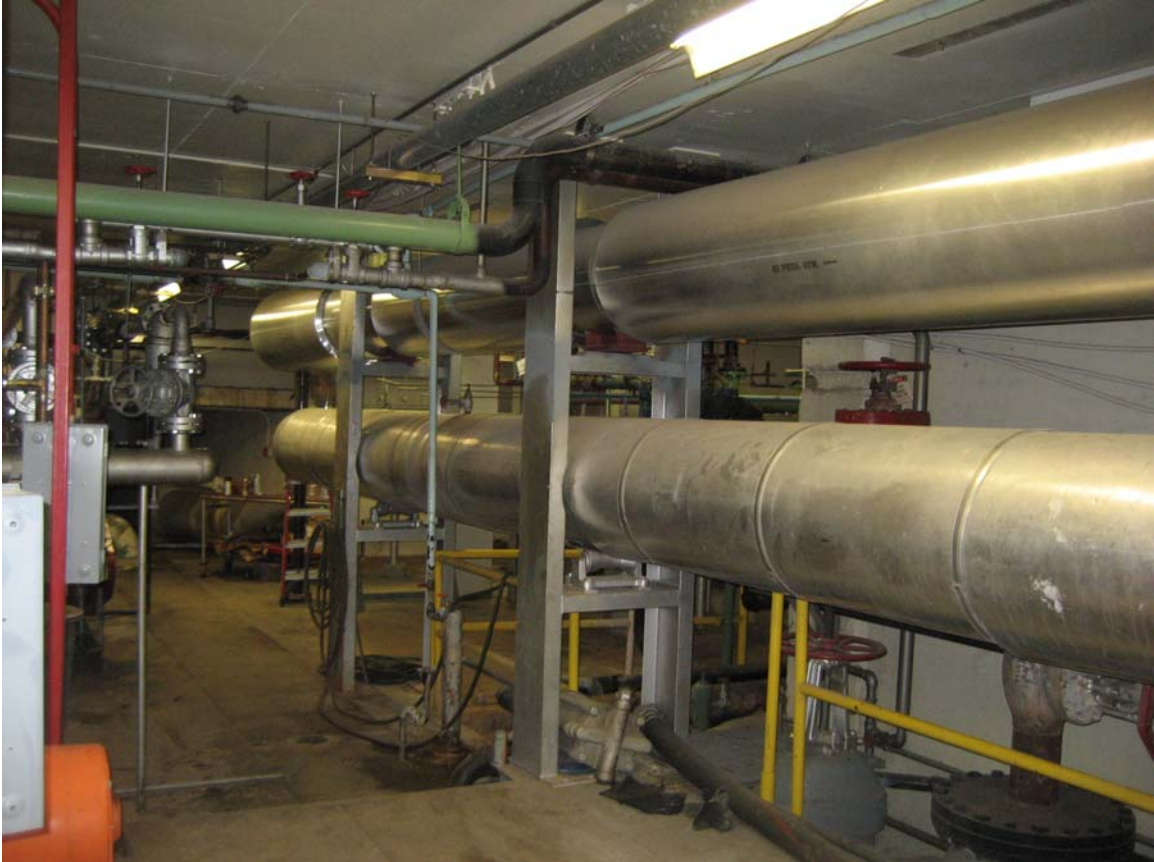
HA #6 – Assumed asbestos containing 12”-36” metal jacketed steam line insulation

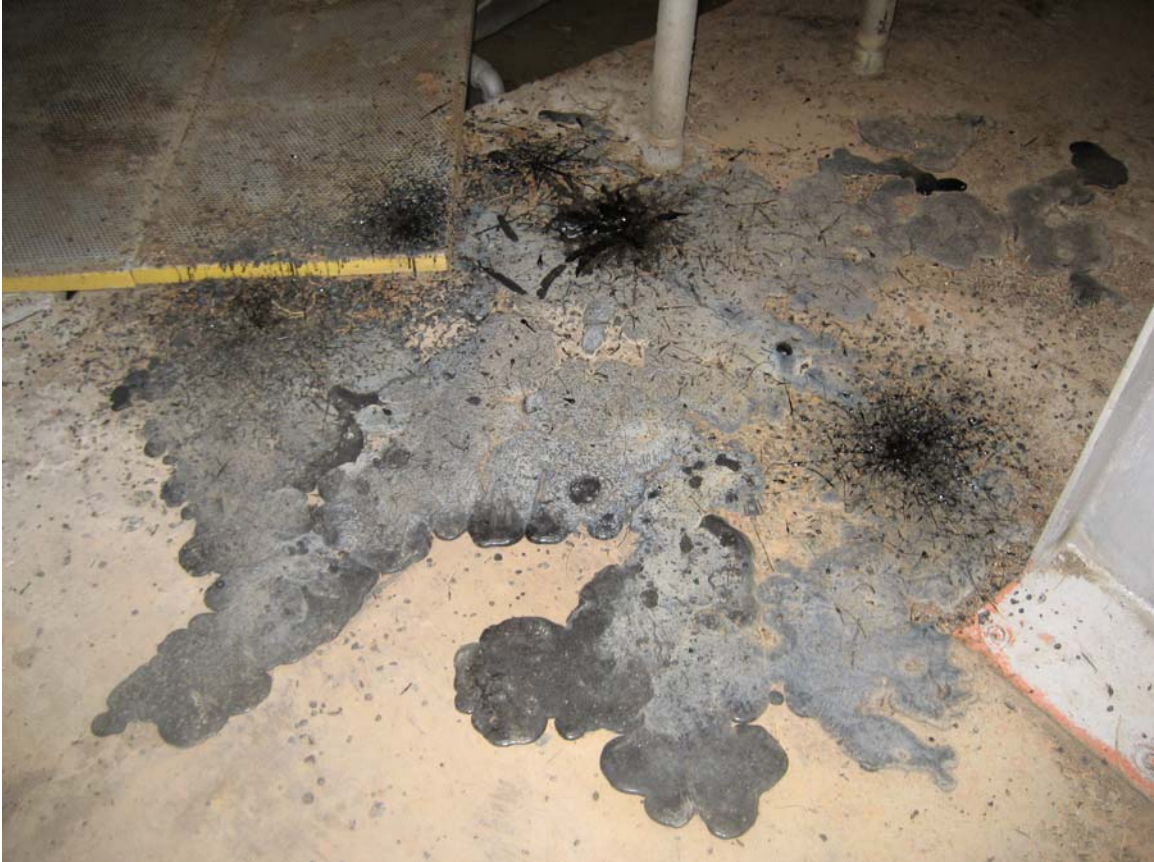
HA #7 – Non asbestos containing melted tar material

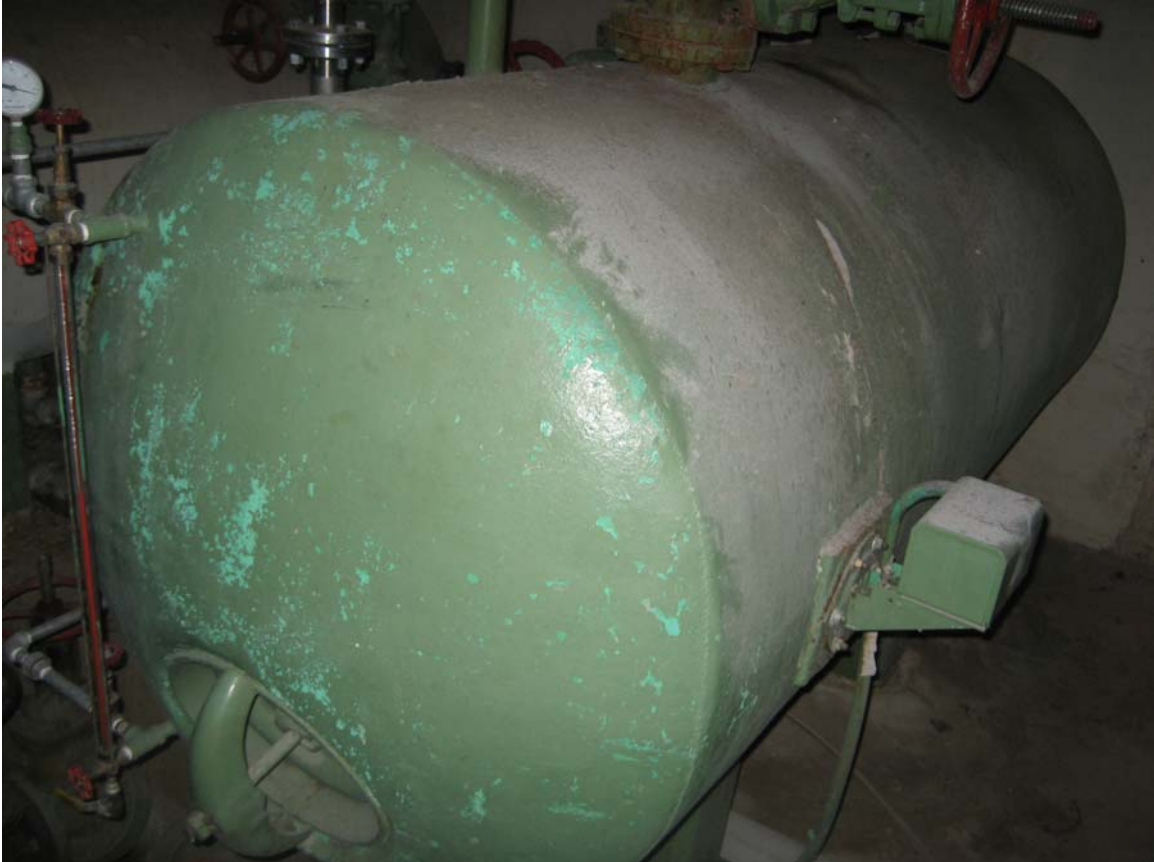
HA #8 – Assumed asbestos containing tank insulation

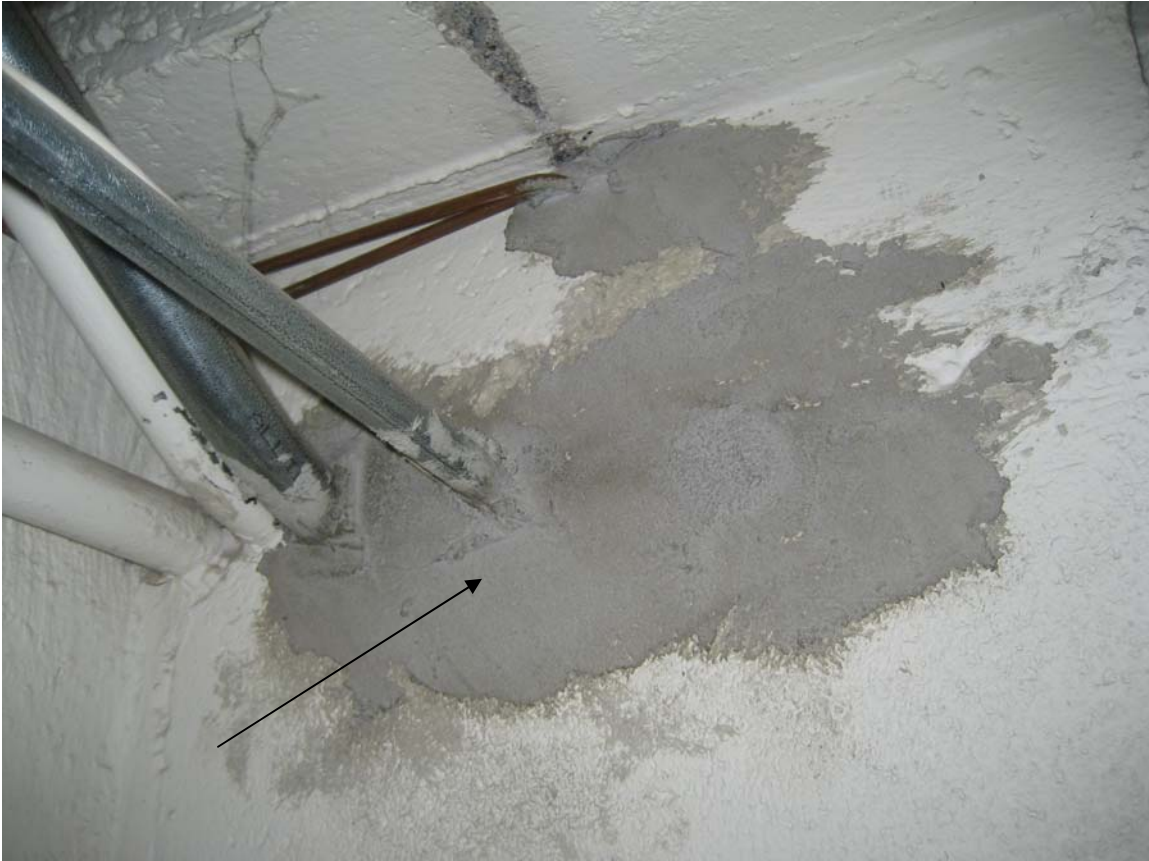
HA #9 – Non-asbestos containing wall penetration fireproofing

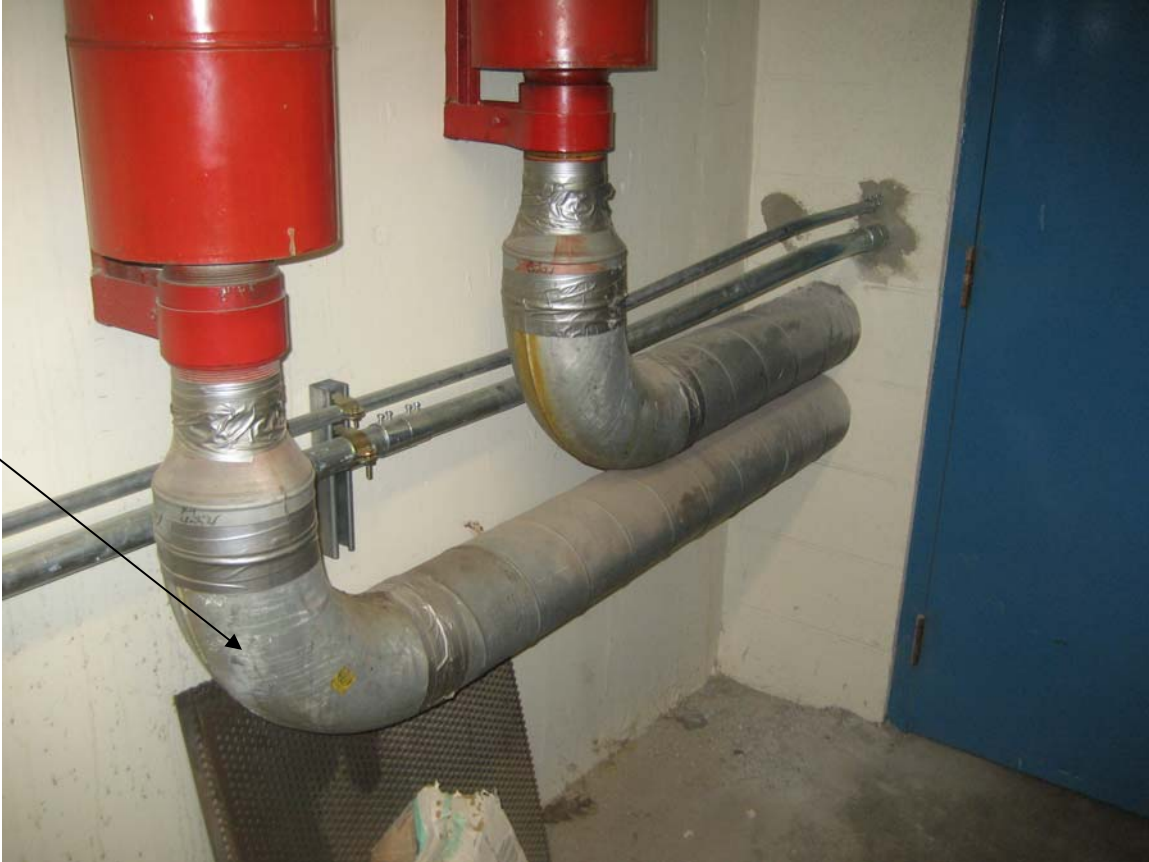
HA #10 – Assumed asbestos containing 0”-12” metal jacketed steam line

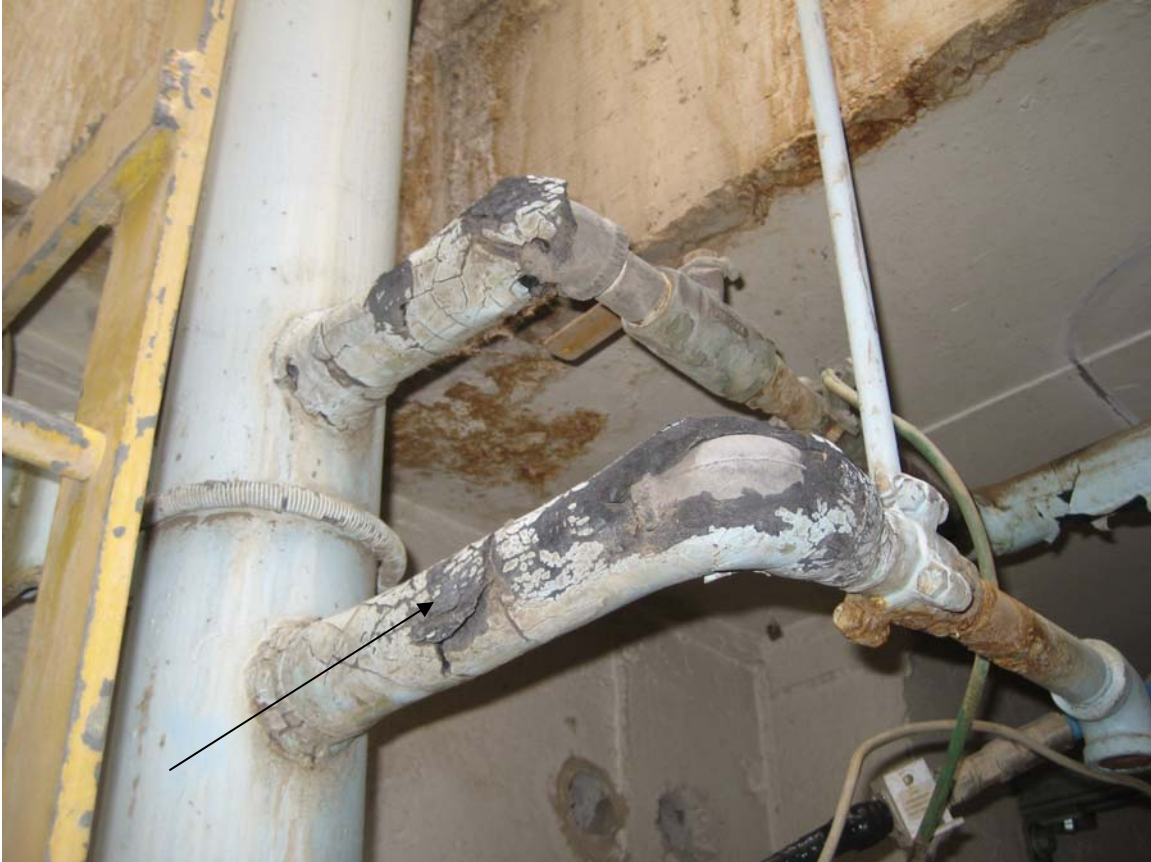
HA #11 – Non asbestos containing black pipe covering
