Michigan State University
Asbestos Inspection Photo Log

Pathological Incinerator (#524)

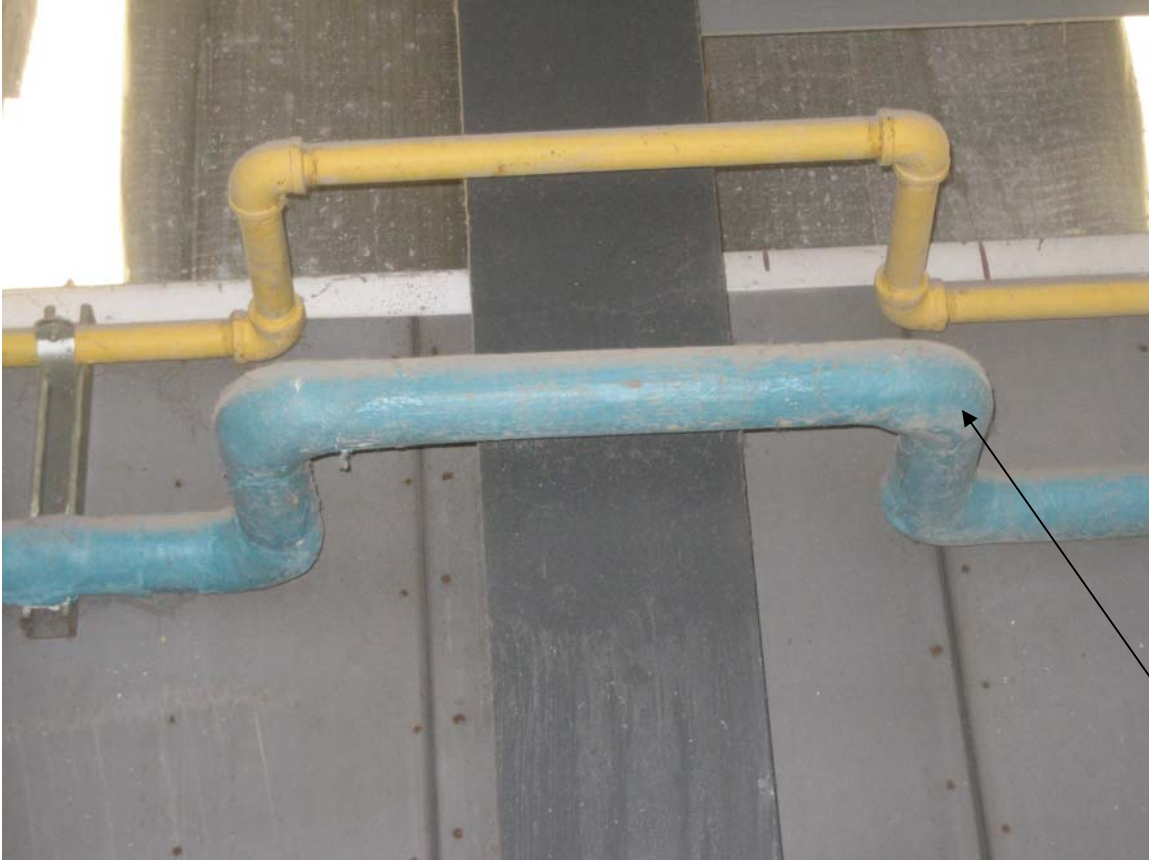
HA #1 – Non asbestos containing mud fittings on fiberglass

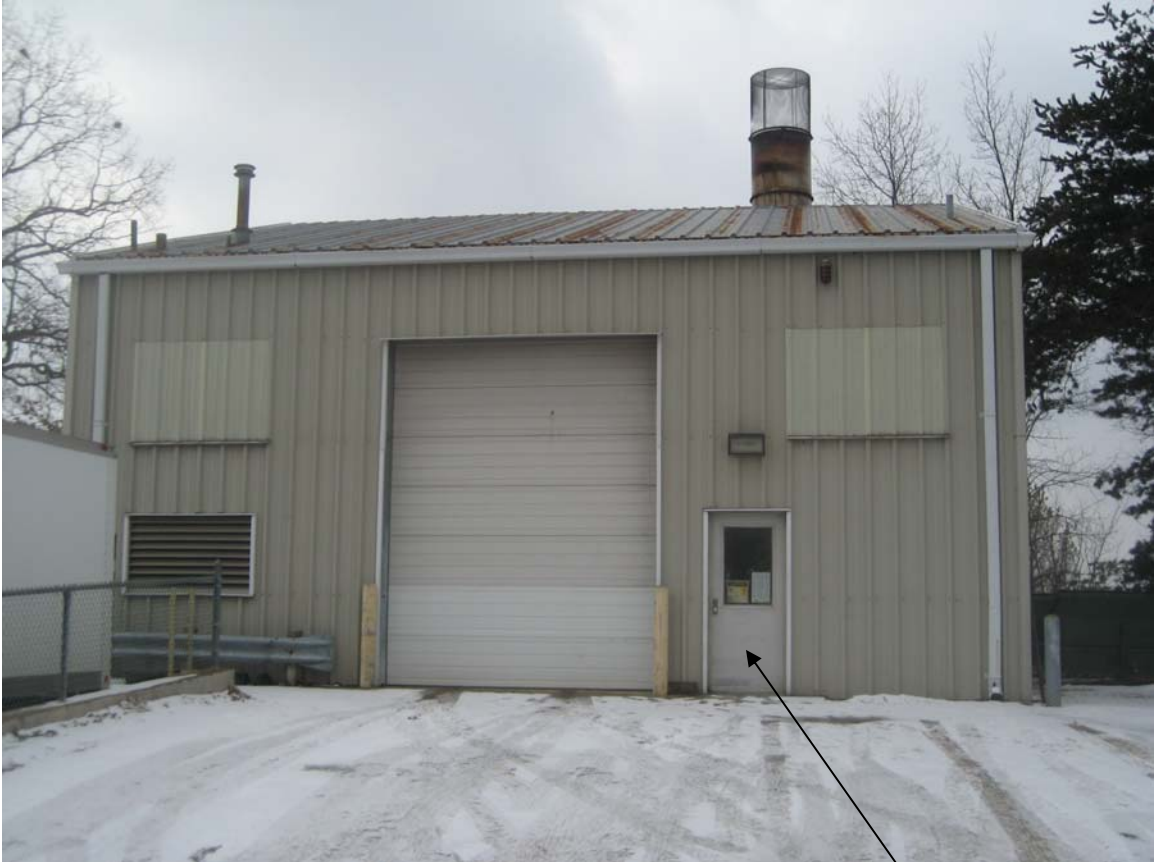
#2 Assumed Fire Door and Frame
